# Carswell Eroding Refuse AML Project

**Location:** Kimball, McDowell County, West Virginia

**Date Submitted:** 5/12/2008

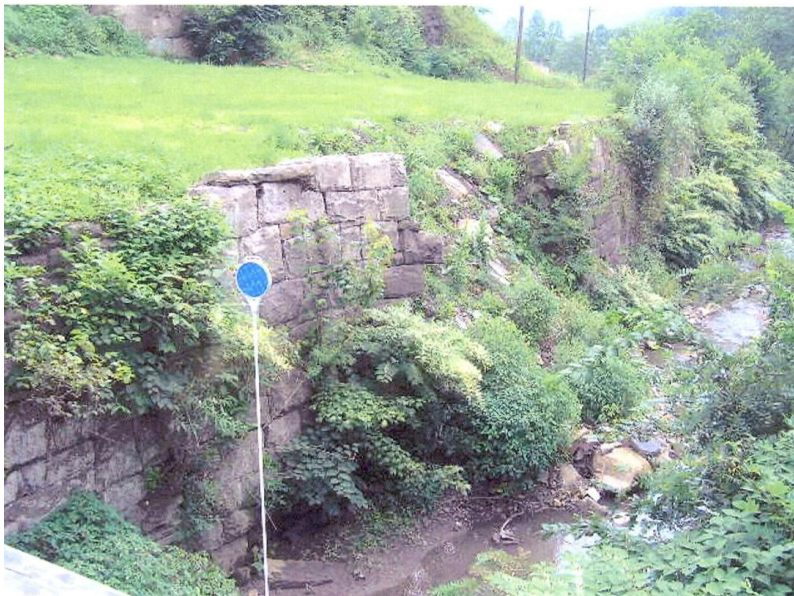
Photo #1

This photo shows one section of the failing cut stone retaining wall partially blocking stream flow along Laurel Branch. Further collapse of the wall would have blocked stream flow causing nearby homes to be flooded or even destroyed if the refuse embankment itself were to fail.

Site #1 not only consisted of the unstable refuse slope along the creek but also included the old cut-stone retaining wall that failed in two sections during one of the earlier floods. To repair the damage and match the appearance of the existing wall as much as possible, as well as provide the necessary lateral supporting strength, engineers decided to use a modular, interlocking, pre-cased concrete stone block with a natural look and texture. However, because the unconsolidated fill behind the existing wall contained a large amount of rock that might prevent each helical screw from reaching an adequate depth in some areas, a new design was required to meet specifications. After inserting each screw to its greatest depth possible, it was decided that each 12 inch diameter hole would then be filled with non-shrink grout, effectively gluing it to the surrounding matrix.

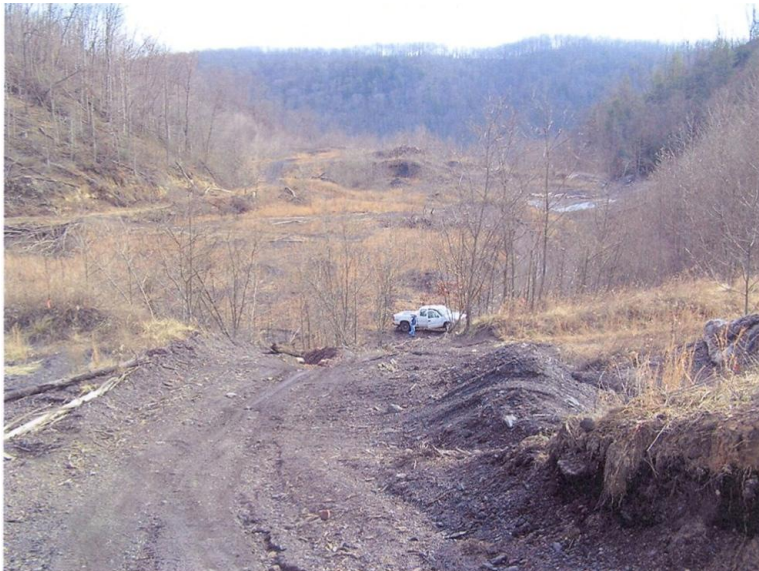
Photo #2

Coupled with the looming potential for catastrophic property damage along Laurel Branch, located nearby was another abandoned mine lands site, Site #2, which consisted of a 20-acre refuse pile. This pile had steep slopes and the easily erodable material was very unstable. Numerous homes as well as a public road located at the pile's toe were in danger of being flooded or destroyed by a landslide, should one develop. Local residents and abandoned mine lands officials alike were concerned that this site could also cause serious damage to downslope properties should these issues go unresolved.

This photo shows the abandoned, partially vegetated 20 acre refuse area with its highly erodable and unstable outcrops.

Field conditions at Site #2 also required special design considerations. Of greatest concern was establishing an adequate toe and subdrainage system for the re-graded 20 acre refuse area. These concerns would be satisfied by the installation of a large rock toe fill to serve as both a supporting buttress that would hold the material in place as well as provide drainage, along with a drainage blanket to collect subsurface water.

The unstable refuse at Site #2 was then graded to a 2:1 slope with drainage benches placed at 50 feet intervals. A total 191,000 cubic yards of refuse were excavated in the process and a rock toe fill consisted of 6,450 cubic yards of sandstone shot rock. Also, a drainage blanket 40 feet wide, 4 feet thick, and 510 feet long was placed to collect subsurface water.

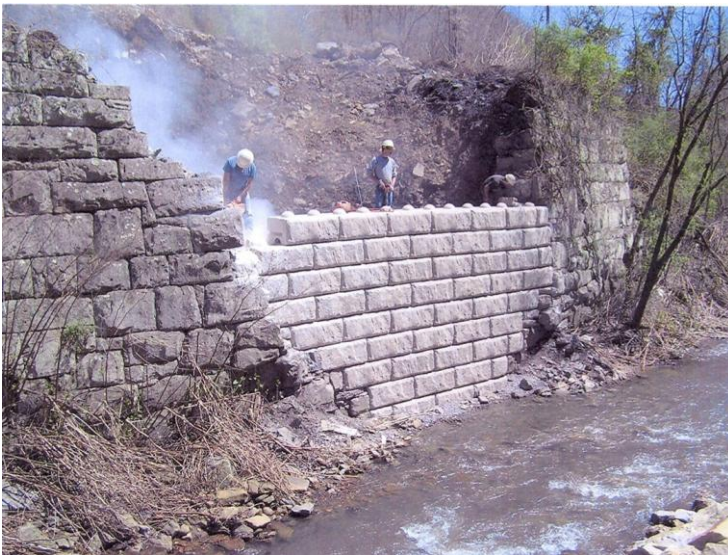
Photo #3

This photo shows repair at one of the damaged sections of the cut stone wall. Installation involves placing successive rows of a modular, interlocking, pre-cast concrete stone block with a natural appearance that tie into the existing wall at both ends.

Each natural appearance man-made concrete block used to repair the damaged wall at Site #1 were 30” deep, 46” long, and 18” in height, and weighed approximately 2,400 lbs. After placing the first course of block on a pad of class I stone aggregate, each successive row was installed and tied-in to the existing stone at both ends to insure maximum strength. As installation progressed, the contractor filled the void behind each block with compacted stone. In total, the contractor repaired 55 linear feet of damage wall.

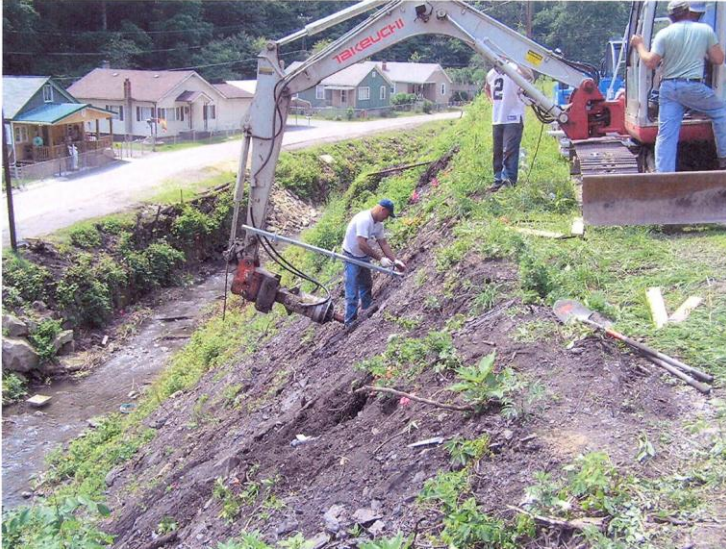
Photo #4

This photo shows the contractor installing one of the long helical screws into the unstable refuse outslope at Site #1. After all the screws are in place, the slope is covered with steel mesh and secured with spike plates.

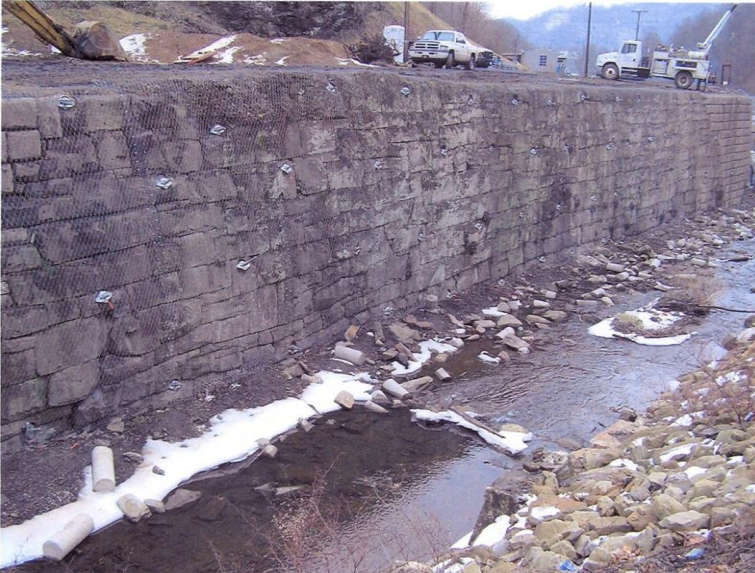
Photo #5

This photo shows the repaired stone wall after it was covered with high tensile-strength steel mesh. The entire wall is now stable and safe.

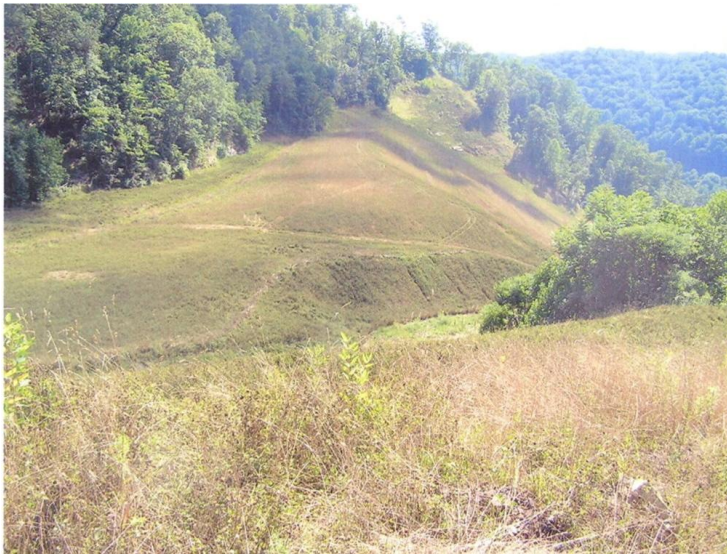
Photo #6

This photo shows the reclaimed 20 acre refuse area after being re-graded and vegetated. This work eliminated the potential threat of flooding or a devastating landslide.
