**CONSENT ORDER  
ISSUED UNDER THE  
WATER POLLUTION CONTROL ACT  
WEST VIRGINIA CODE CHAPTER 22, ARTICLE 11**

ORDER NO.: 10260

1. Horus West Virginia 1, LLC is conducting land disturbance activity associated with the Blake Solar Project in Jefferson County, West Virginia. Horus West Virginia 1, LLC was issued WV/NPDES Water Pollution Control Permit No. WV0115924, Registration No. WVR111837, on August 12, 2022.
2. On May 15, 2023, West Virginia Department of Environmental Protection (WVDEP) personnel conducted an inspection of the facility. During the inspection, violations of the following sections of the WV/NPDES permit were observed and documented:
  - a. Section II.H.1.d. – Horus West Virginia 1, LLC failed to provide an adequate stone access entrance/exit to reduce the tracking of sediment onto public or private roads.

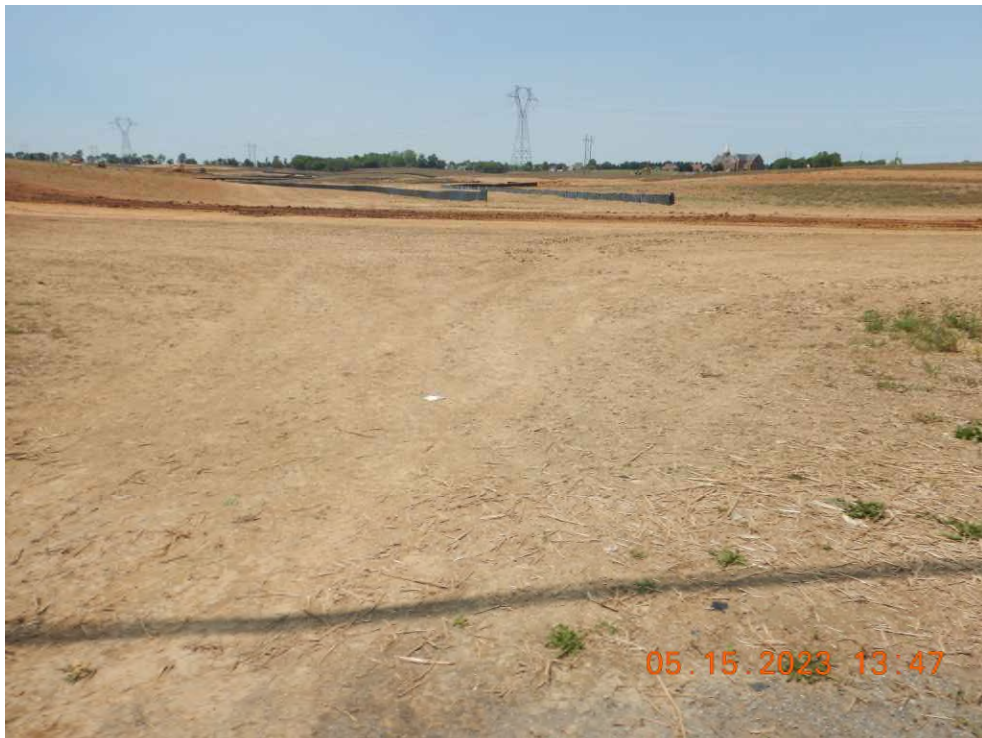
Construction entrance needs stabilization.

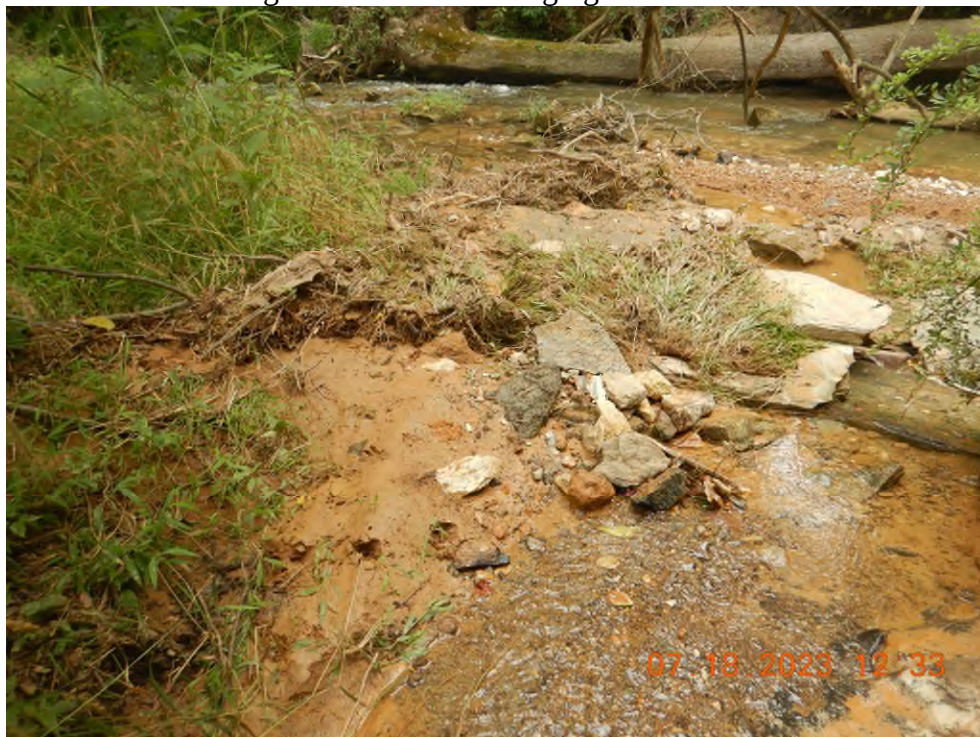
Sediment laden water that has caused conditions not allowable in Evitts Run.

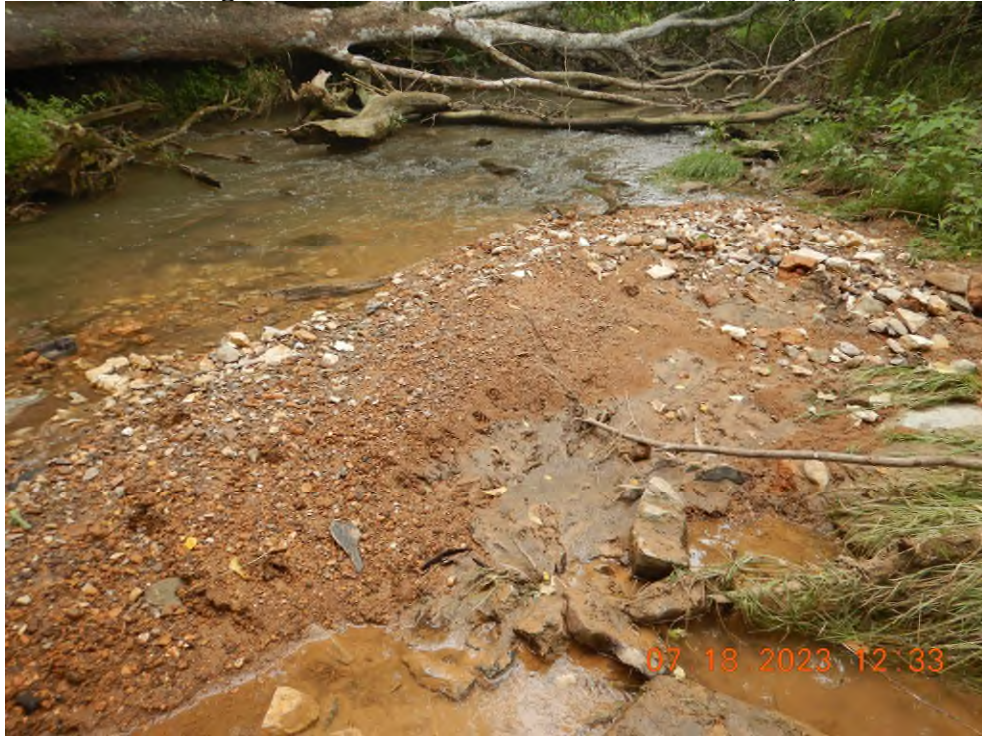
Sediment in Evitts Run.

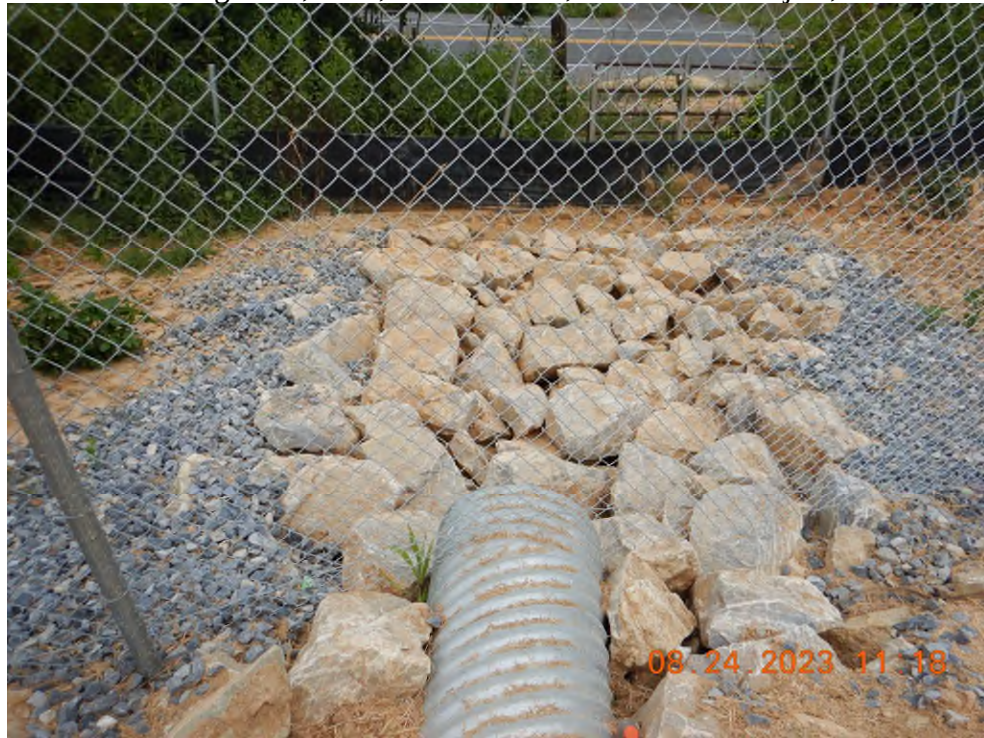
Area of Sediment Basin 6. No outlet marker has been installed.

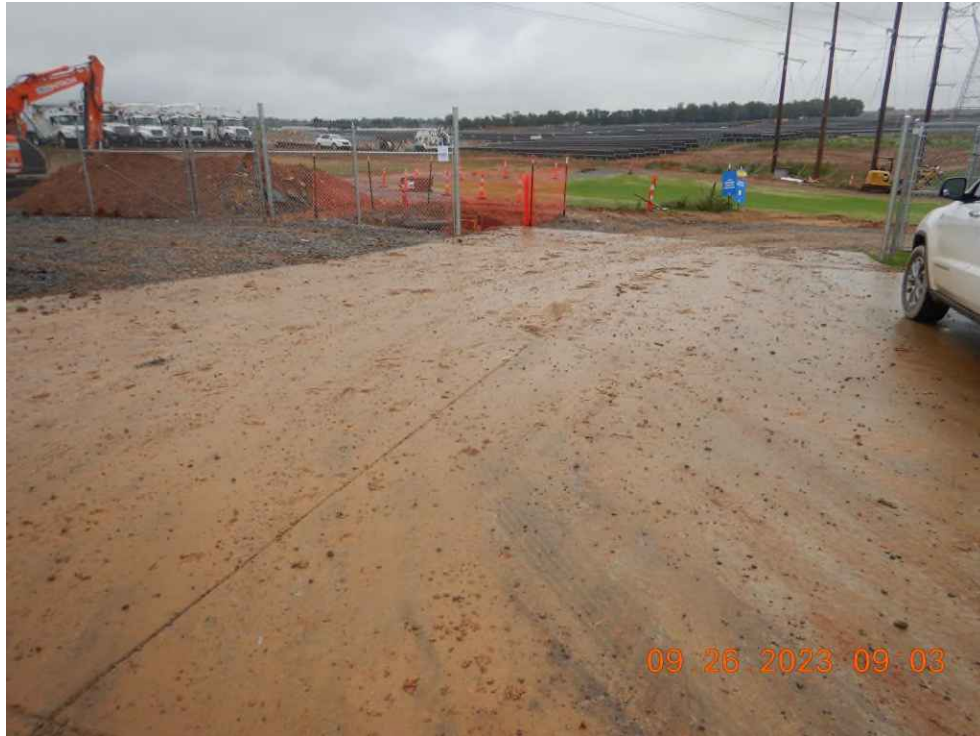
Inadequate construction entrance installed to prevent track-out from the site.

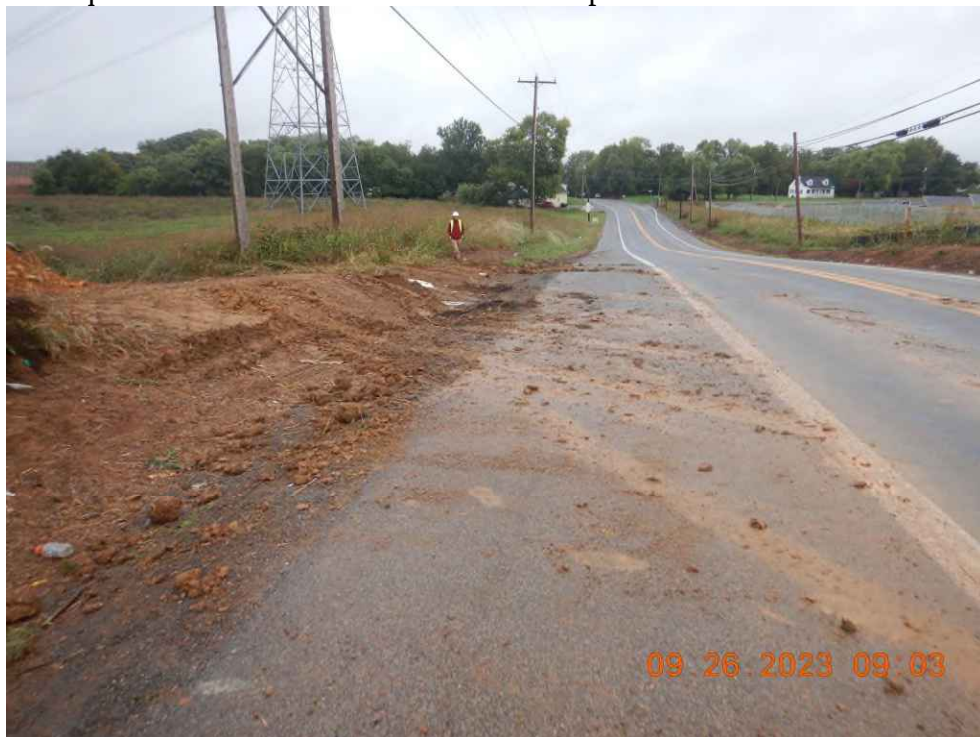
Unstabilized construction entrance.

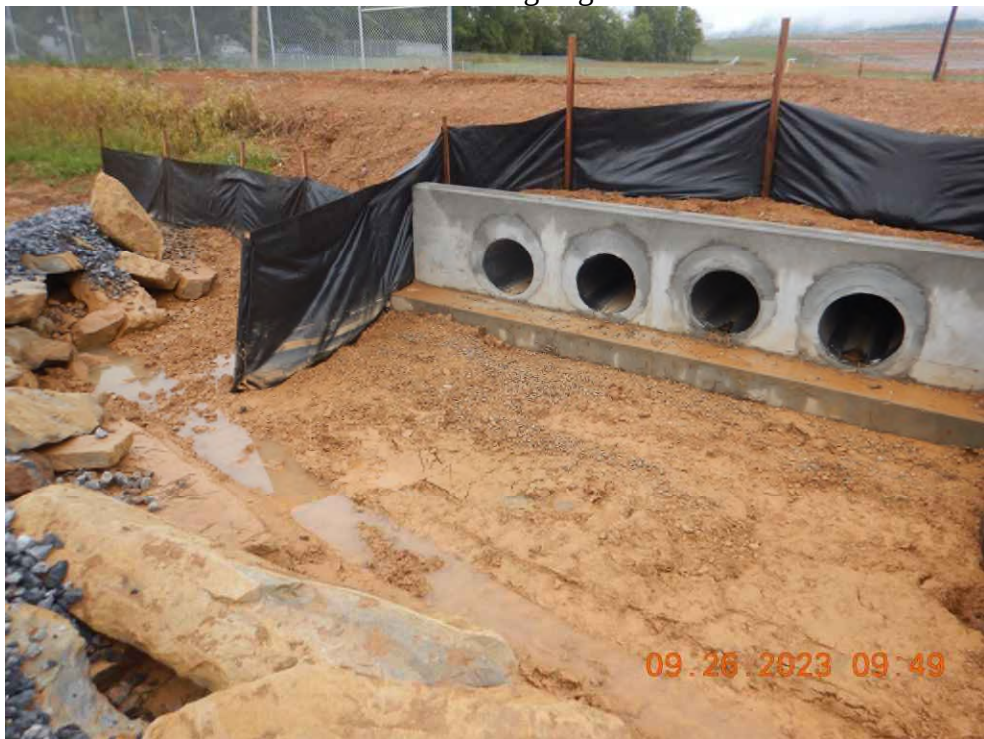
Outlet for stormwater pond 14 has been installed. Sediment laden water leaving site through outlet.

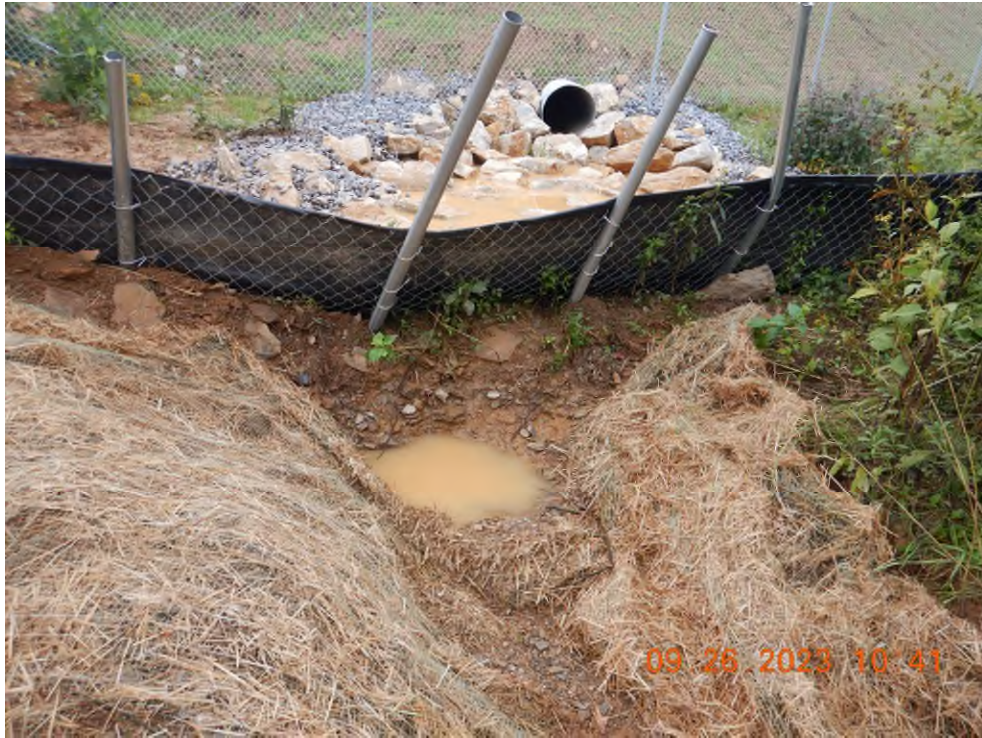
Area of Sediment Basin 6. Sediment laden water leaving site through outlet. No outlet sign is visible.

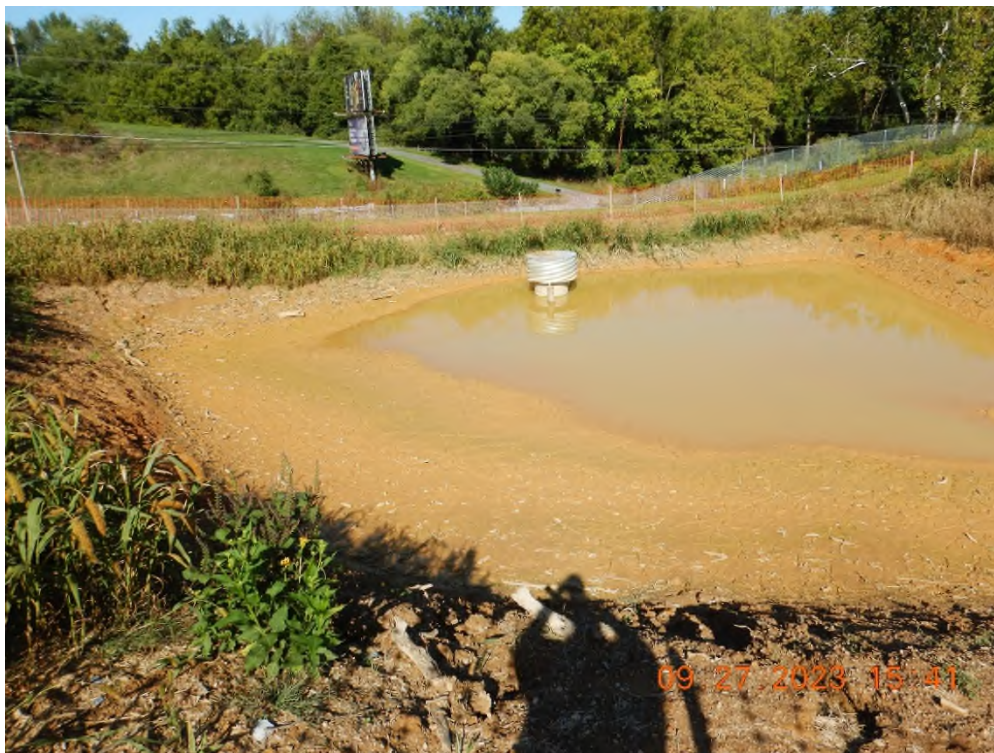
Sediment Basin 6 with accumulated deposits.

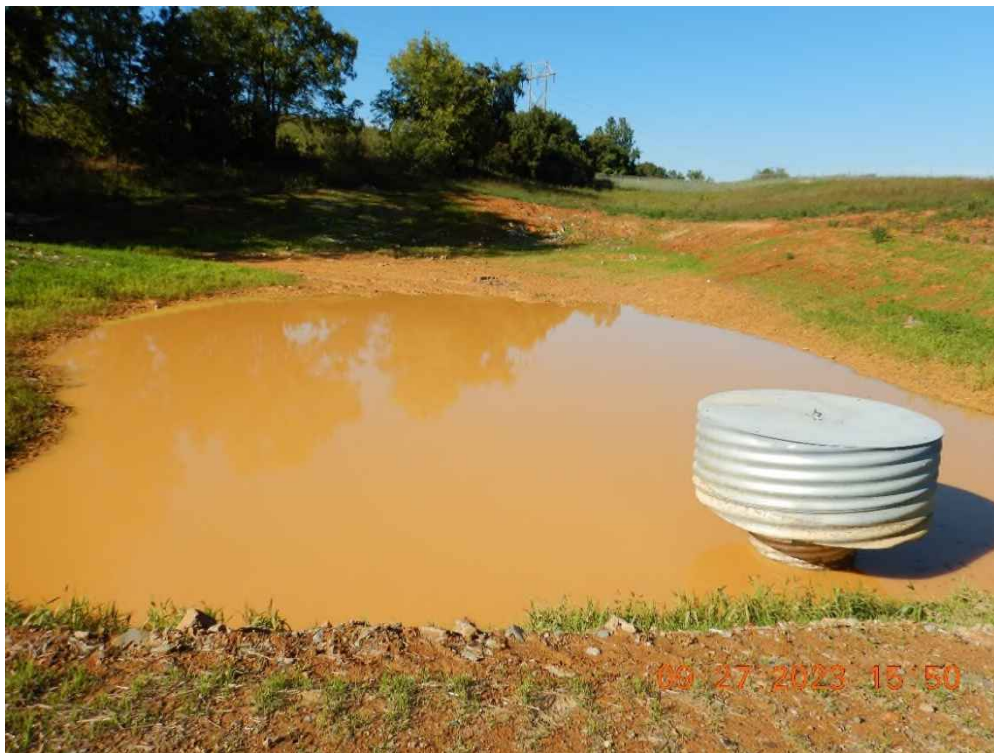
Sediment Pond 5, showing the lack of a stabilized inlet.

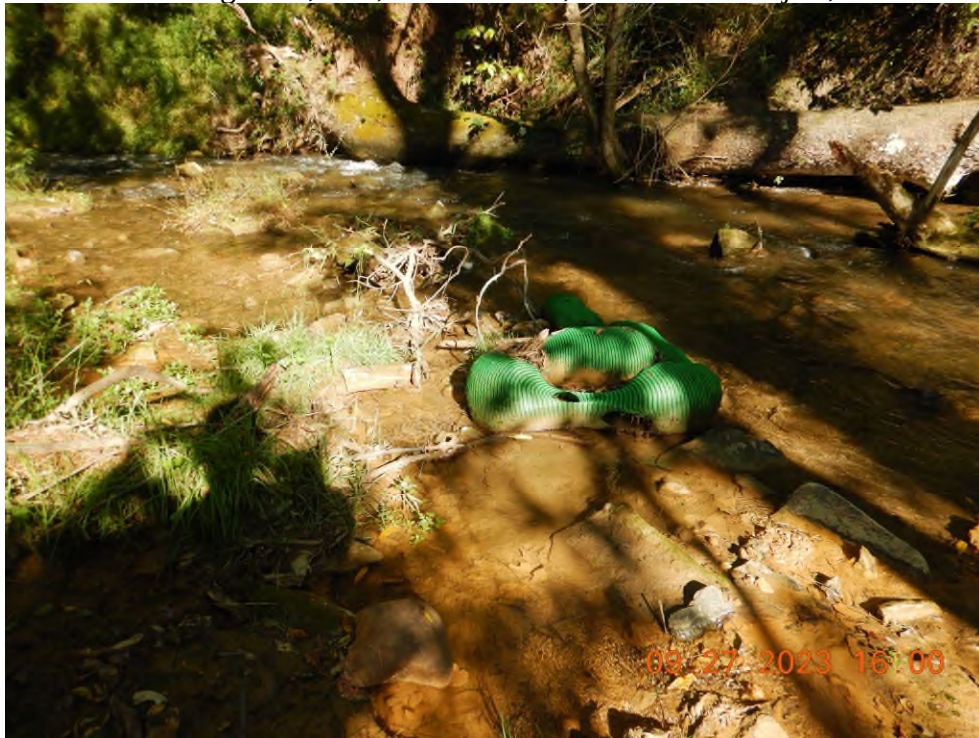
Conditions not allowable - deposits in Evitts Run (39° 15' 17.2288" X -77° 49' 26.9350") from Sediment Basin 5. Filter sock laying in creek.

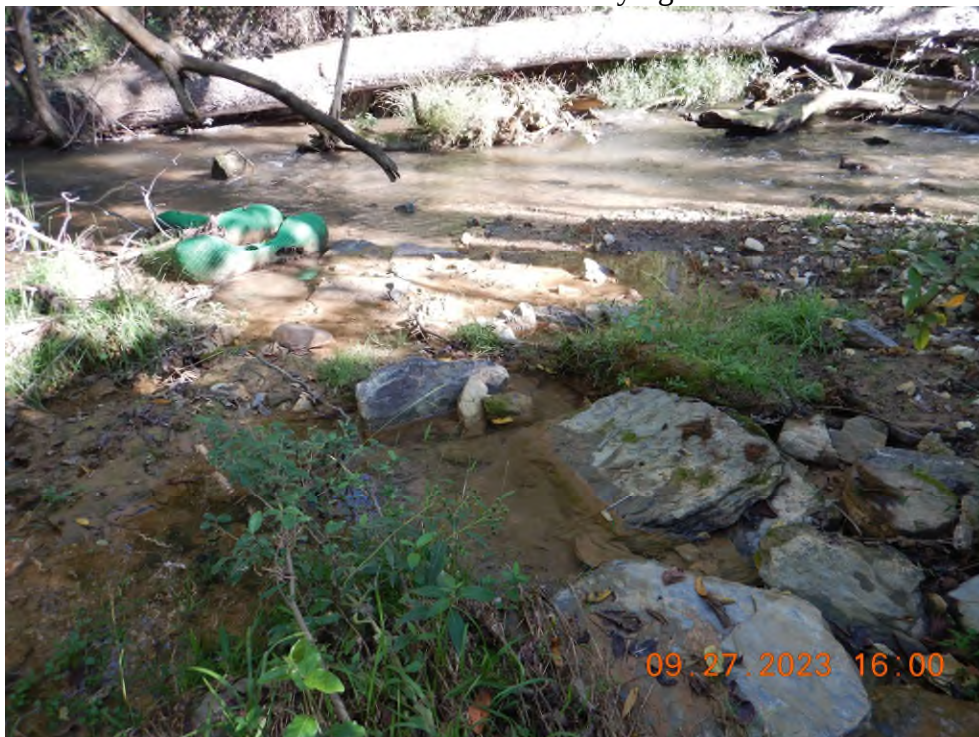
Conditions not allowable - deposits in Evitts Run (39° 15' 17.2288" X -77° 49' 26.9350") from Sediment Basin 5.

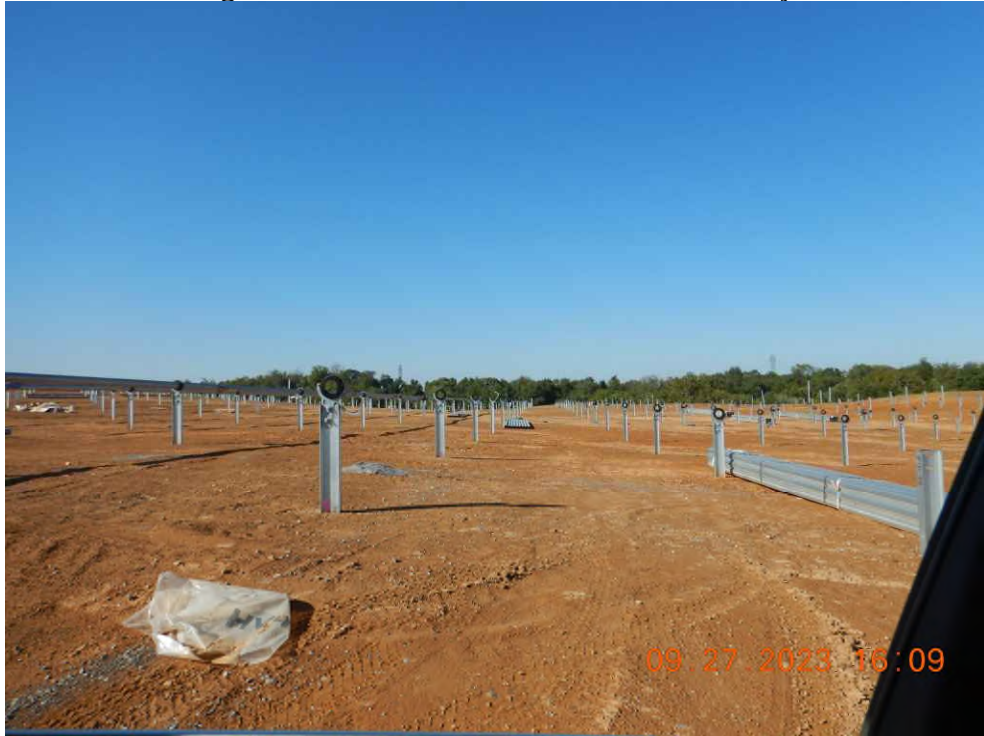
Unstabilized area of project. Temporary or permanent stabilization has not been started.

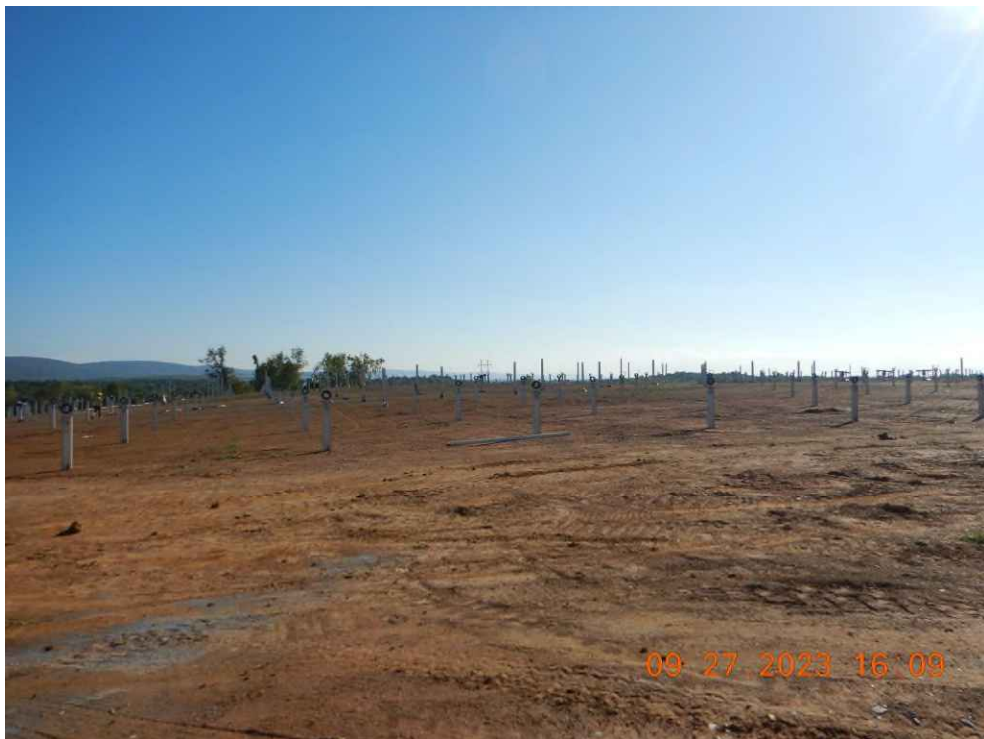
Unstabilized area of project. Temporary or permanent stabilization has not been started.

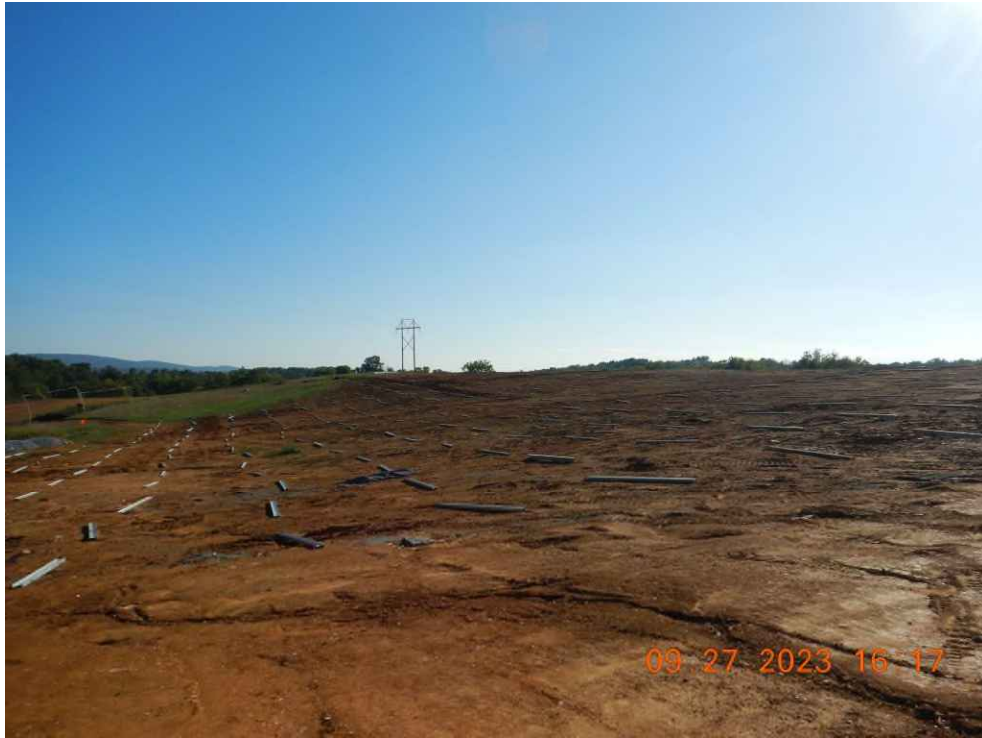
Unstabilized area of project. Temporary or permanent stabilization has not been started.

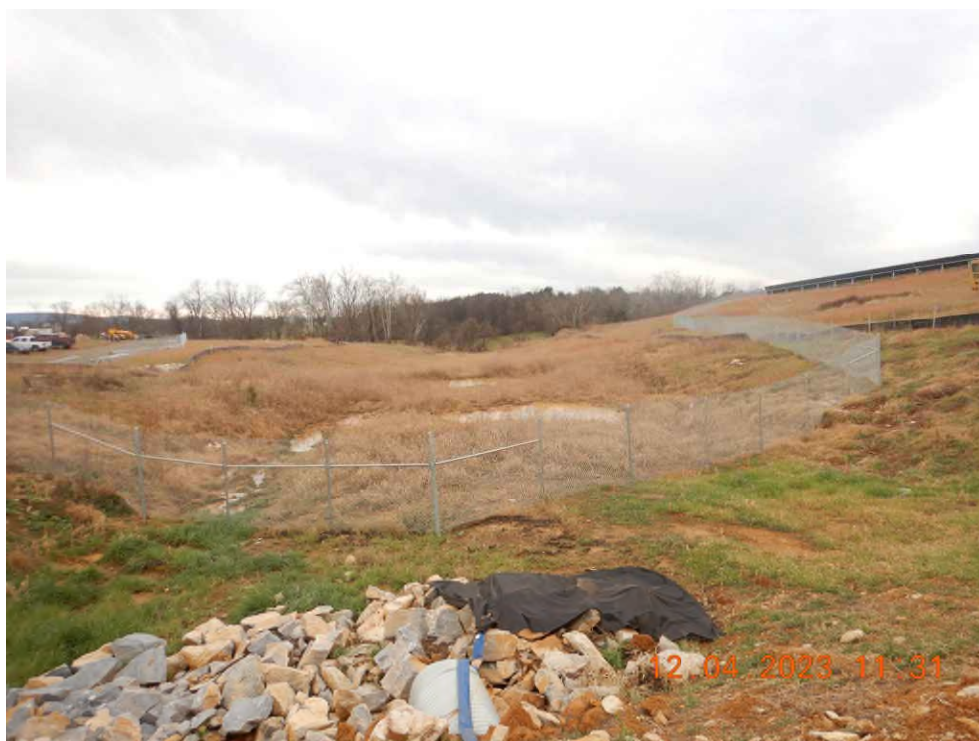
Sediment laden water leaving area Sediment Basin 13. Outlet structure has been installed prior to all uphill disturbance being vegetated.

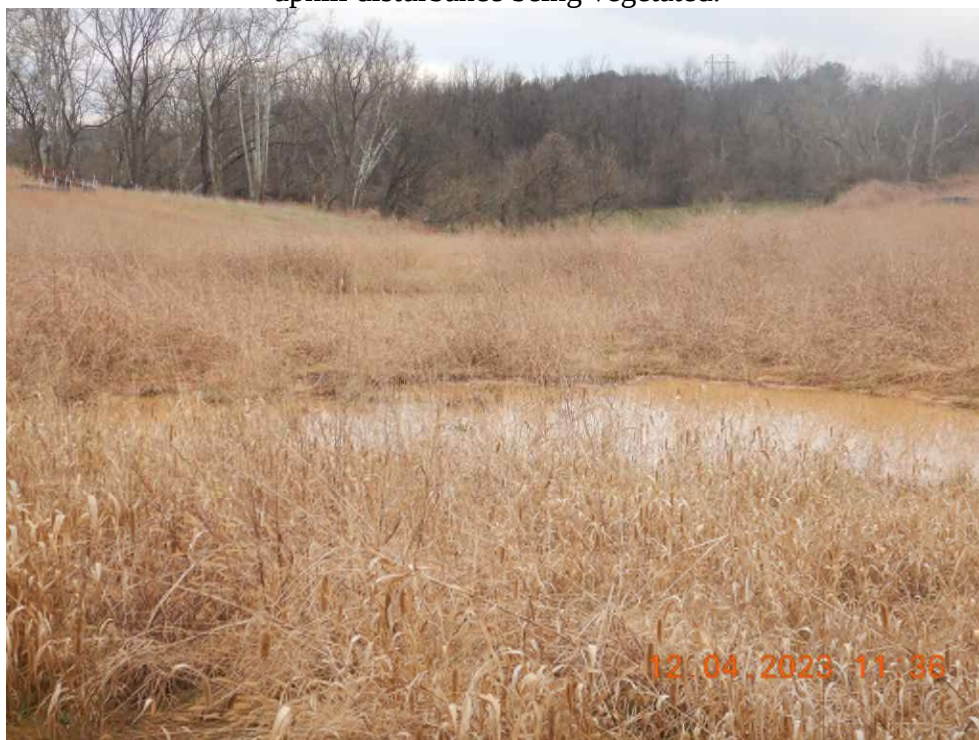
Sediment laden discharge from Sediment Basin 13 into Evitts Run.

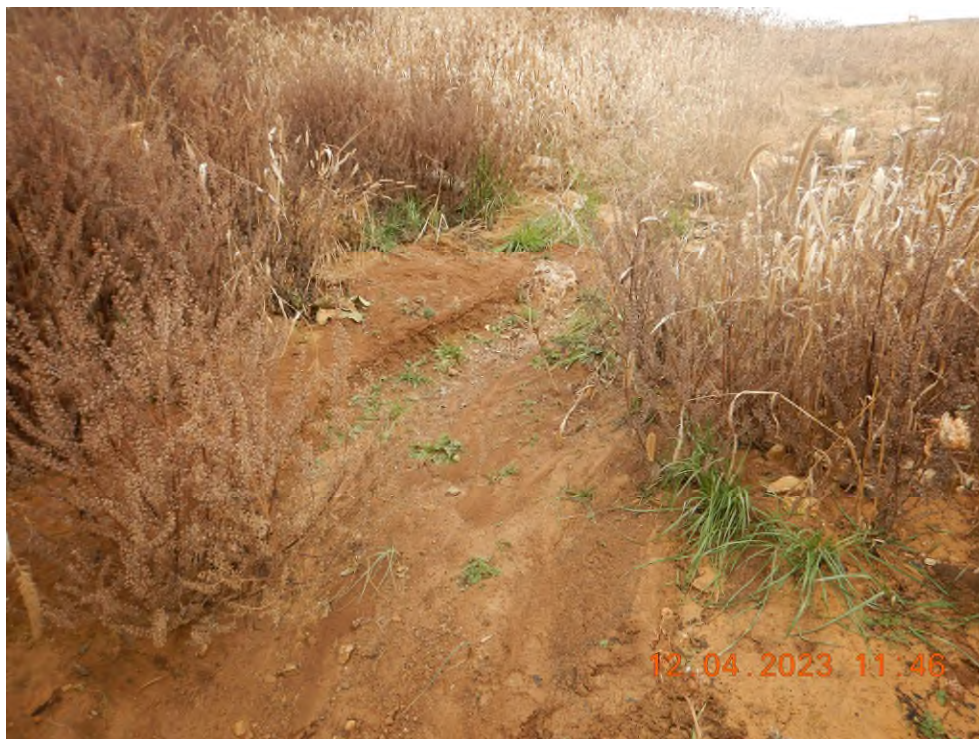
Sediment laden discharge from Sediment Basin 13 into Evitts Run.  
Offsite conditions not allowable in Evitts Run (39.253314D X -77.833903D) pictured.

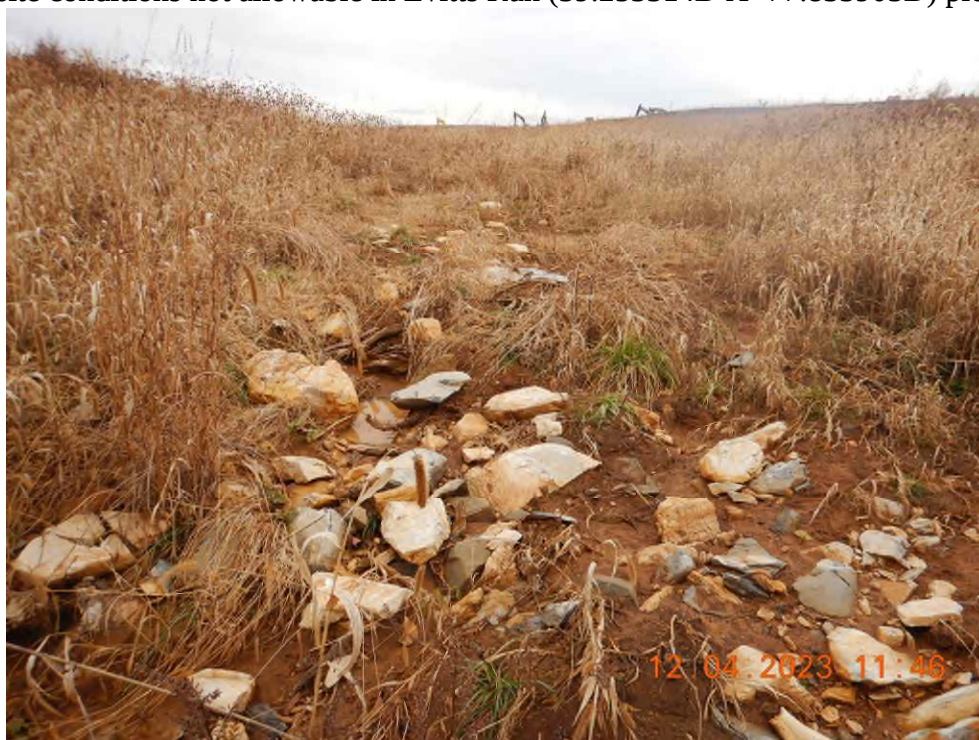
Sediment laden discharge from Sediment Basin 13 into Evitts Run.  
Offsite conditions not allowable in Evitts Run (39.253314D X -77.833903D) pictured.

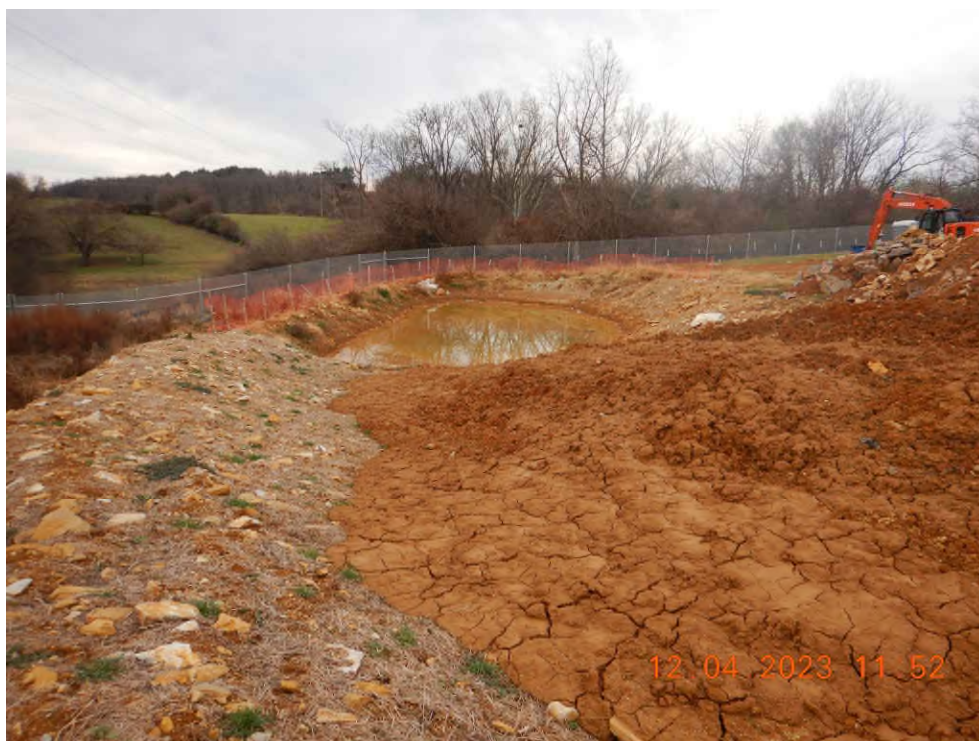
Sediment basin 4 that has been converted to permanent stormwater Pond 4a on redline plans.

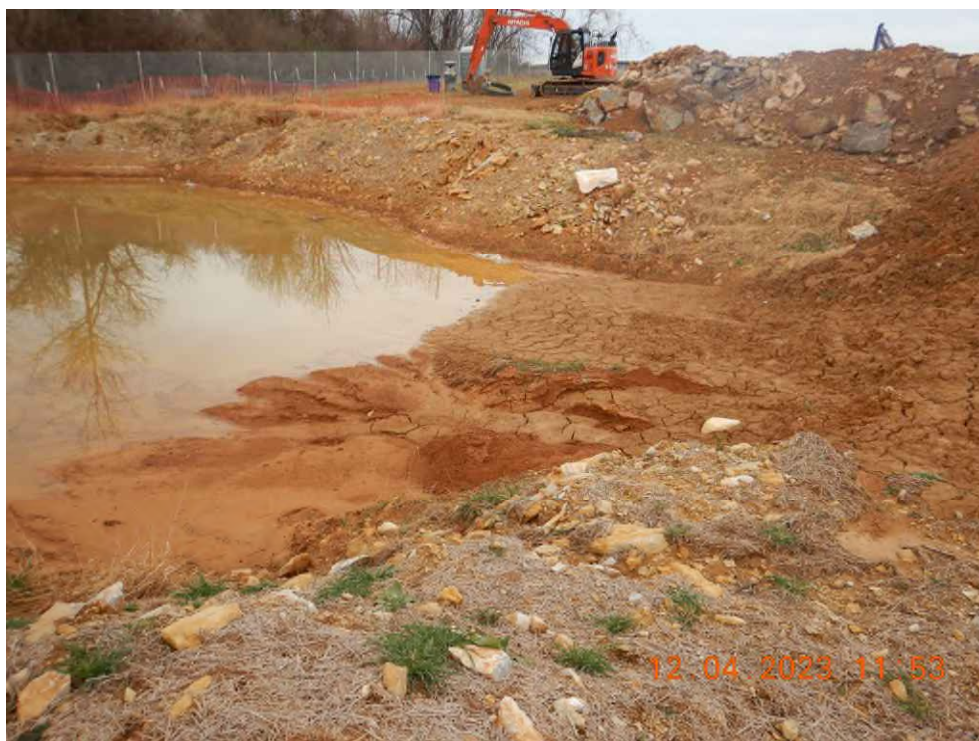
Unstable inlets to sediment basin 3.

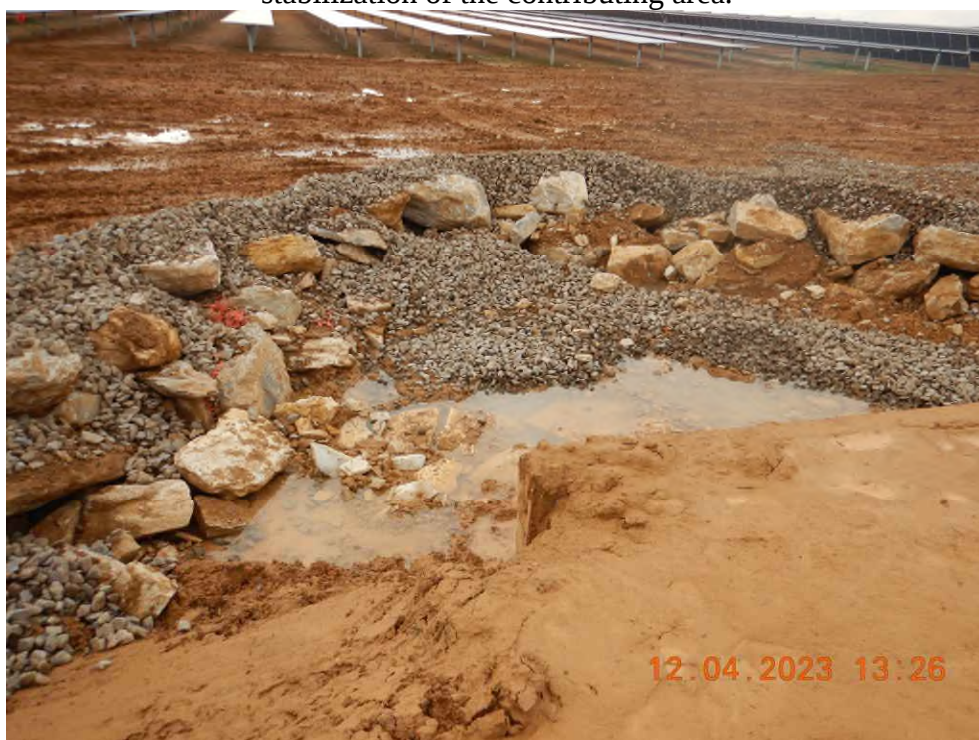
Sediment basin SB-11 (Pond 2B redline) that has been converted to stormwater retention prior to stabilization of the contributing area. Outlet pictured.

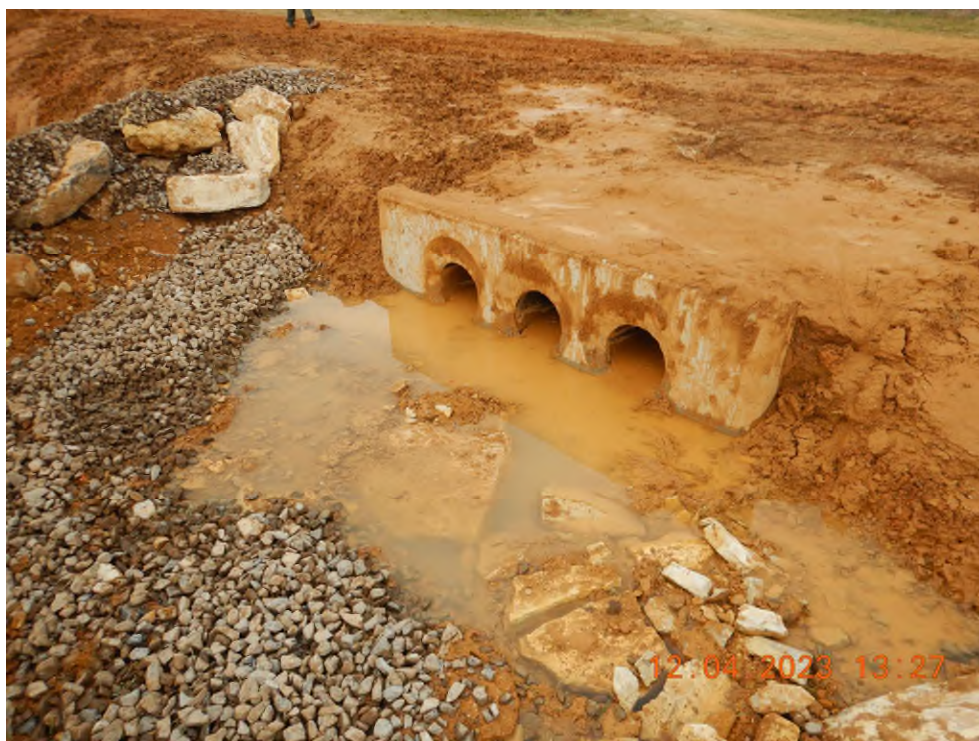
Sediment basin SB-11 (Pond 2B redline) that has been converted to stormwater retention prior to stabilization of the contributing area. Outlet pictured.

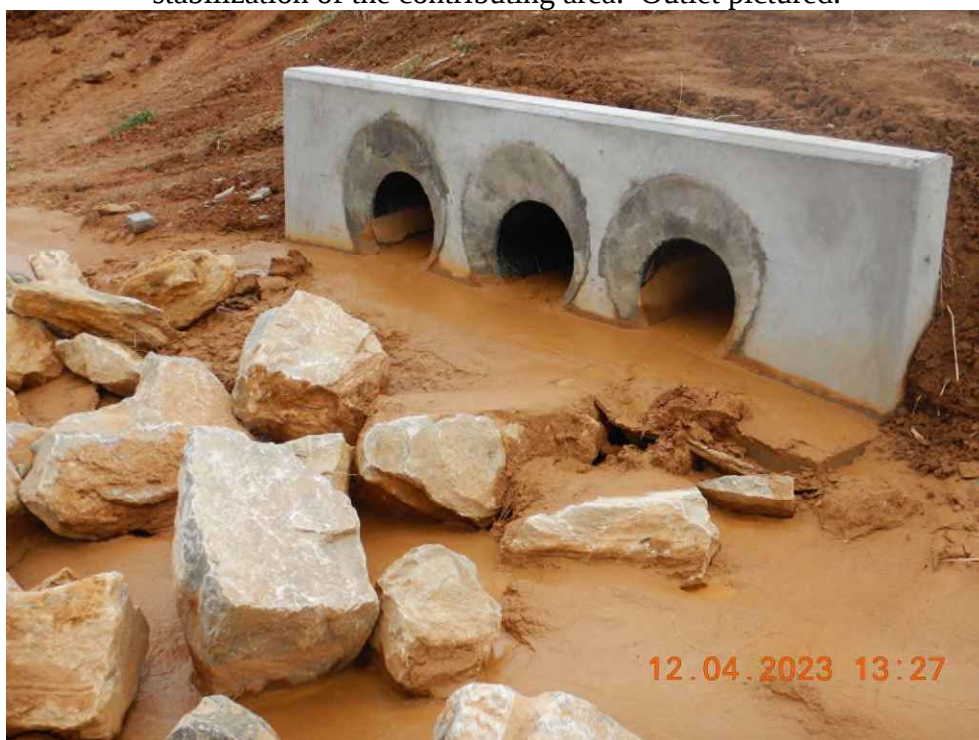
Sediment basin SB-11 (Pond 2B redline) that has been converted to stormwater retention prior to stabilization of the contributing area. Outlet showing sediment laden discharge pictured.

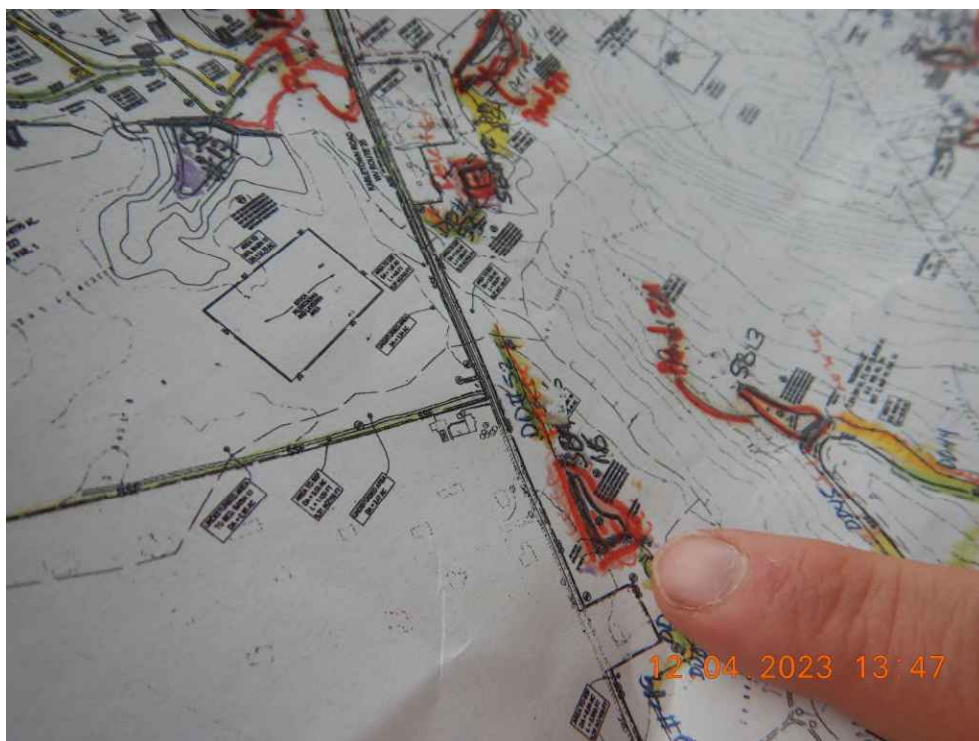
Sediment Basins 12 and 15 have been deleted prior to all uphill disturbance being vegetated.

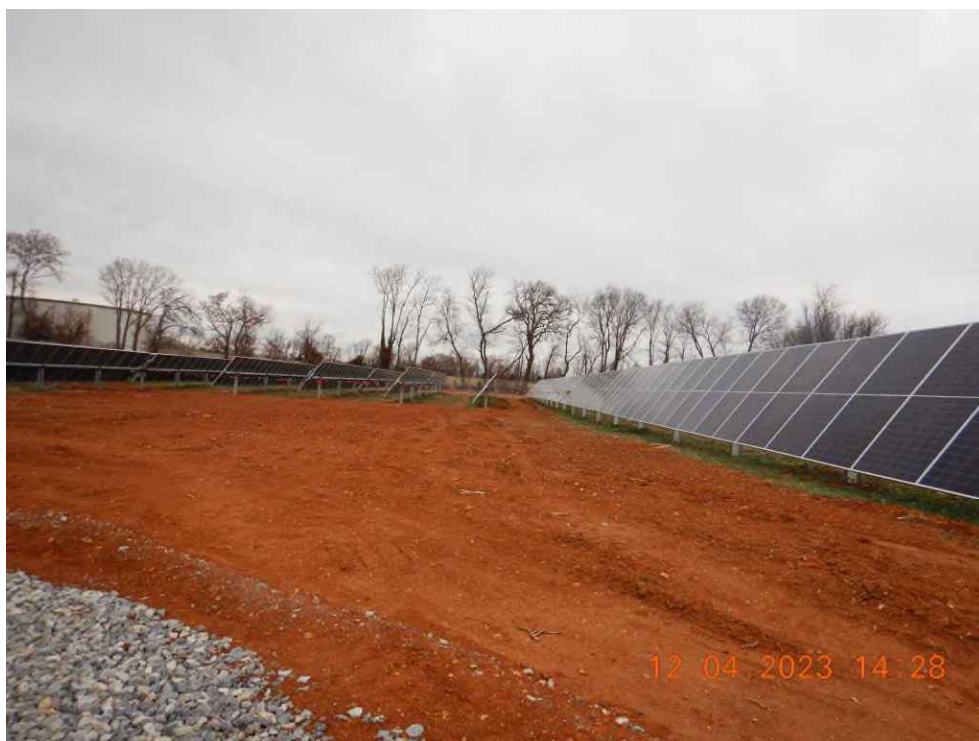
Area where Sediment Trap 5 should be installed.

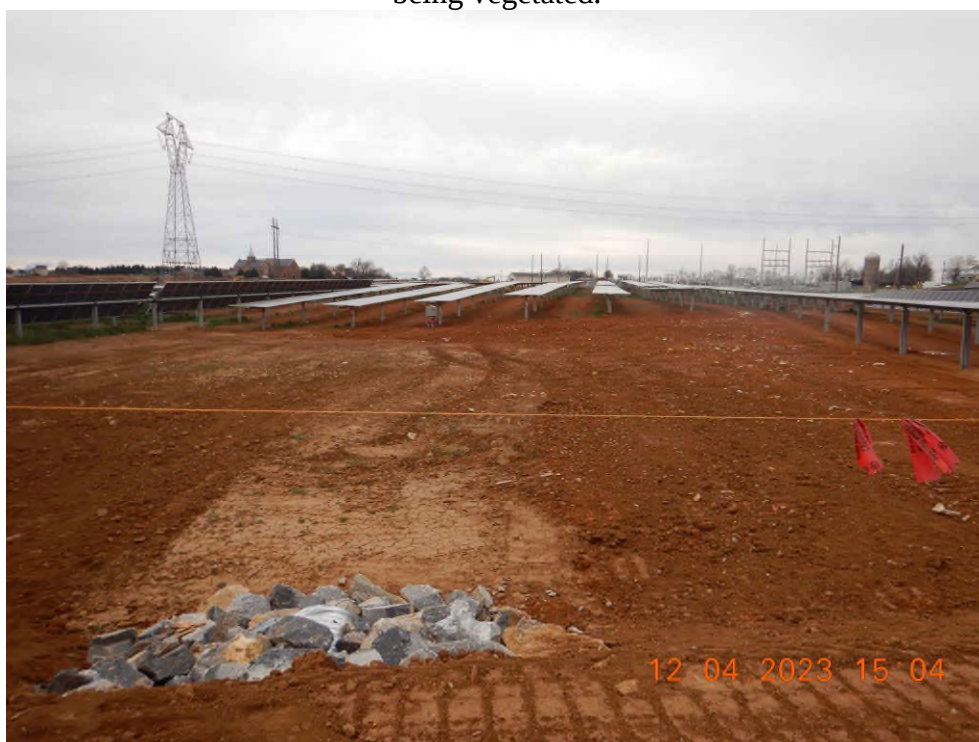
Unstabilized area above Pond 14A.

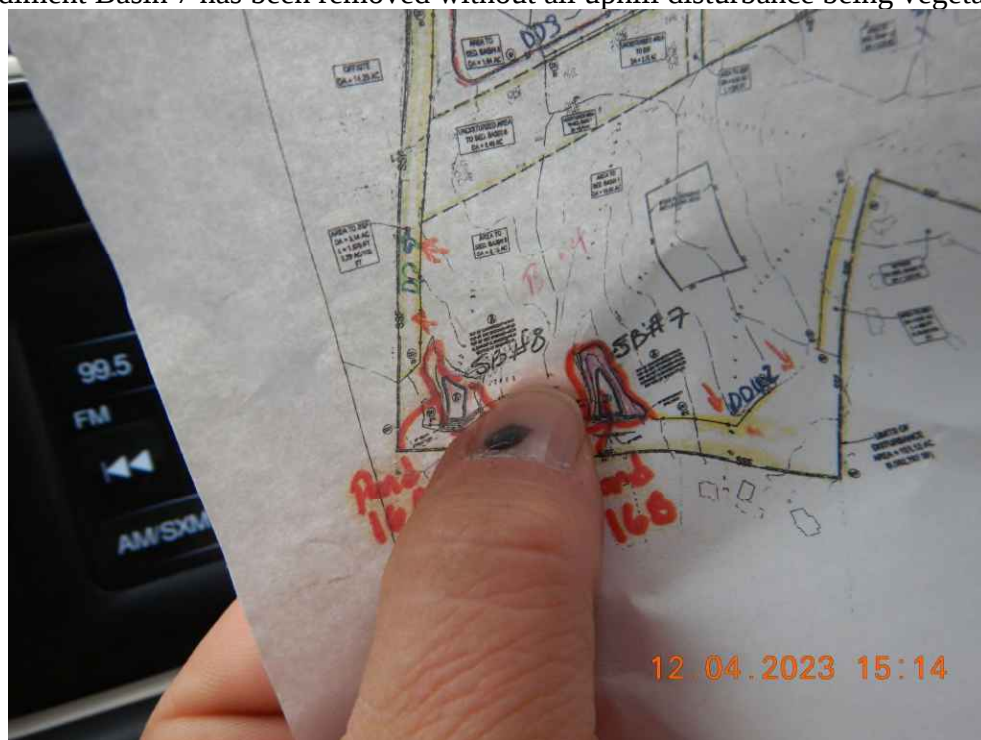
Map stating that Sediment Basin 7 has been converted into Pond 16B.

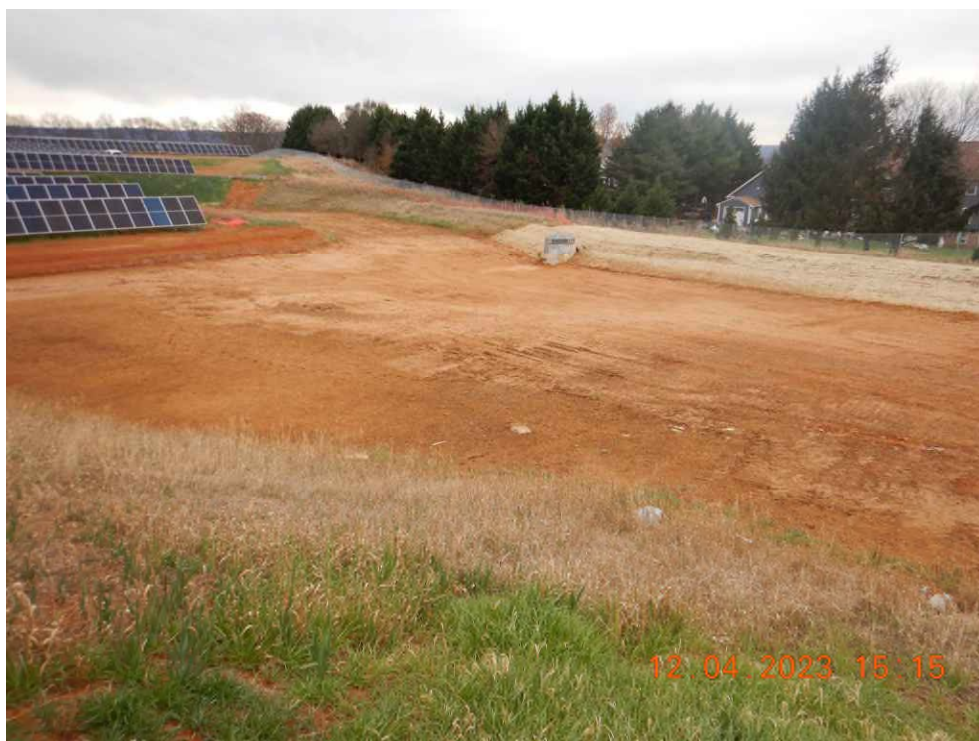
Sediment Basin 7 has been converted into Pond 16B.

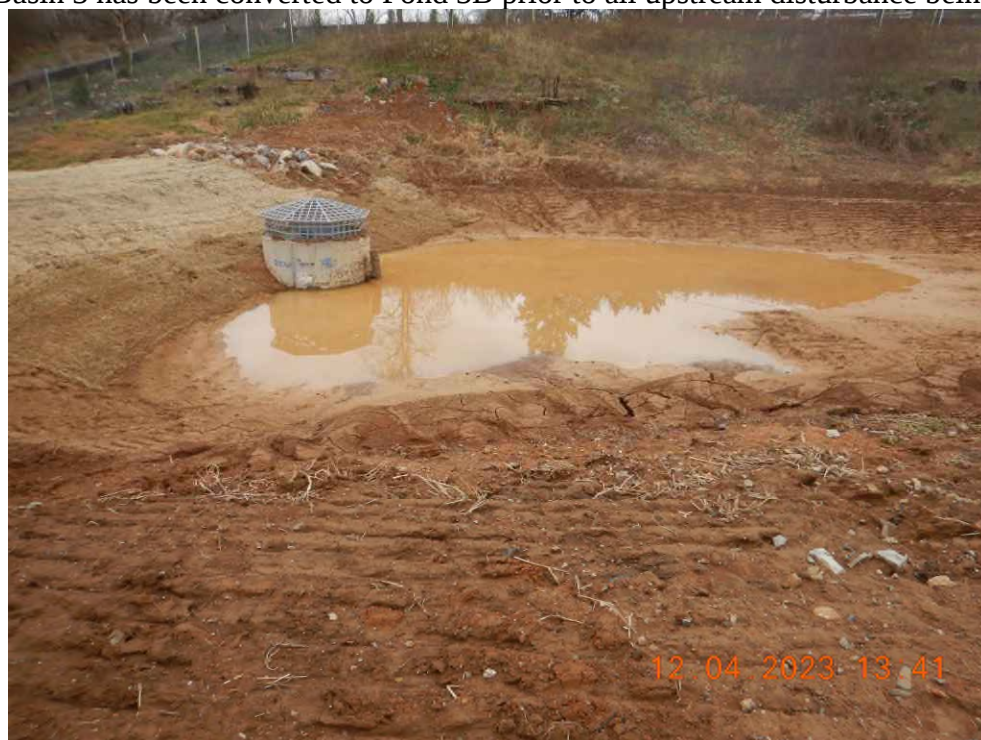
Sediment Basin 15 has been converted to Pond 1 prior to all upstream disturbance being vegetated.
