**CONSENT ORDER  
ISSUED UNDER THE  
WATER POLLUTION CONTROL ACT  
WEST VIRGINIA CODE CHAPTER 22, ARTICLE 11**

ORDER NO.: 10260

1. Horus West Virginia 1, LLC is conducting land disturbance activity associated with the Blake Solar Project in Jefferson County, West Virginia. Horus West Virginia 1, LLC was issued WV/NPDES Water Pollution Control Permit No. WV0115924, Registration No. WVR111837, on August 12, 2022.
2. On May 15, 2023, West Virginia Department of Environmental Protection (WVDEP) personnel conducted an inspection of the facility. During the inspection, violations of the following sections of the WV/NPDES permit were observed and documented:
  - a. Section II.H.1.d. – Horus West Virginia 1, LLC failed to provide an adequate stone access entrance/exit to reduce the tracking of sediment onto public or private roads.

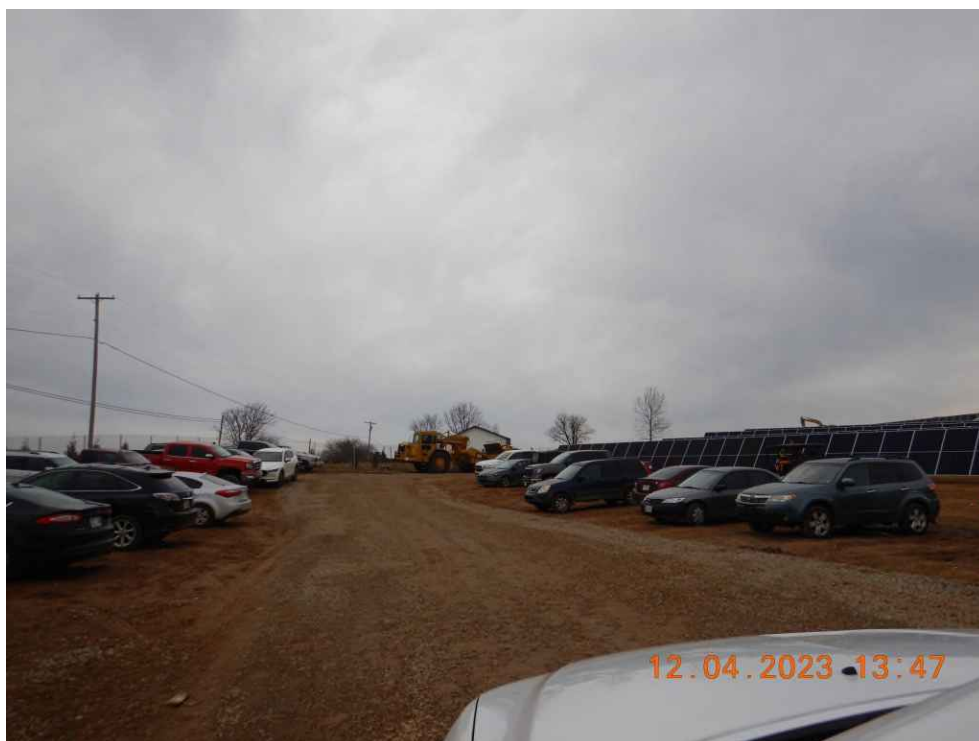
Sediment Basin 16 has been removed prior to all upstream disturbance being vegetated.

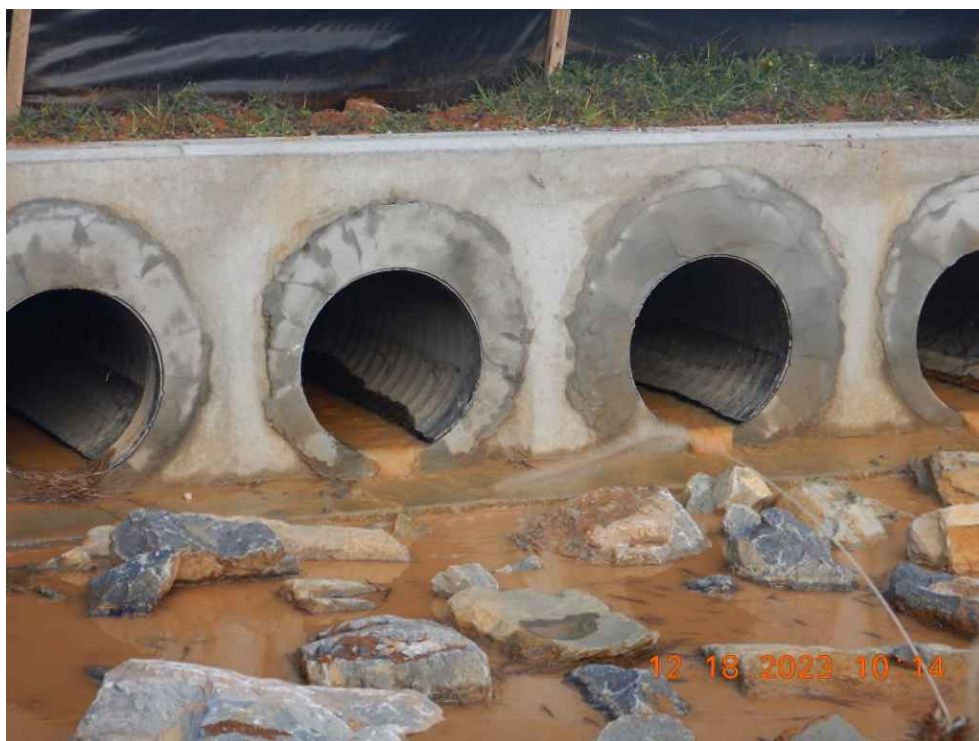
Sediment laden water leaving site onto Kabletown Road via outlet of Pond 14A that has been redlined on the plans.

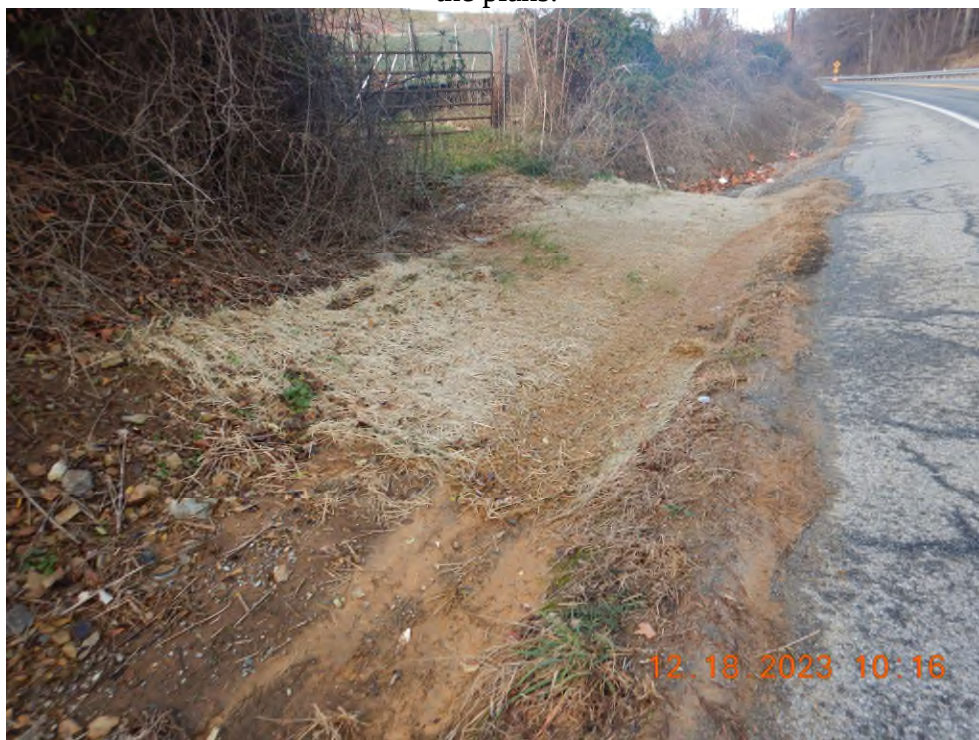
Sediment laden water leaving site via outlet of Sediment Basin 6.

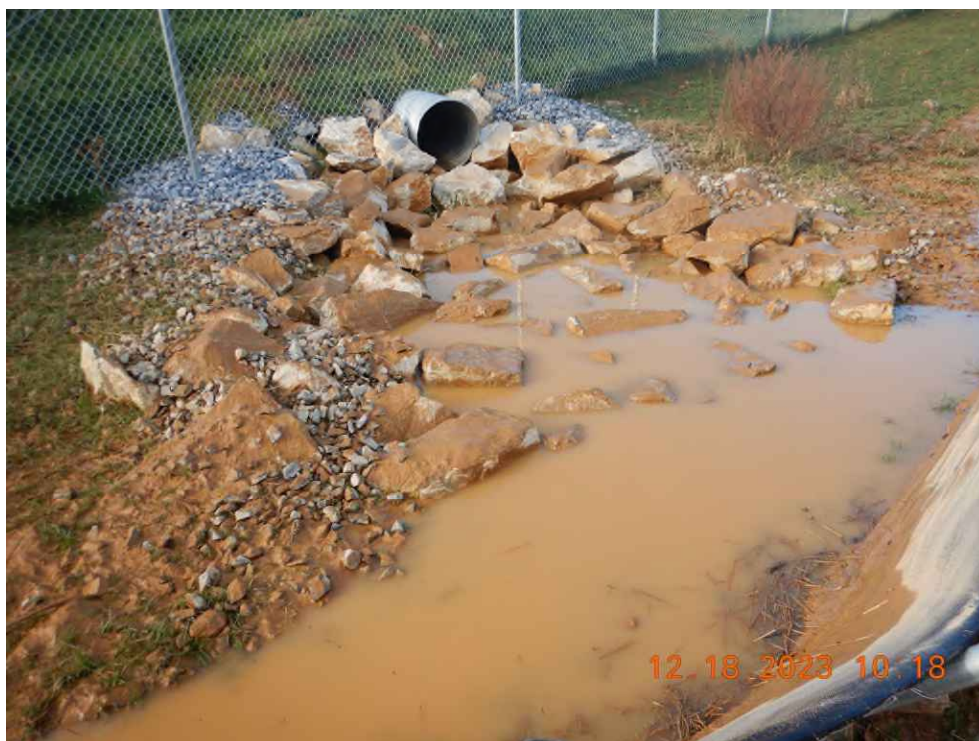
Sediment laden water leaving site via outlet of Sediment Basin 6.

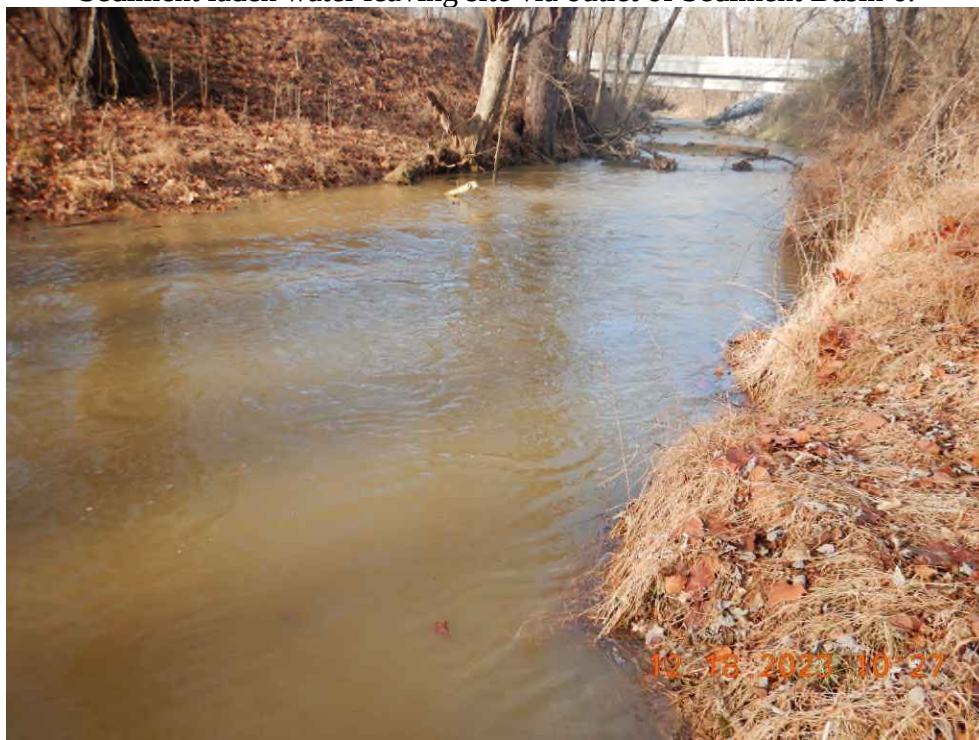
Sediment leaving site in Evitts Run causing conditions not allowable.

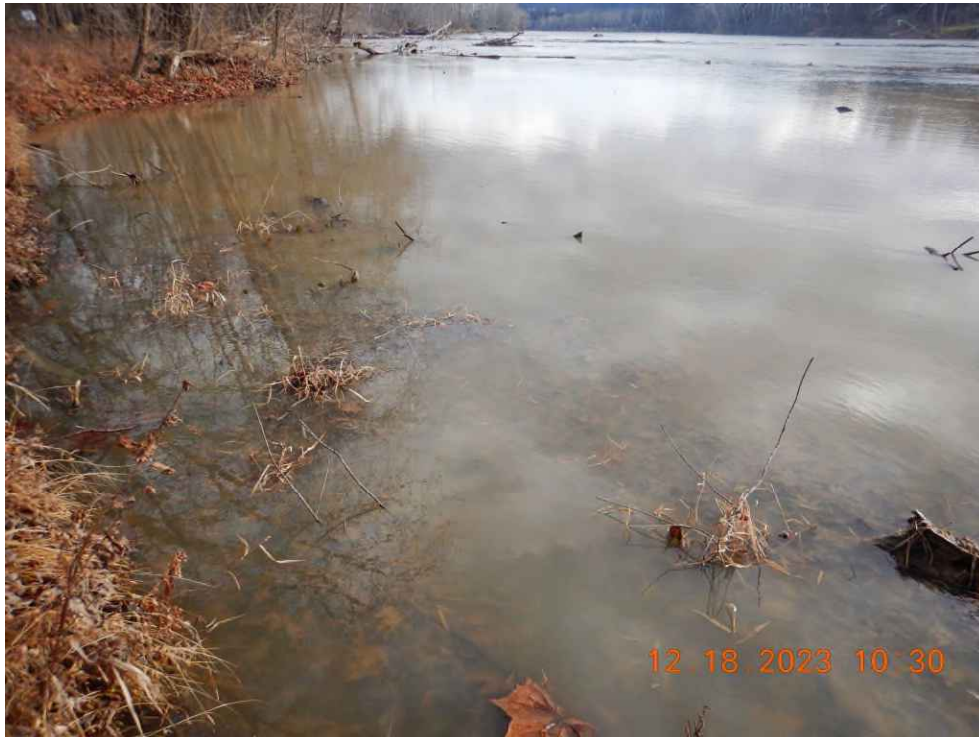
Sediment laden water causing conditions not allowable in the Shenandoah River.

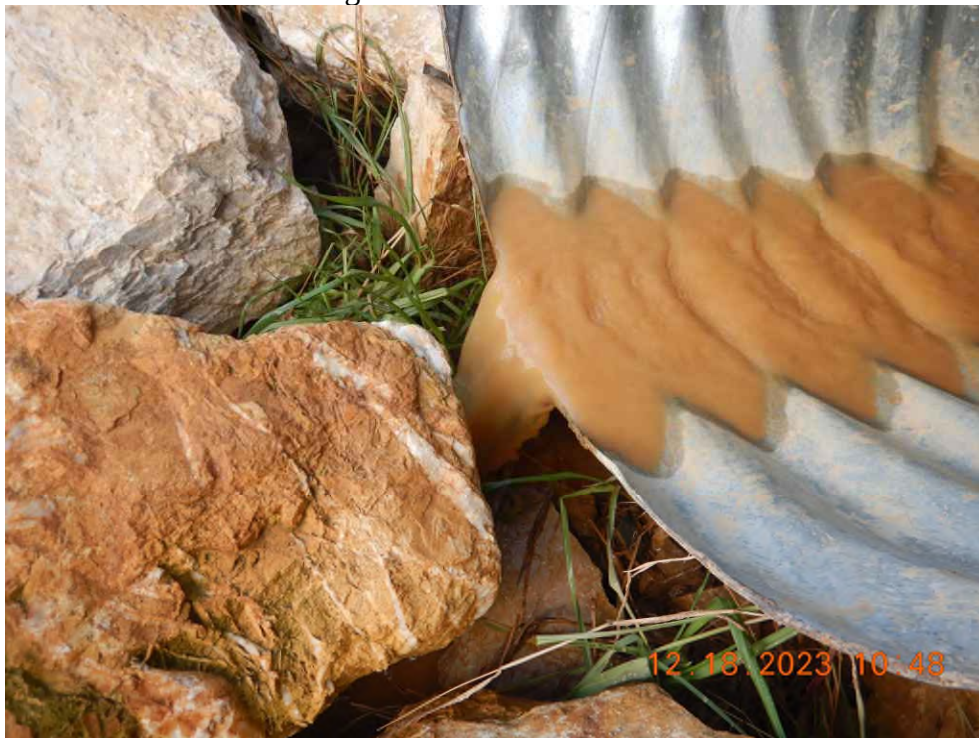
Sediment laden water leaving outlet of Sediment Basin 5.

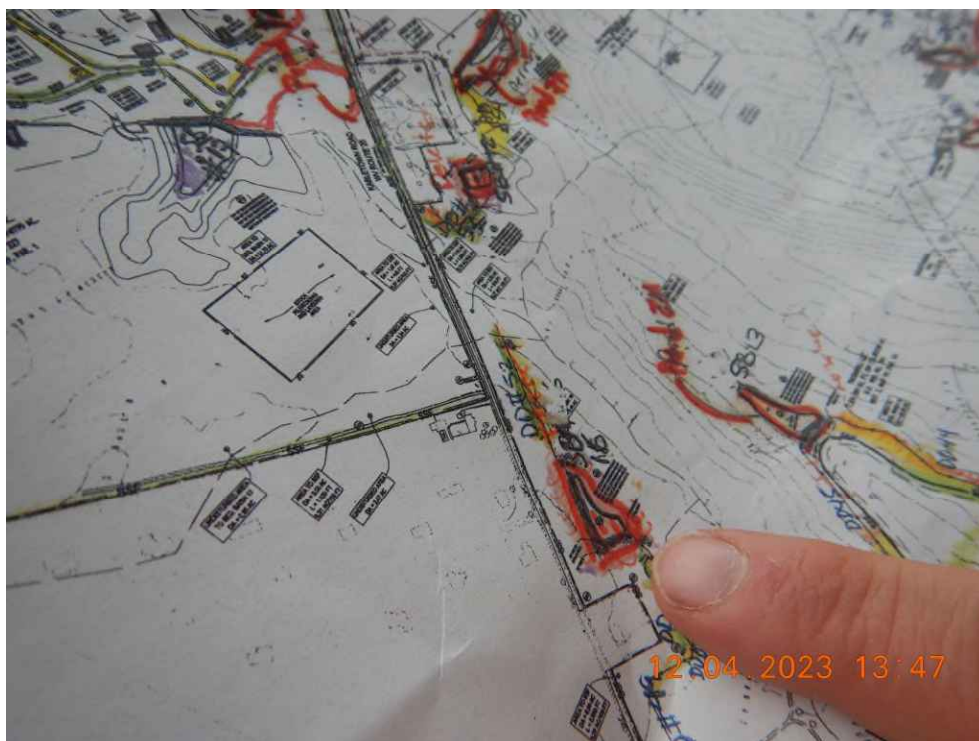
Sediment Basins 12 and 15 have been deleted prior to all uphill disturbance being vegetated.

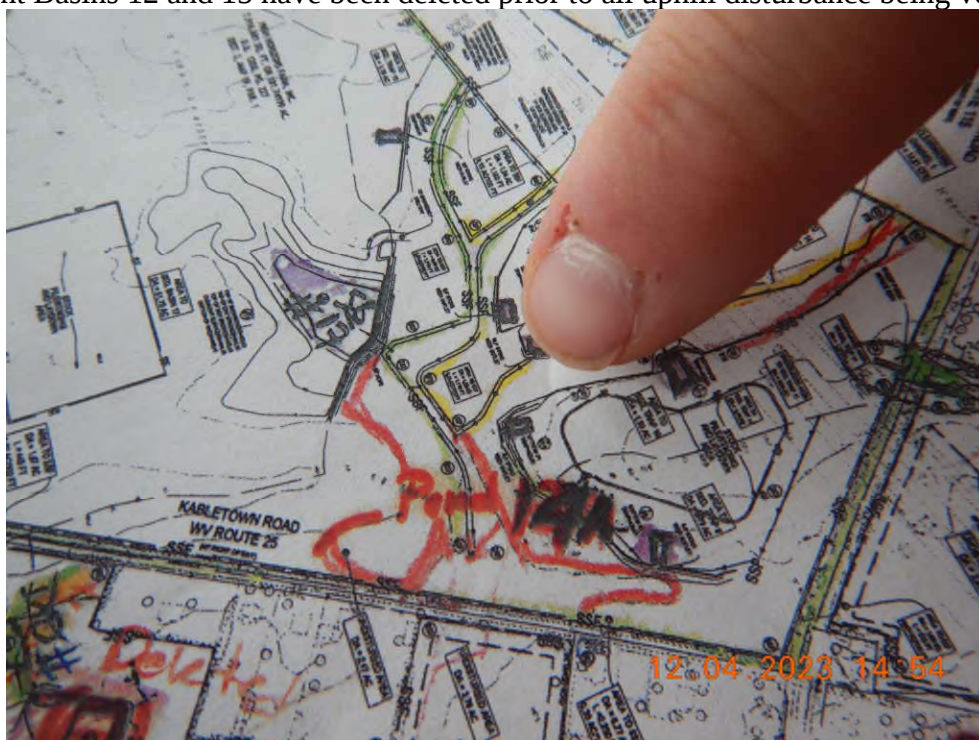
Pond 14A which is installed and not in the approved SWPPP.

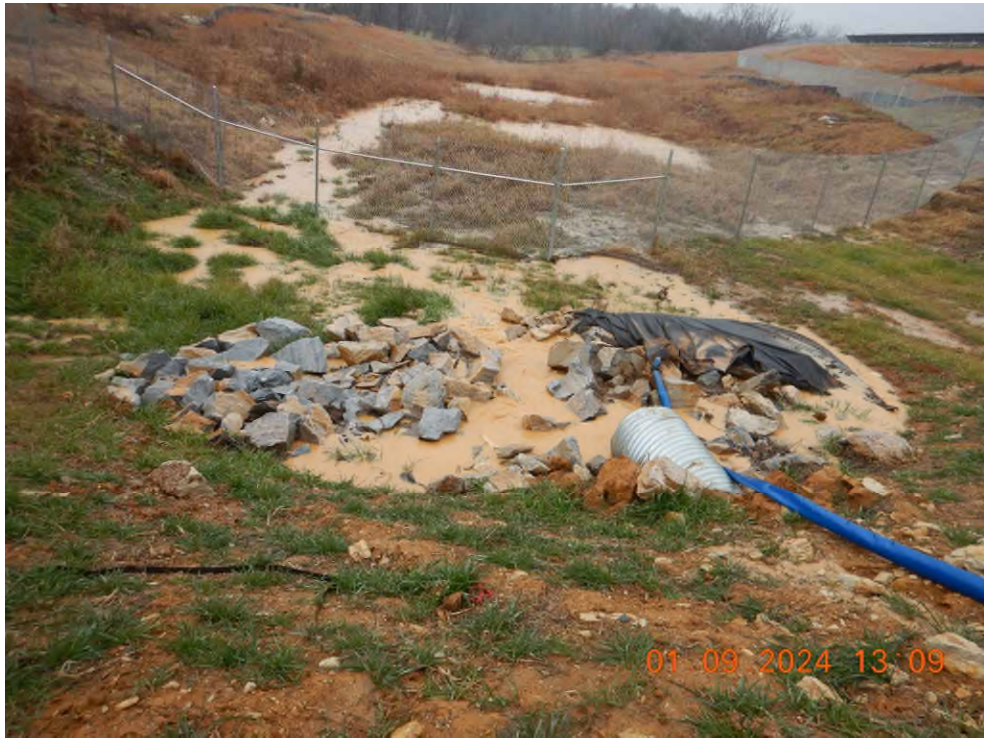
Sediment Basin 13 discharging into Evitts Run.

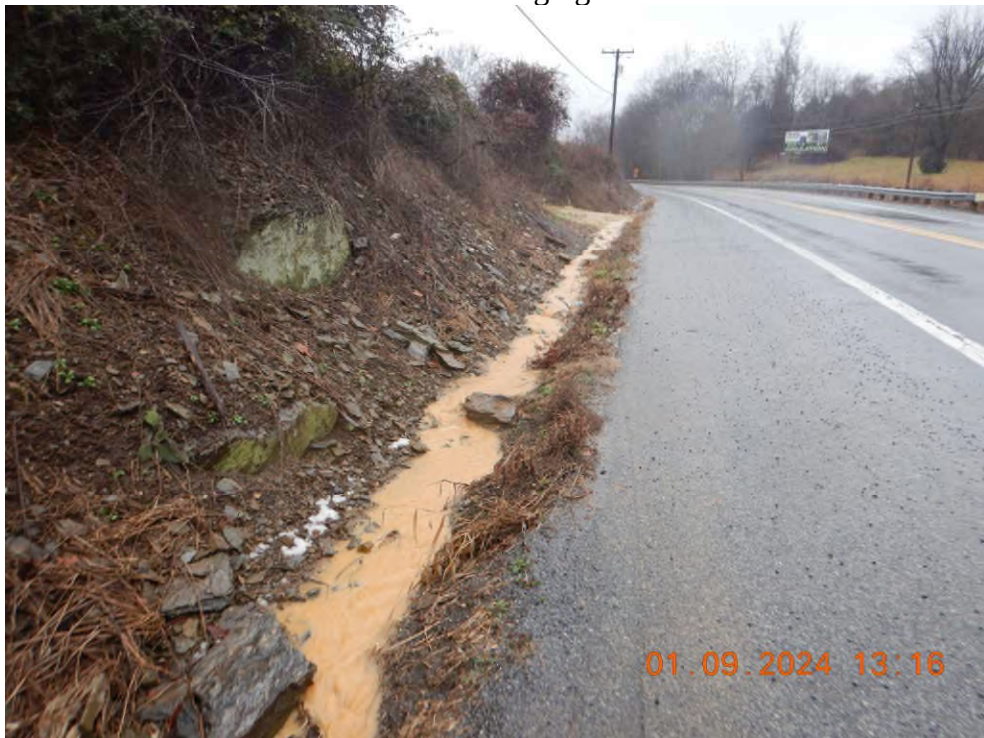
Sediment Basin 6 Discharging into WVDOH ditchline and discharging into WVDOH right of way leading to Shenandoah River.

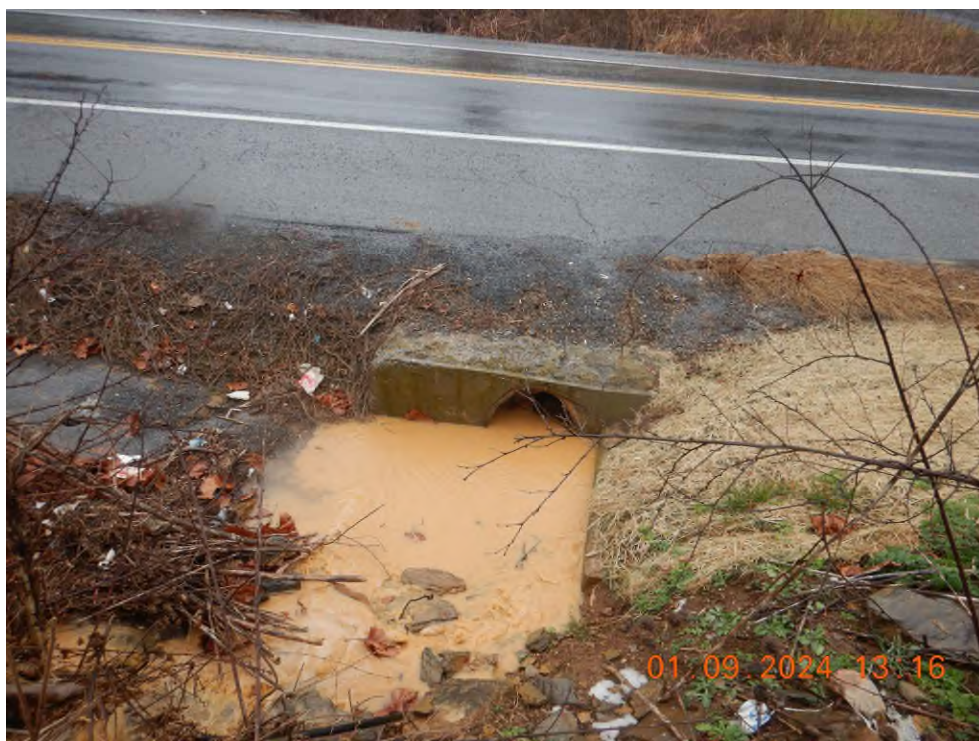
Sediment laden water discharging into WVDOH culvert and flowing into Evitts Run

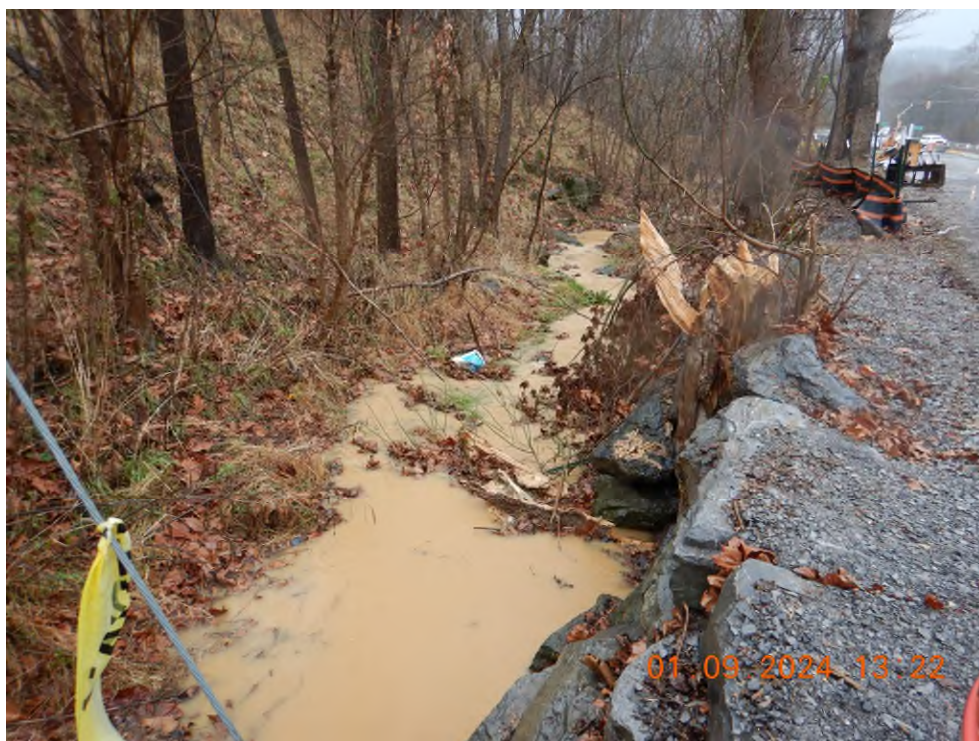
Sediment laden water leaving the site into Evitts Run and into the Shenandoah River.

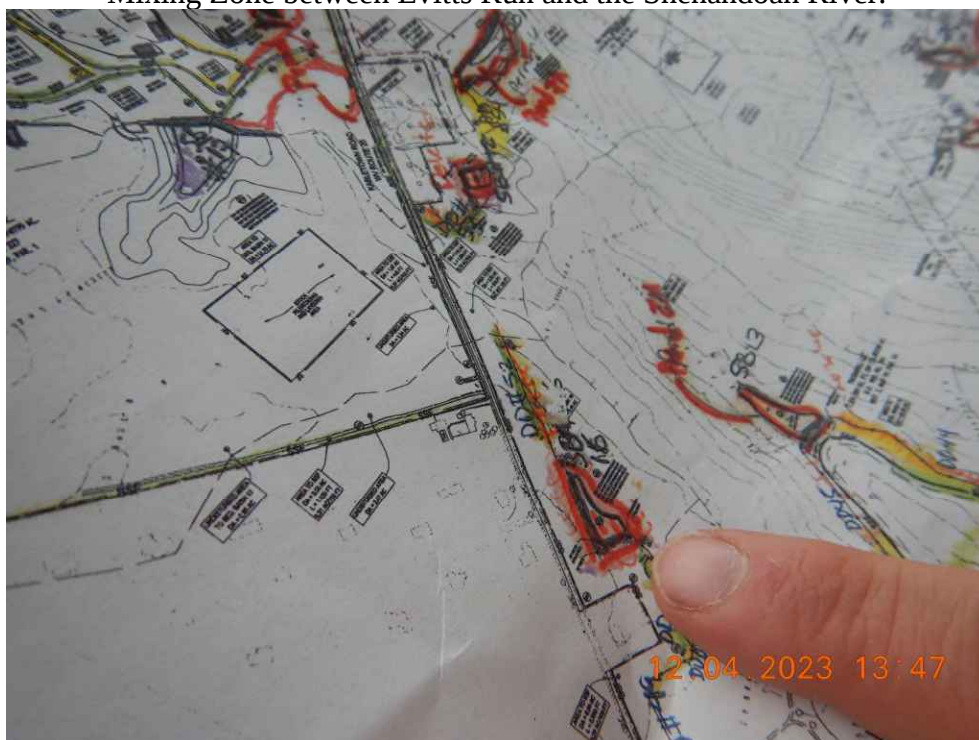
Sediment Basins 12 and 15 have been deleted prior to all uphill disturbance being vegetated.

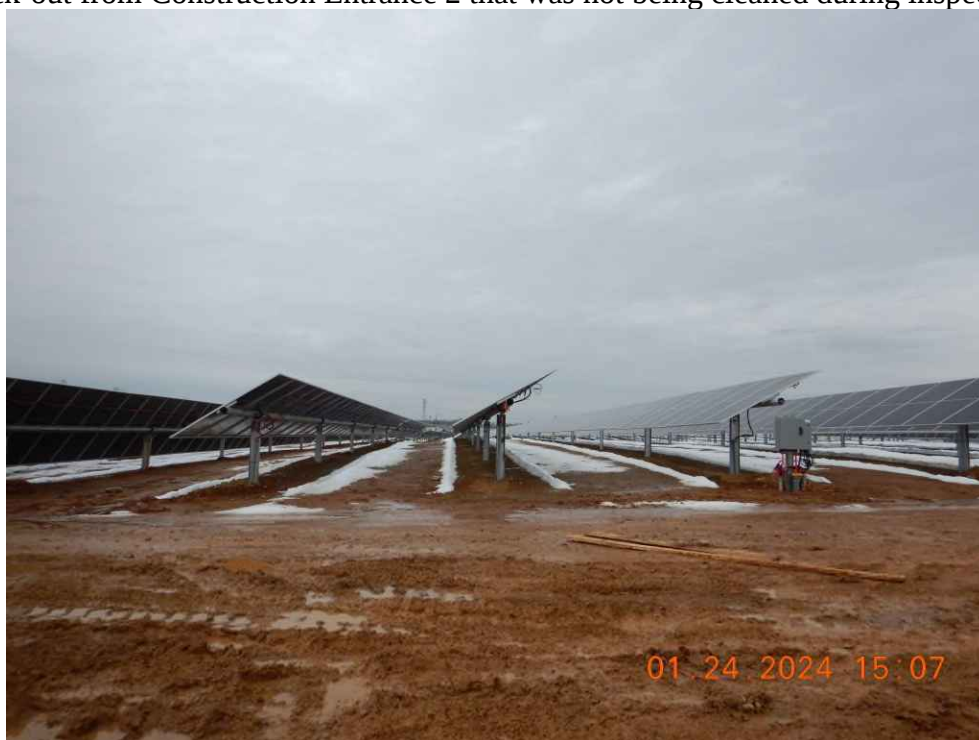
Unstabilized area that has not been worked within the past 14 days.

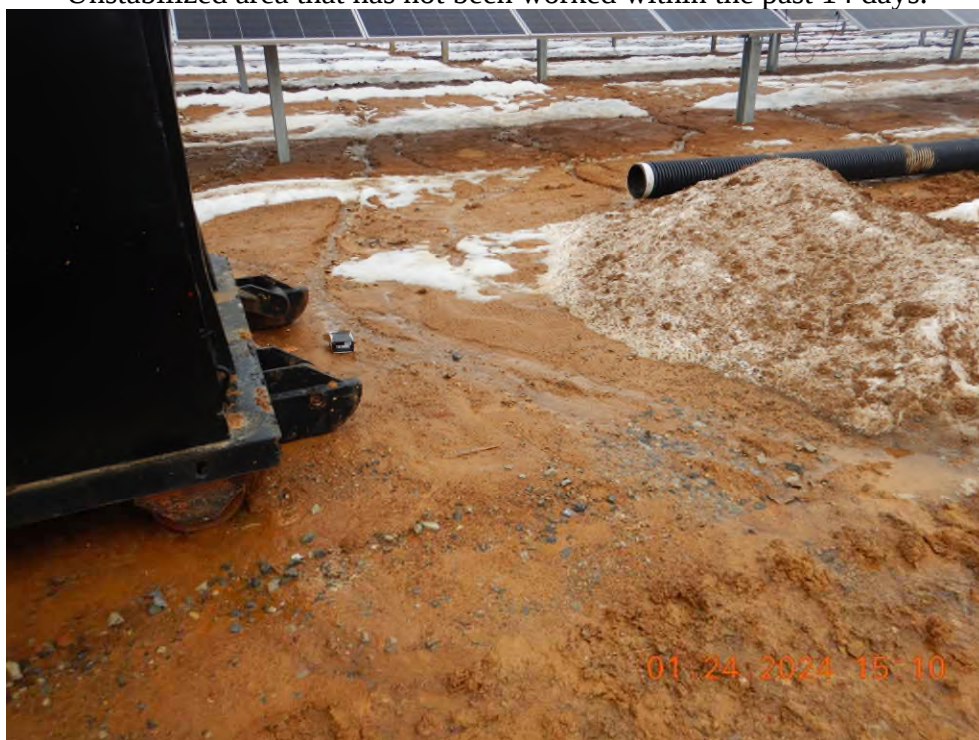
Erosion Rills that have formed above Basin 13. Area above has not been worked within the past 14 days.

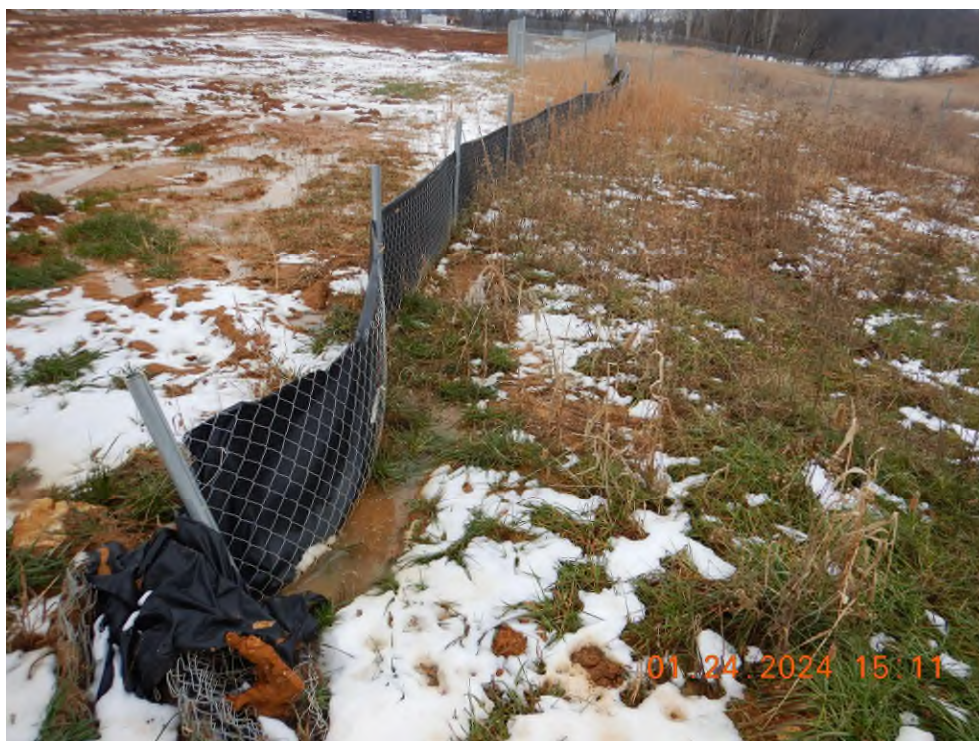
Supersilt fencing above outlet for Basin 13 needs maintenance. Sediment laden water is undermining the fencing.

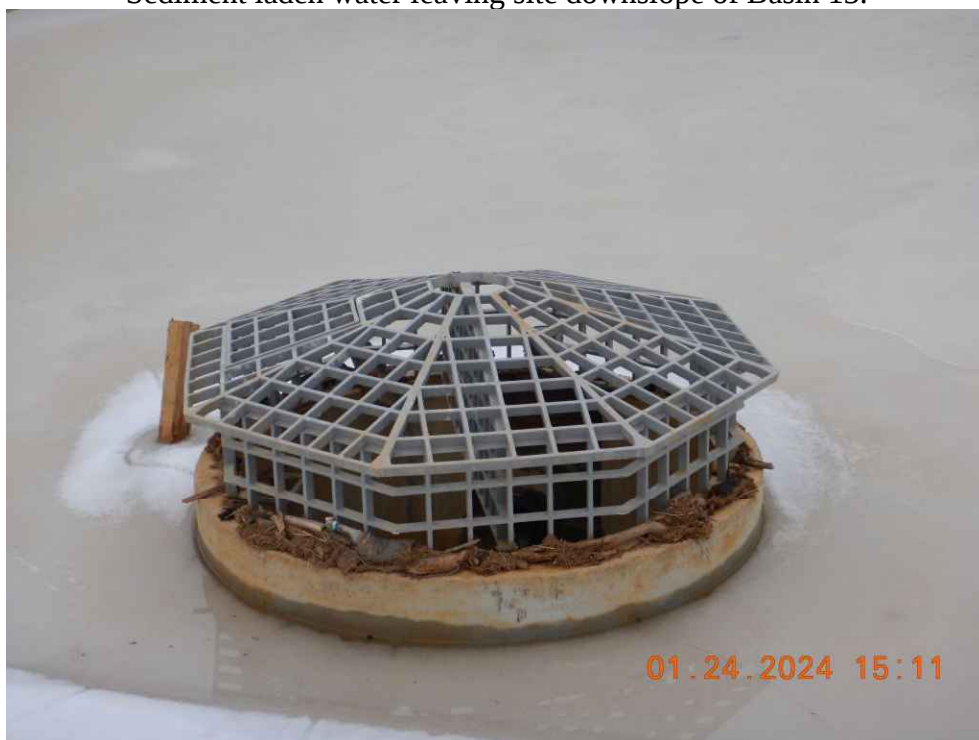
Riser for Basin 13 installed for the final stormwater pond.

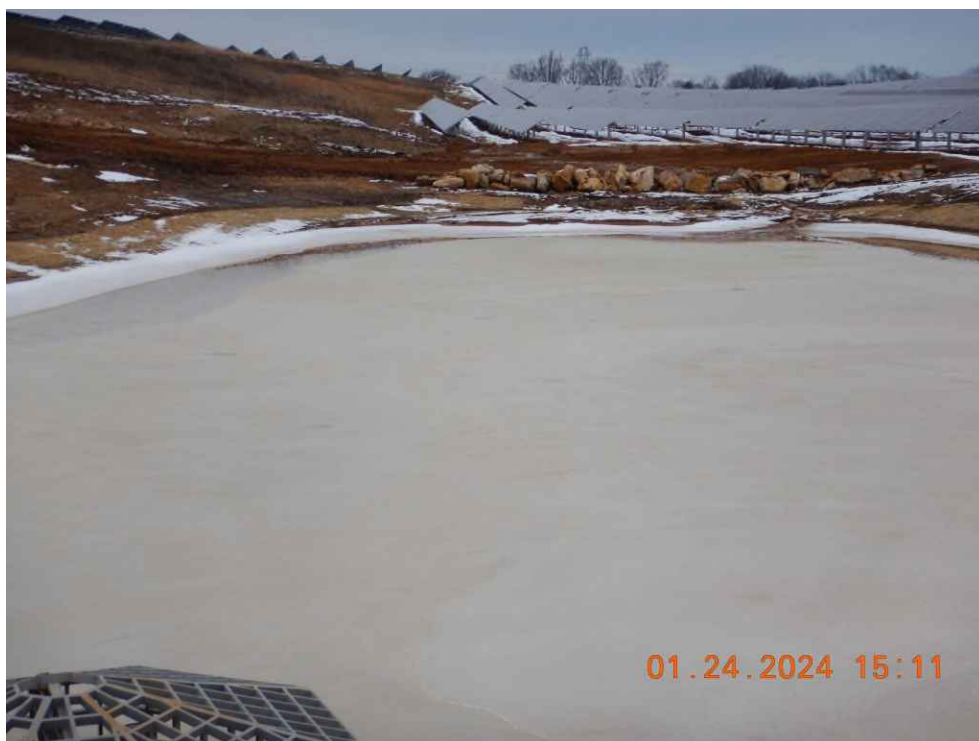
Area above Basin 13 is unstabilized prior to installation of the final stormwater feature.

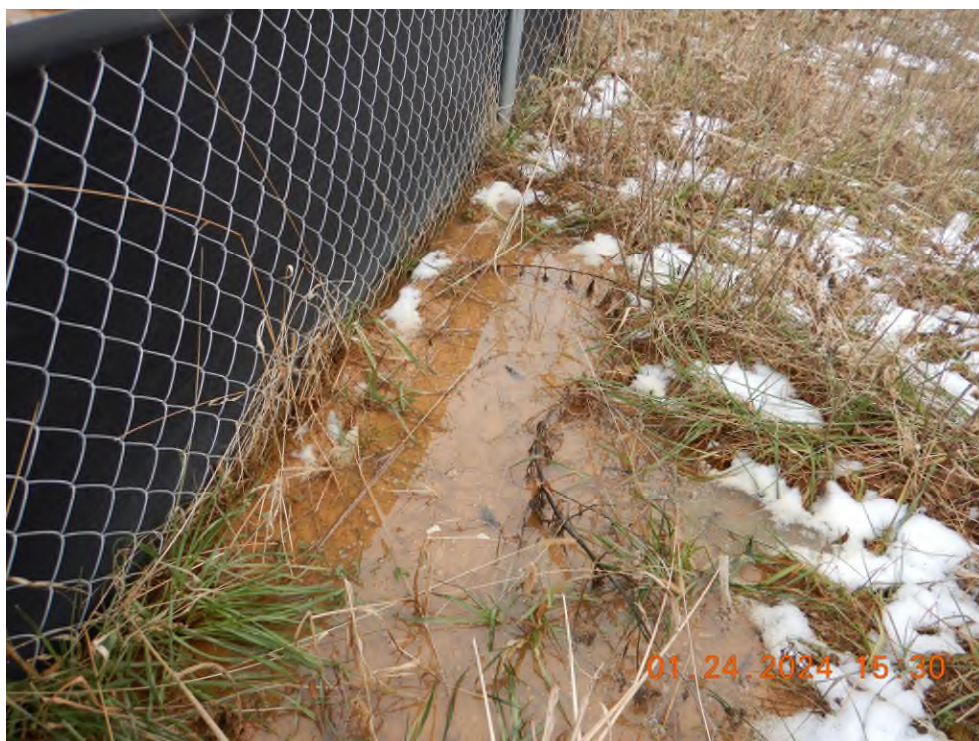
Sediment laden water discharging underneath Supersilt fencing into wetlands area.

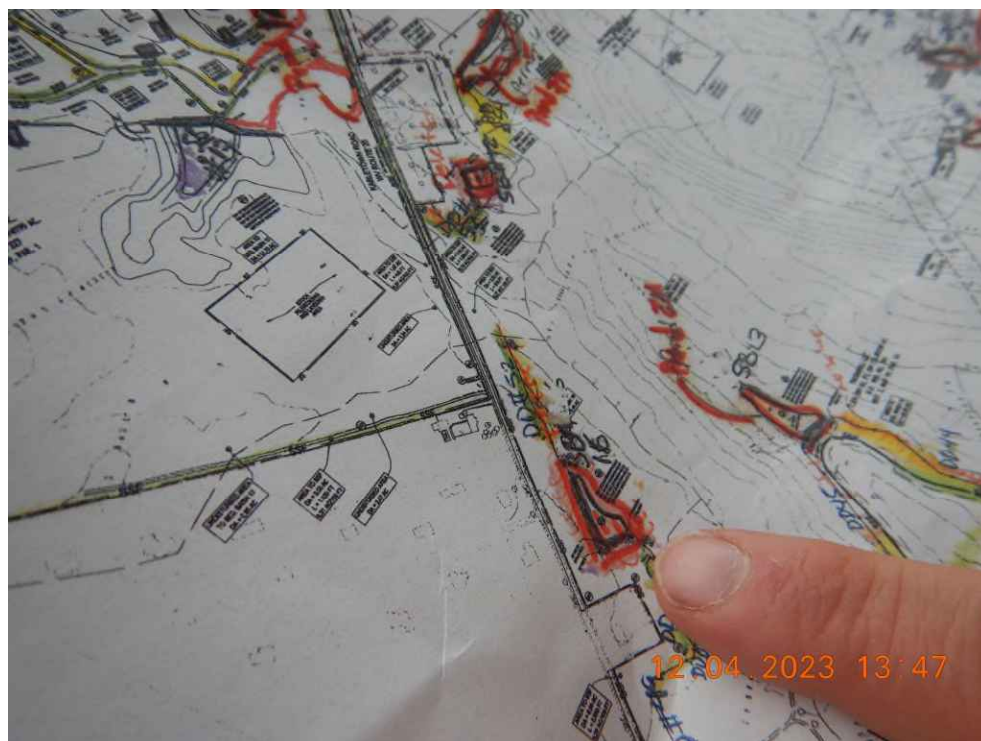
Sediment Basins 12 and 15 have been deleted prior to all uphill disturbance being vegetated.

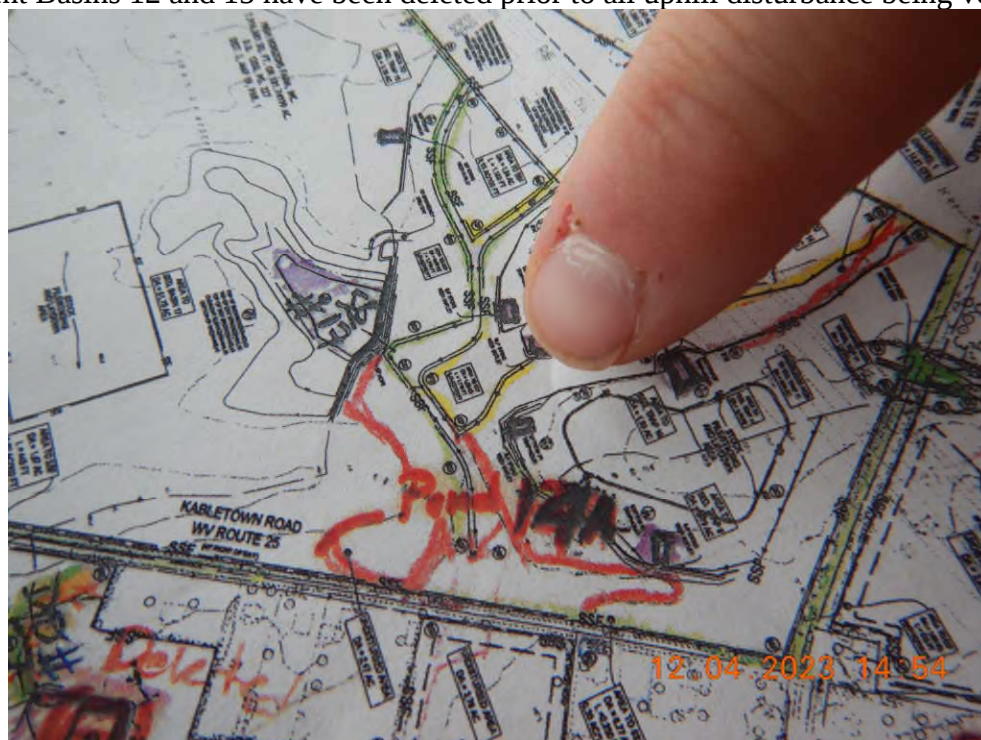
Pond 14A which is installed and not in the approved SWPPP.

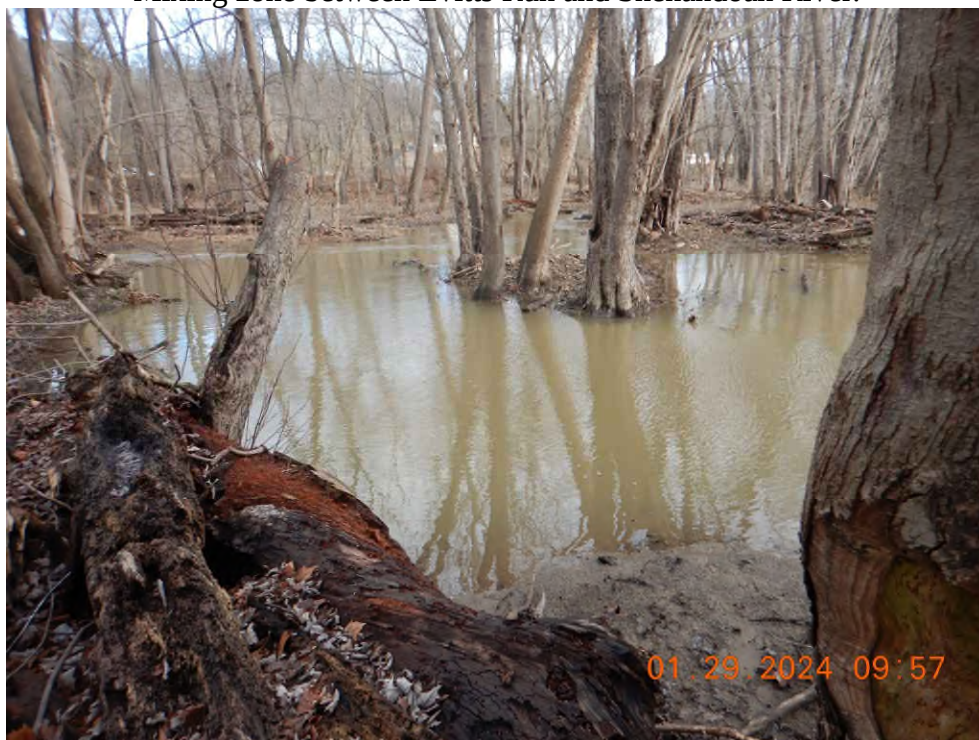
Evitts Run downstream of the construction site.

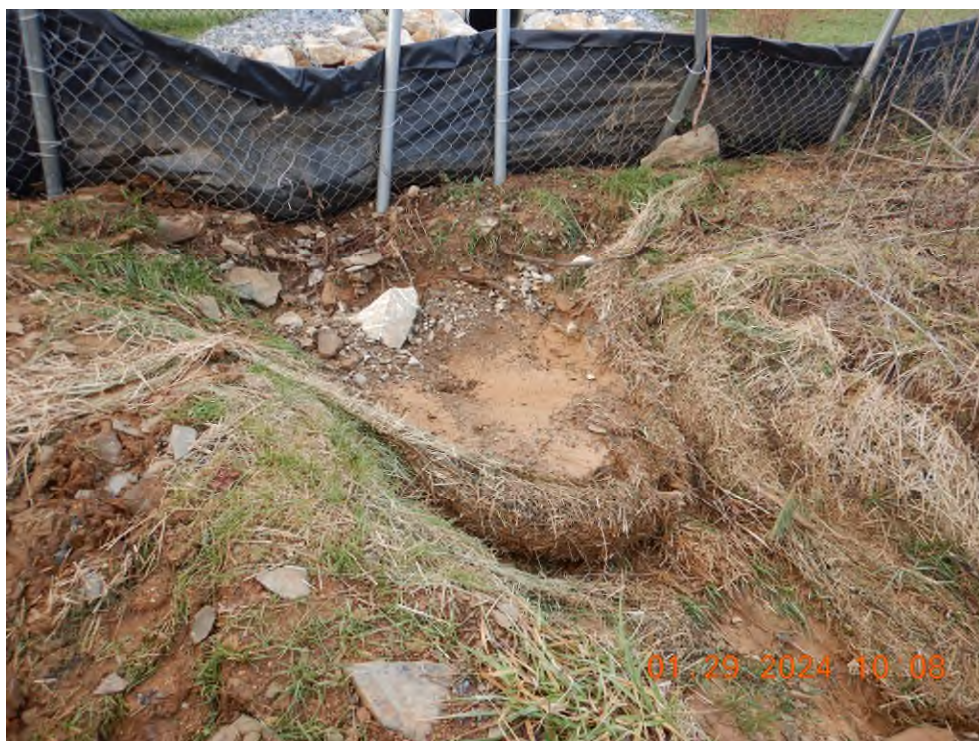
Basin 6 discharging into WVDOH culvert leading to Evitts Run

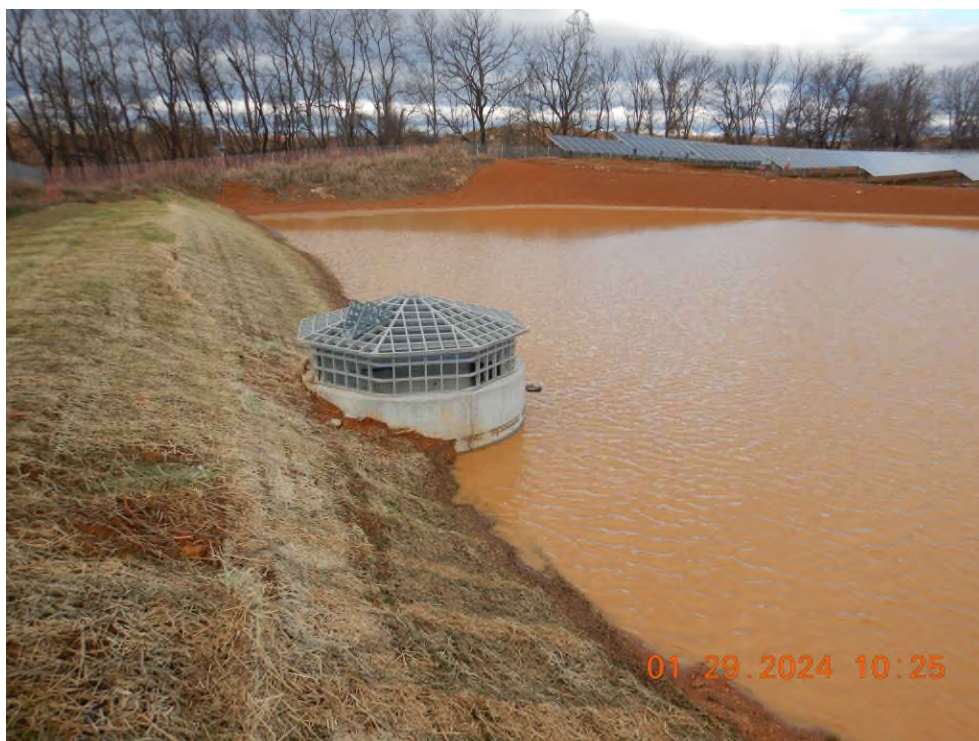
Basin 8 discharging offsite. Pond converted.

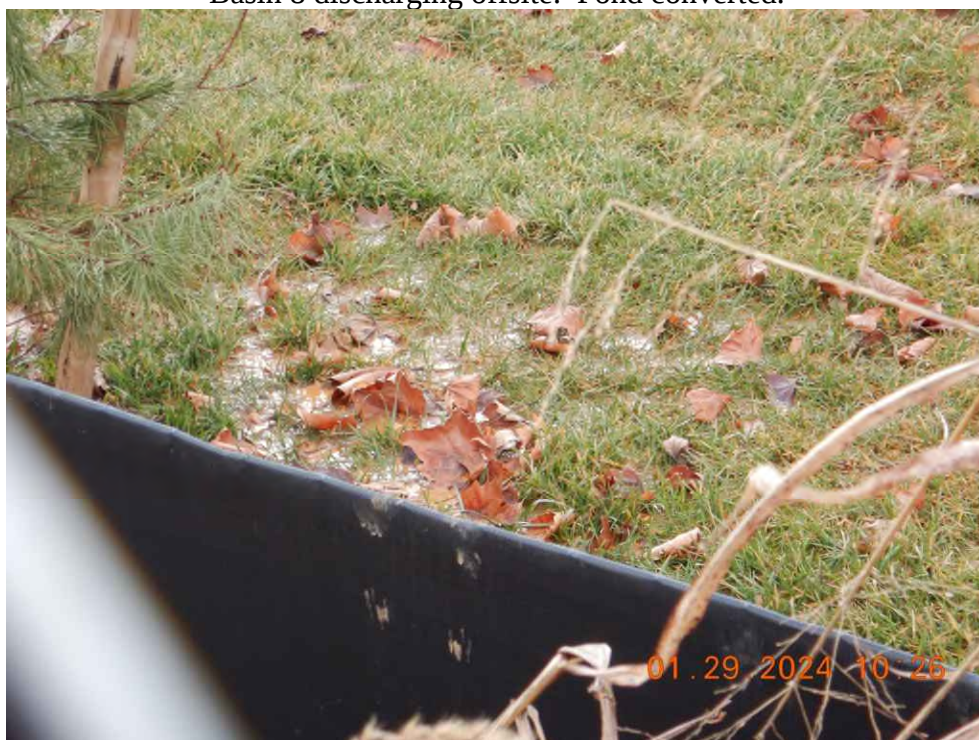
Basin 8 discharging offsite.

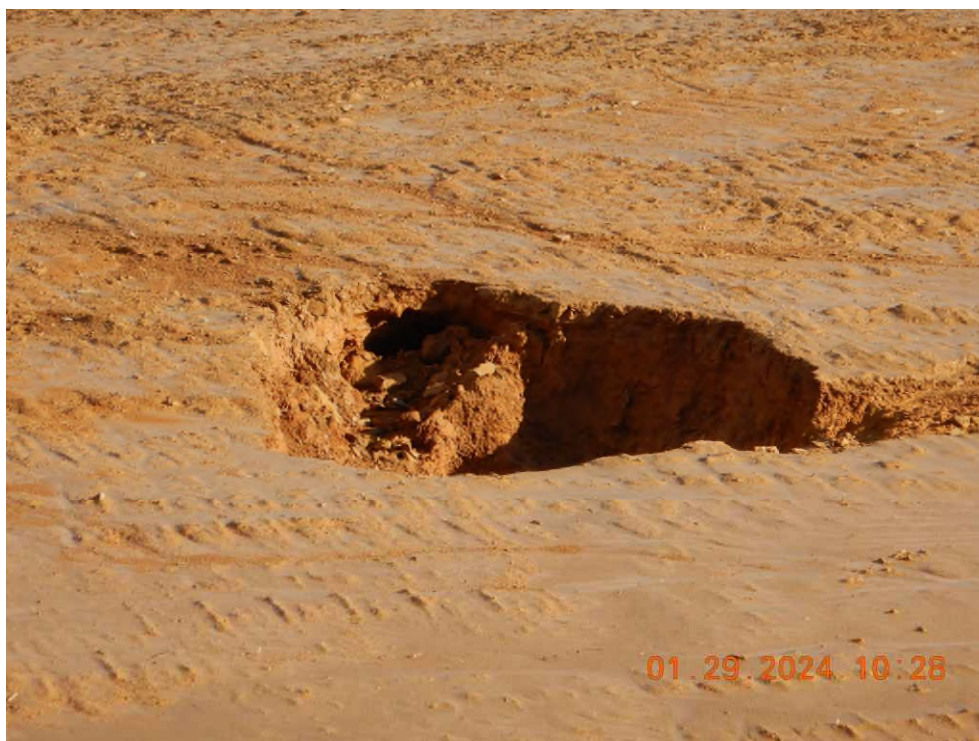
Sinkhole in Basin 7. Basin lacks maintenance.

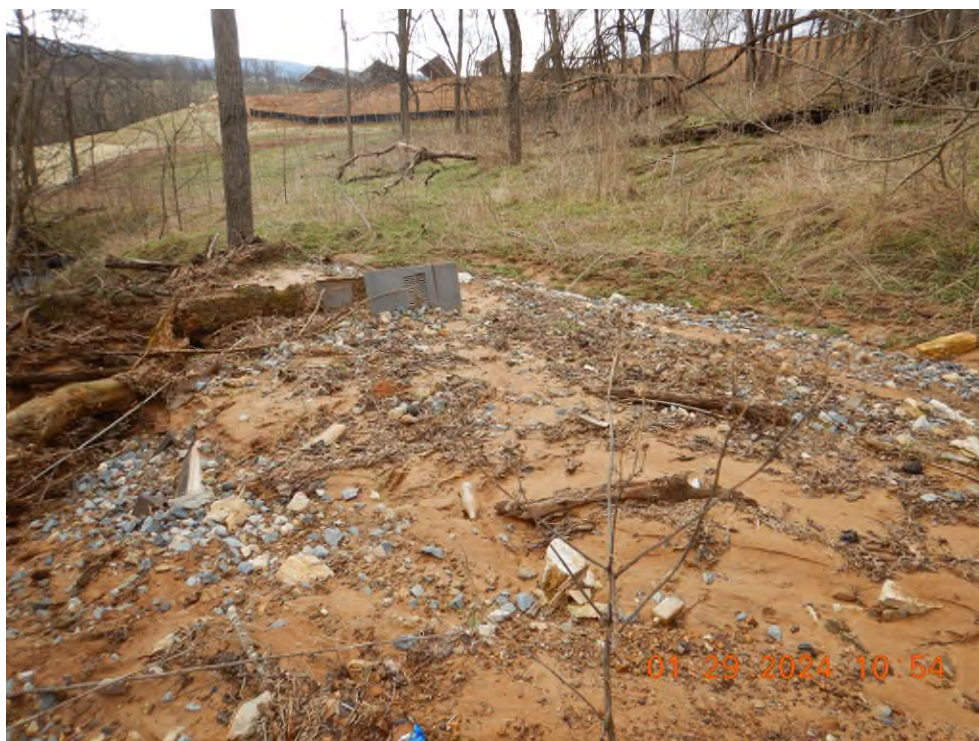
Conservation area above sediment basin 5.

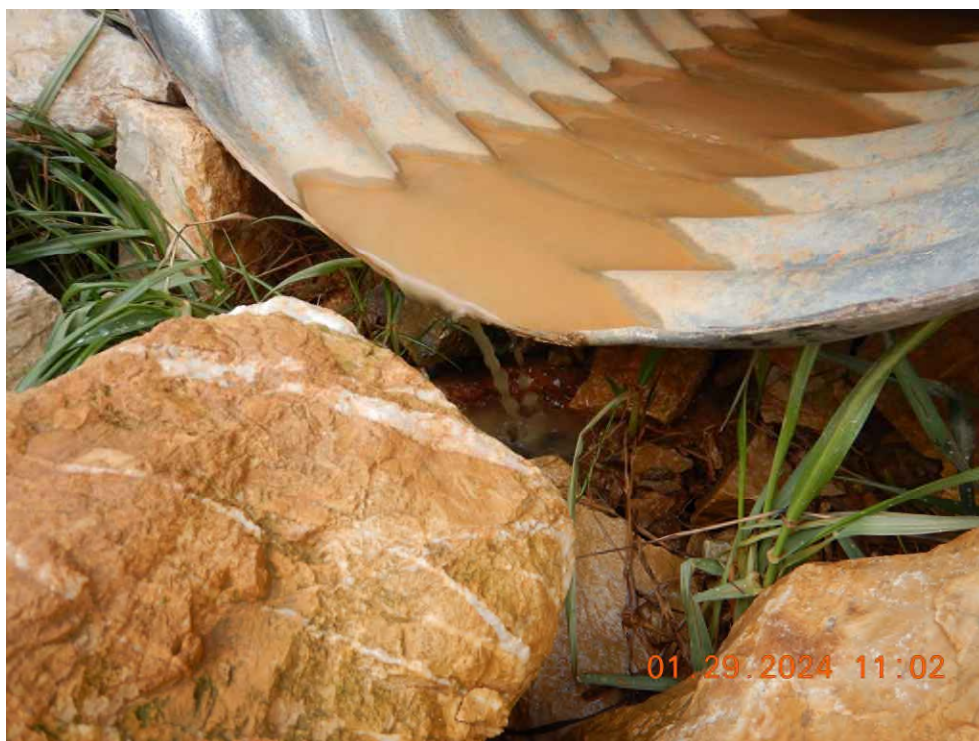
Basin 5 discharging offsite into Evitts Run.

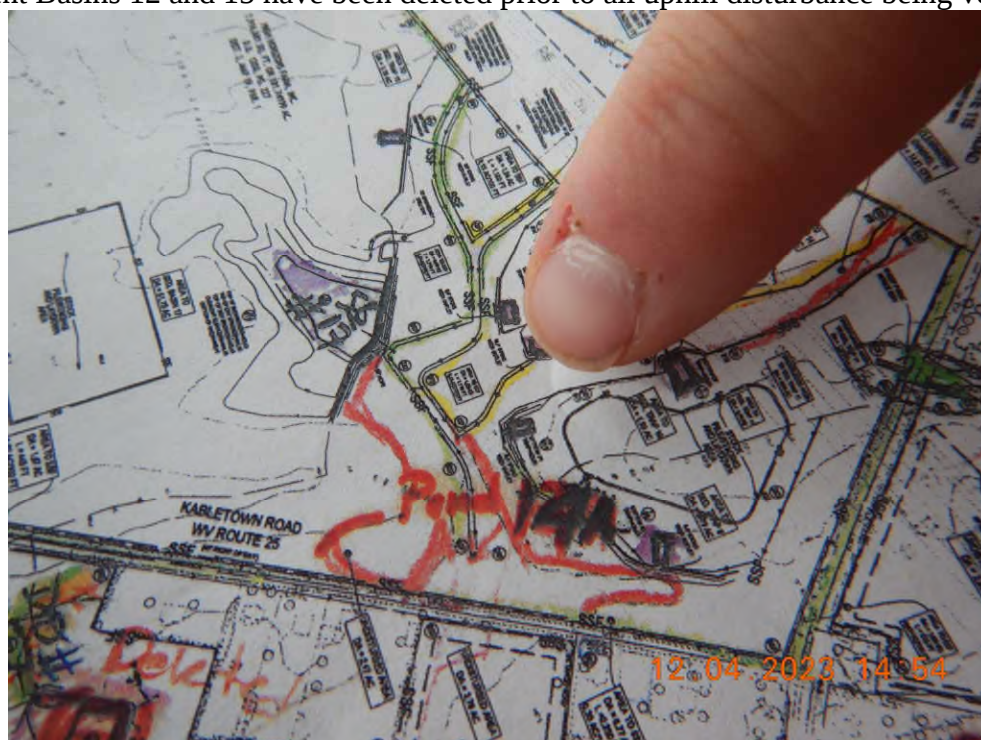
Pond 14A which is installed and not in the approved SWPPP.

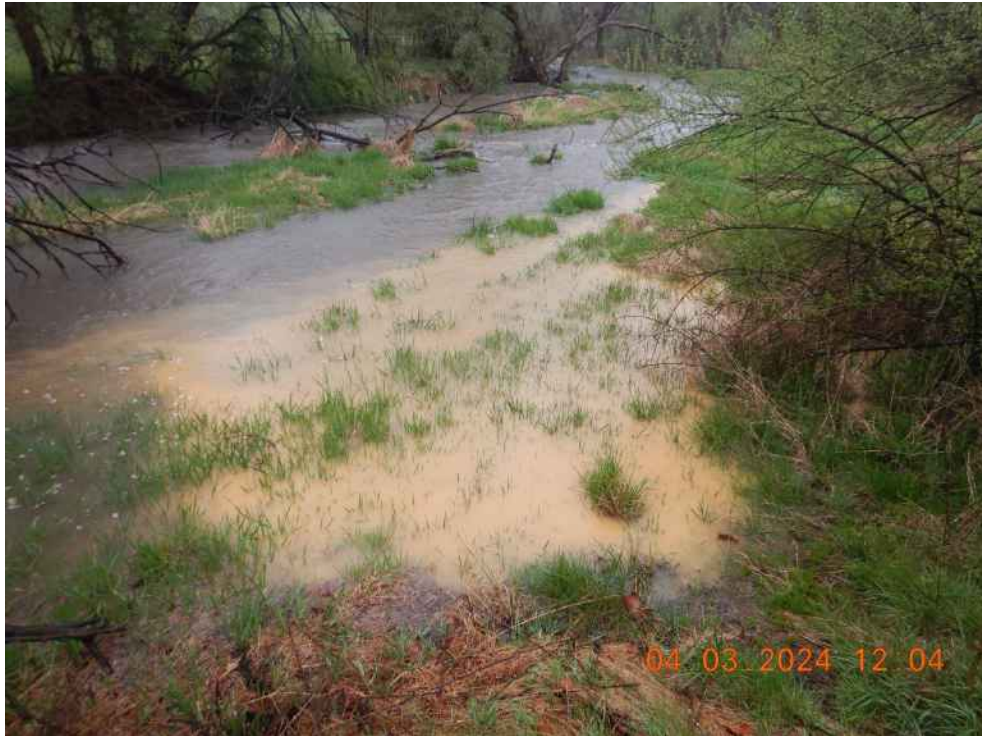
Outlet 2A discharging off site directly into Evitts Run.  
Causing Conditions not allowable.
