**CONSENT ORDER  
ISSUED UNDER THE  
WATER POLLUTION CONTROL ACT  
WEST VIRGINIA CODE CHAPTER 22, ARTICLE 11**

ORDER NO.: 10260

1. Horus West Virginia 1, LLC is conducting land disturbance activity associated with the Blake Solar Project in Jefferson County, West Virginia. Horus West Virginia 1, LLC was issued WV/NPDES Water Pollution Control Permit No. WV0115924, Registration No. WVR111837, on August 12, 2022.
2. On May 15, 2023, West Virginia Department of Environmental Protection (WVDEP) personnel conducted an inspection of the facility. During the inspection, violations of the following sections of the WV/NPDES permit were observed and documented:
  - a. Section II.H.1.d. – Horus West Virginia 1, LLC failed to provide an adequate stone access entrance/exit to reduce the tracking of sediment onto public or private roads.

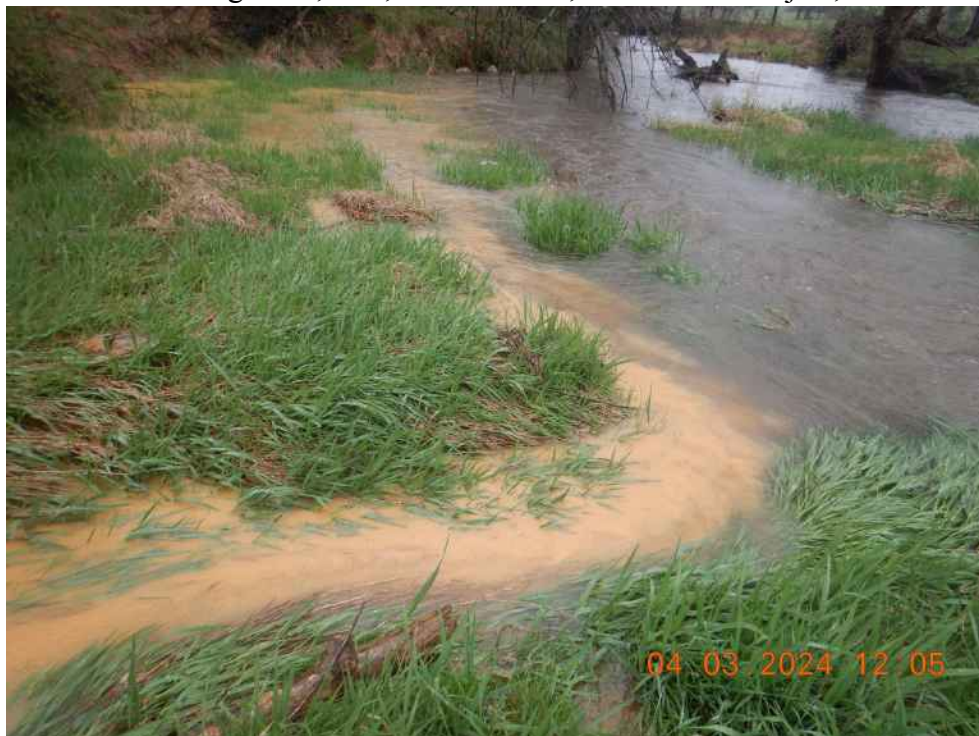
Outlet 2A discharging off site directly into Evitts Run. Causing Conditions not allowable.

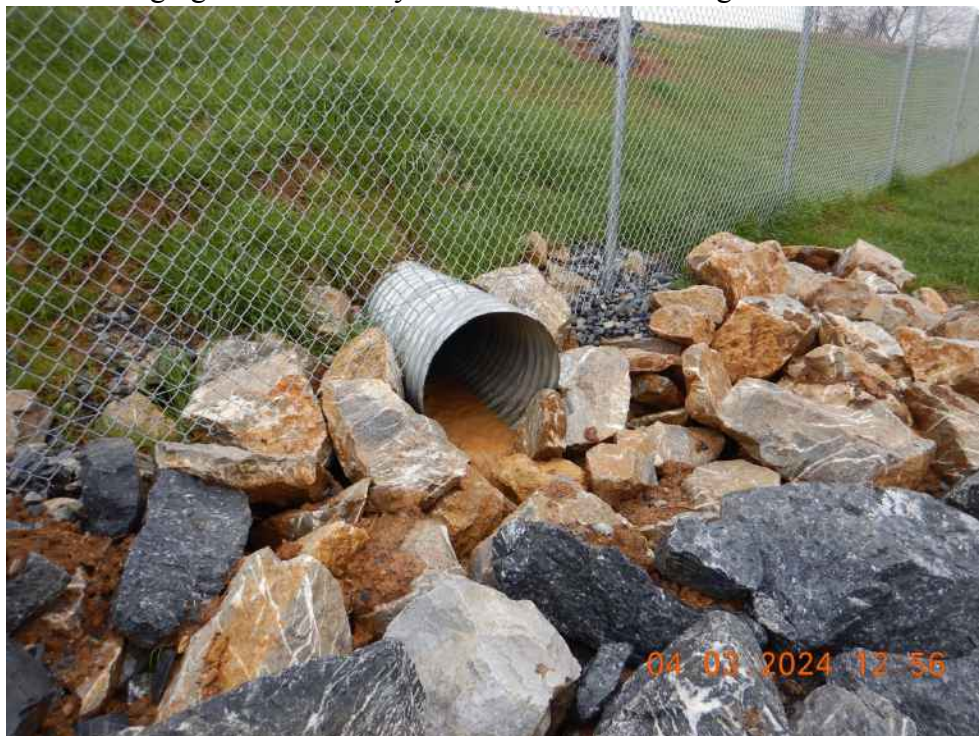
Outlet 6 discharging sediment laden water.

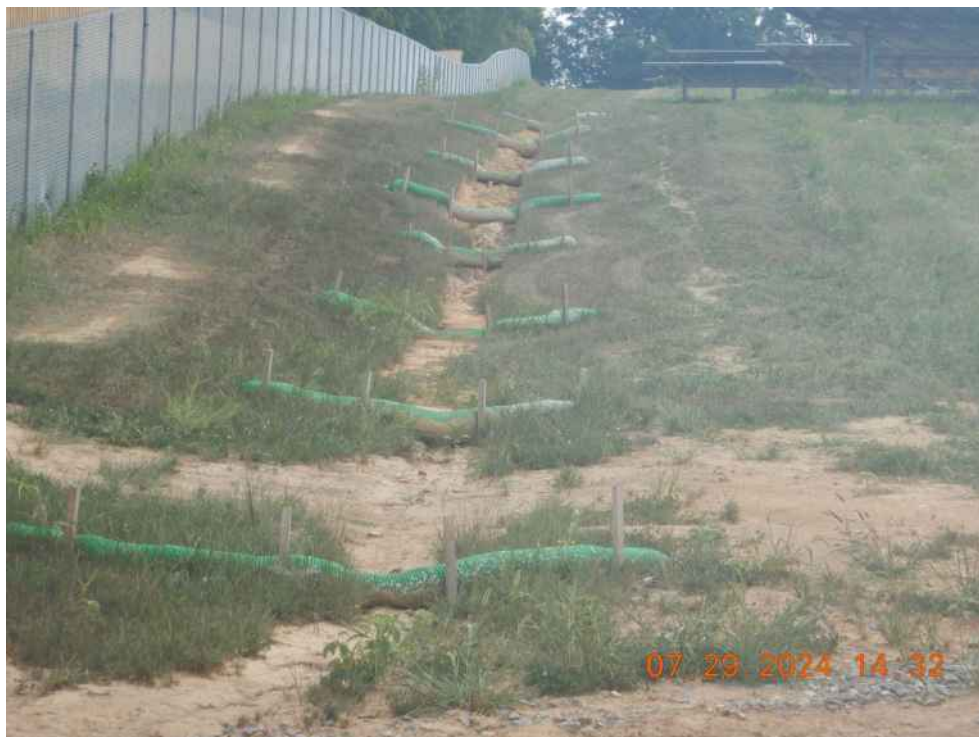
Diversion ditch checks that have been undermined and not repaired. Area of former access road below sediment basin 7.

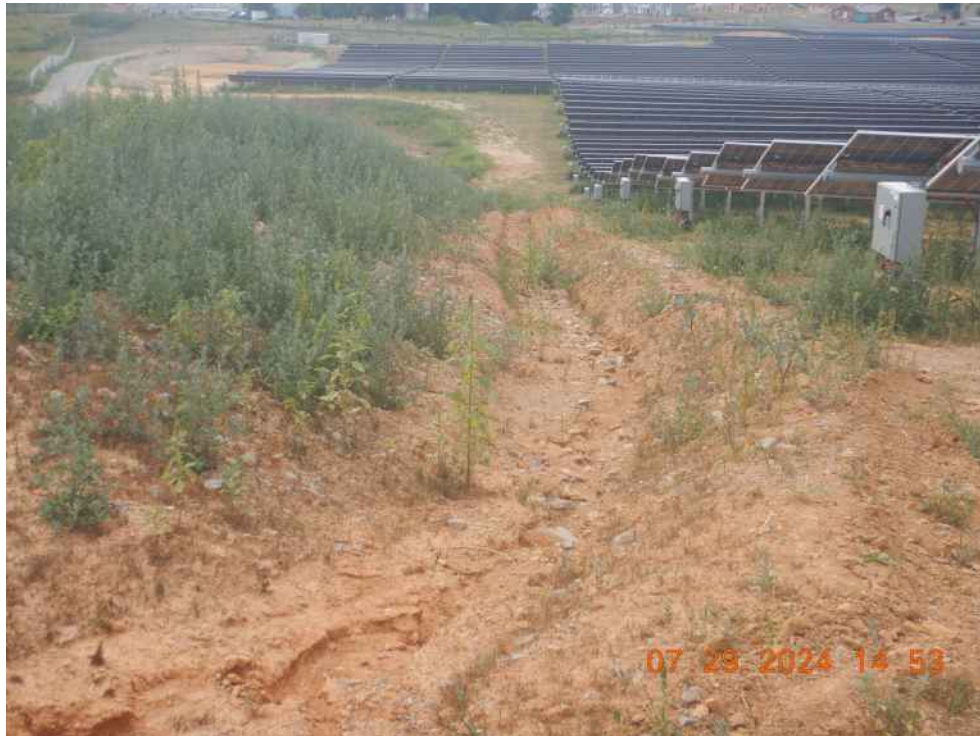
An unstabilized diversion that has not been repaired. Above sediment trap 2.

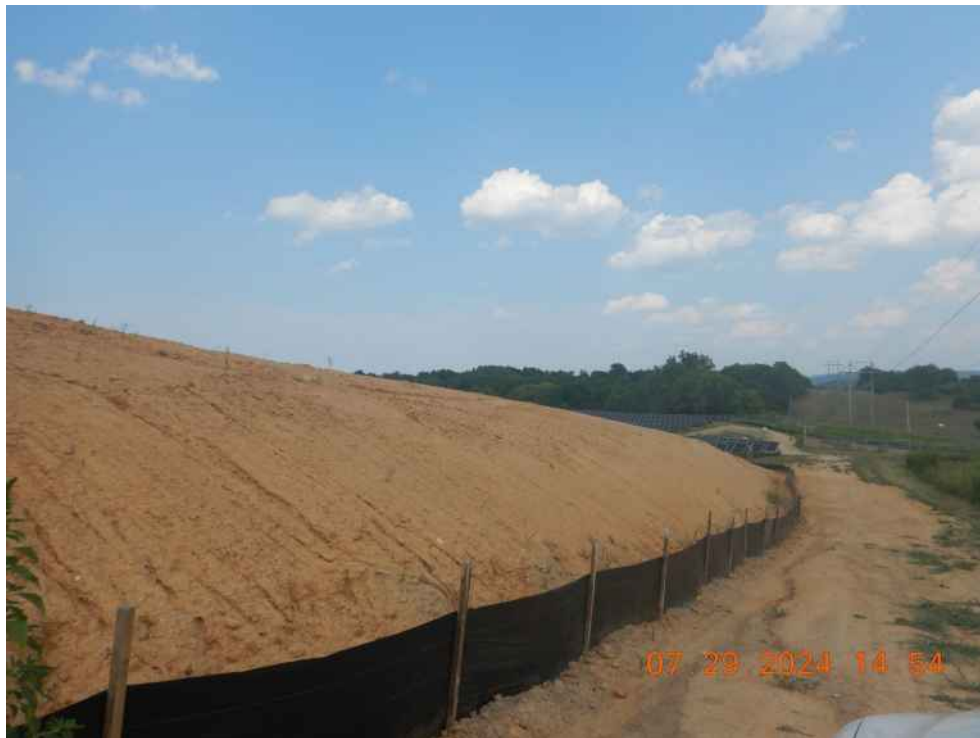
An unstabilized soil stockpile. Sediment trap 2 area.

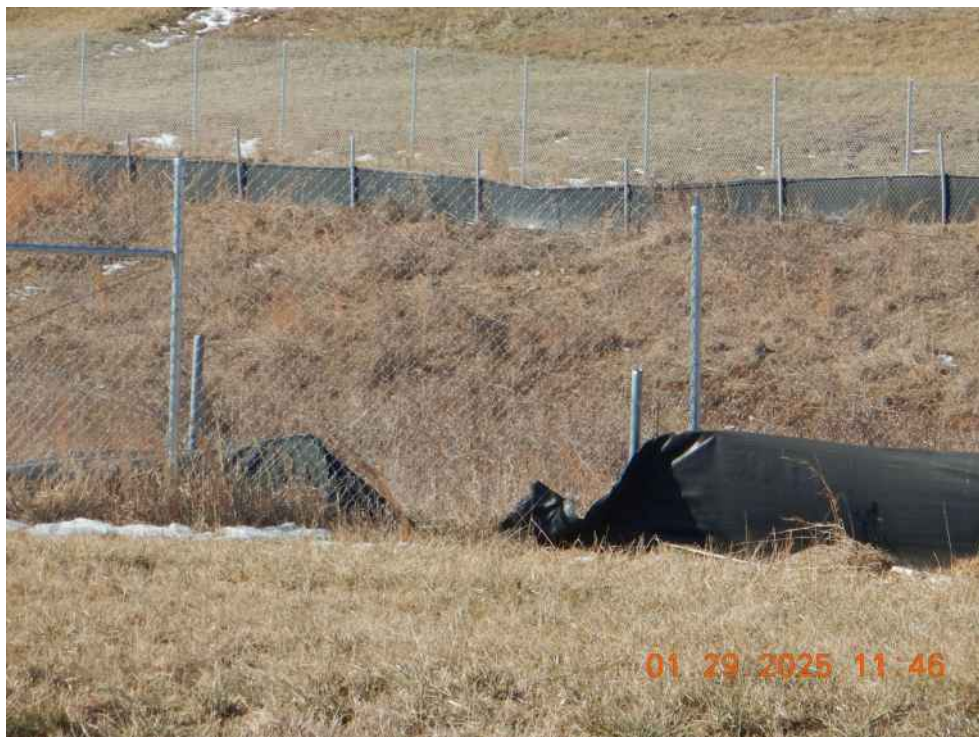
The super silt fencing is in need of maintenance and repair.

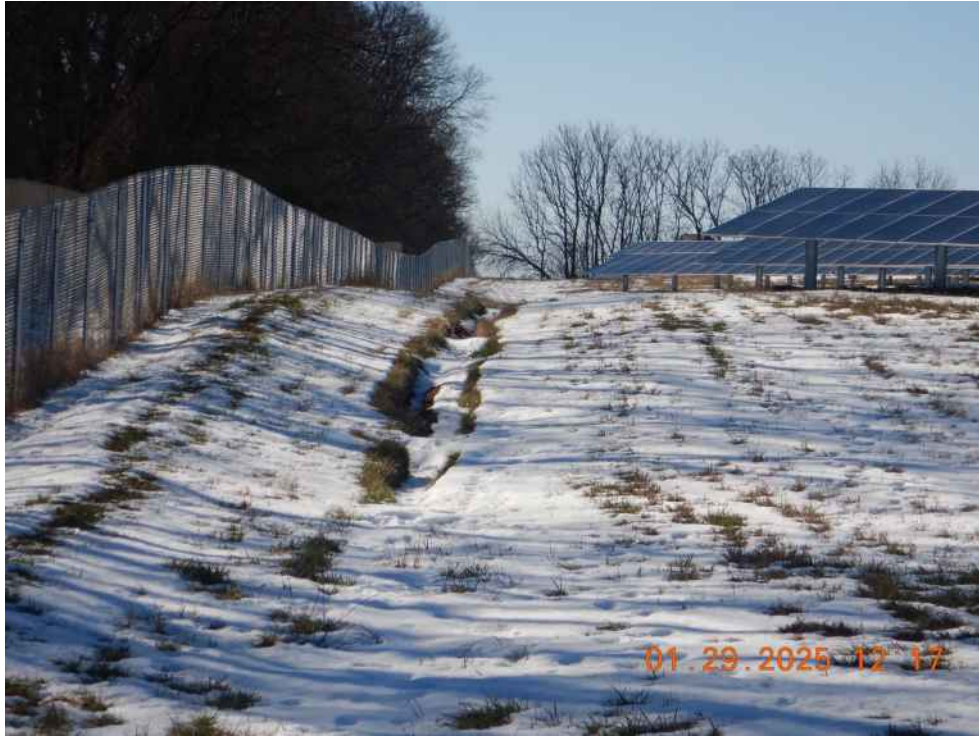
An unstabilized/washed out diversion channel.
