TERRADON

CONTRACT #1 PROJECT UPDATES

west virginia department of environmental protection

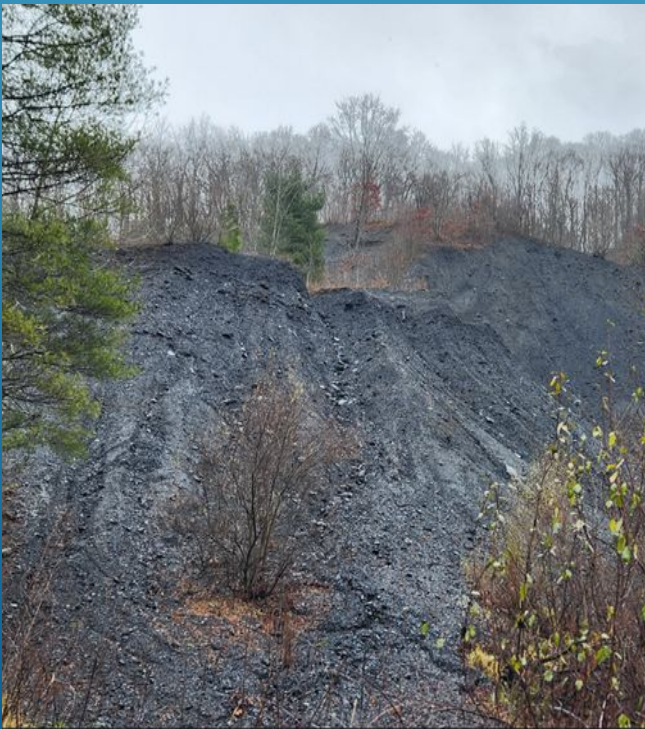
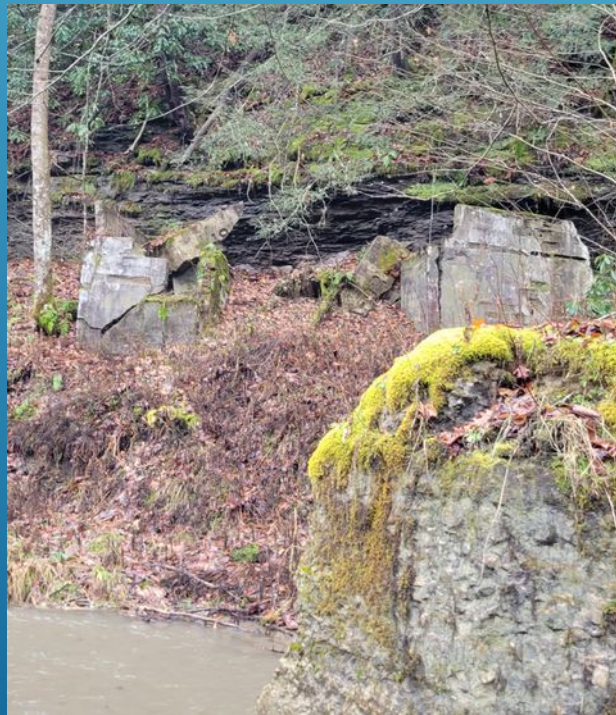
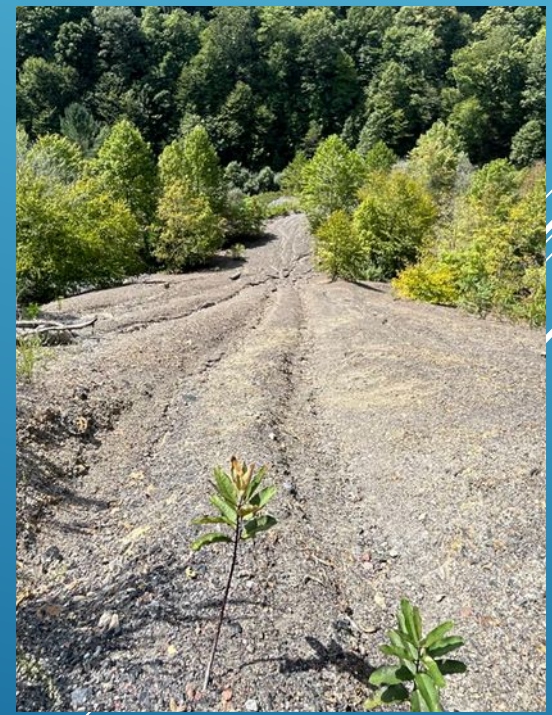
ALGOMA REFUSE AND PORTALS

- ALGOMA IS THE LARGEST SITE OF THE 7 IN CONTRACT #1
- HAS 7 INDIVIDUAL REFUSE PILES IN NEED OF REGRADING
- 6 STRUCTURES IN NEED OF DEMOLITION
- 4 DRAINING PORTALS AND 2 DRY PORTALS

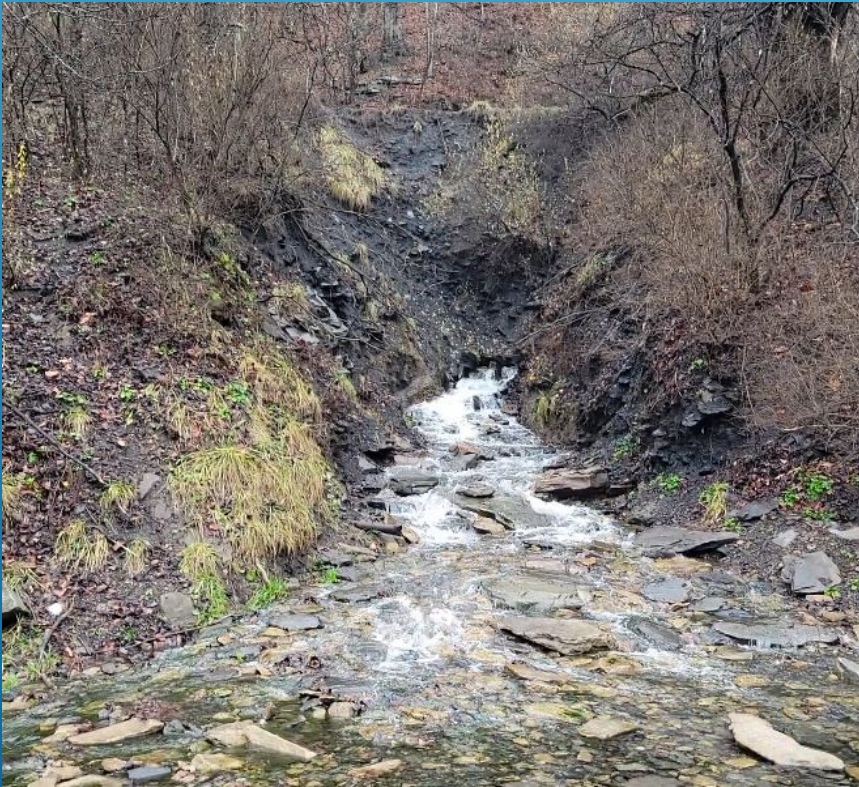
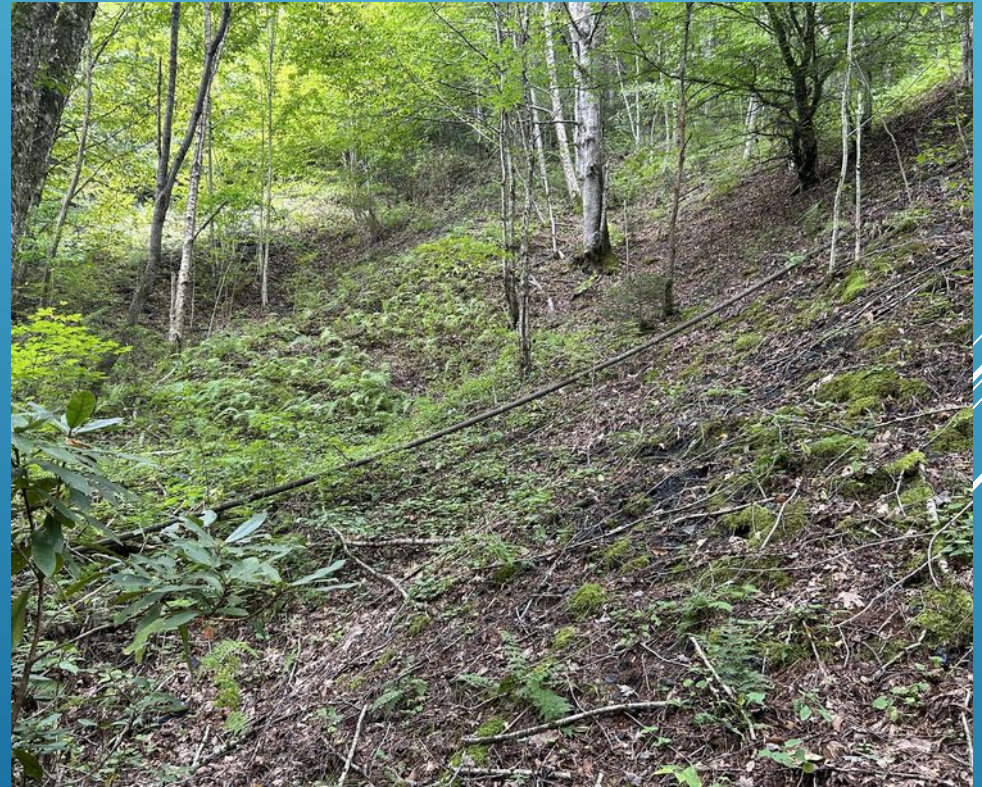
- REFUSE PILES 1,2, AND #6 MAY REQUIRE 1.5:1 SLOPES AND COULD BE DIFFICULT TO CONSTRUCT
- LARGE DRAINING PORTAL COULD BE AN ISSUE, MAY REQUIRE ARCHED CULVERT WITH A GATE
- GASLINE RUNNING UP REFUSE PILE #7 WILL NEED RELOCATED
- ON SITE SOIL BORROW IS MINIMAL / NON EXISTENT

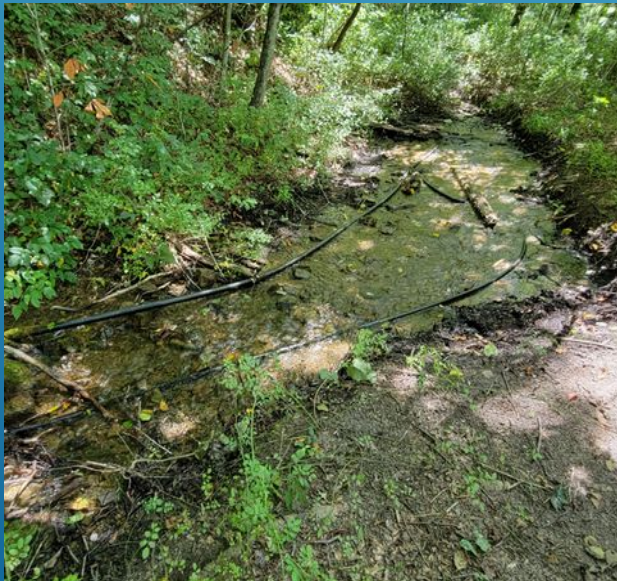
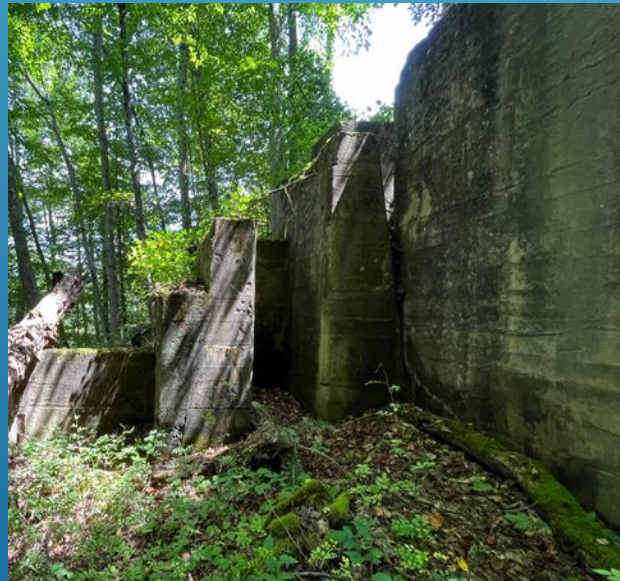
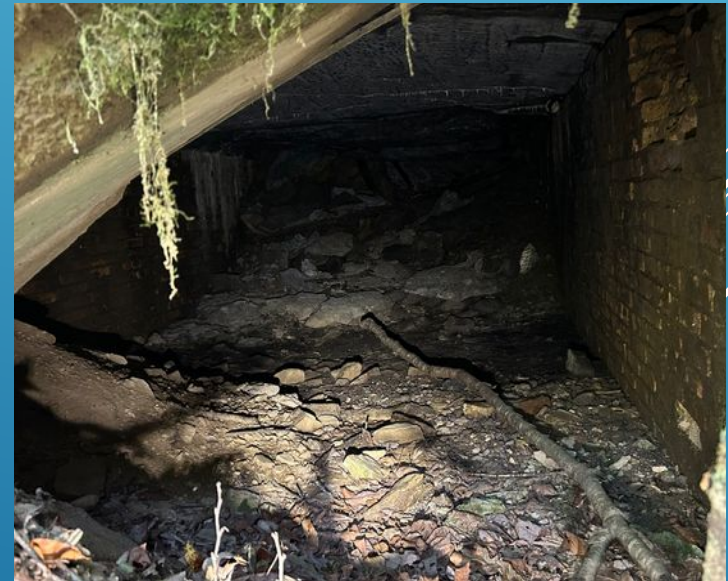
GREENBRIER HOLLOW REFUSE (PHASE II)

- GREENBRIER IS THE 2ND LARGEST SITE OF THE 7' IN CONTRACT #1
- 1 LARGE REFUSE PILE TO REGRADE
- 6 STRUCTURES TO DEMOLISH
- 1 60' LONG HIGHWALL TO BACKFILL
- 19 DRAINING PORTALS AND 3 DRY PORTALS

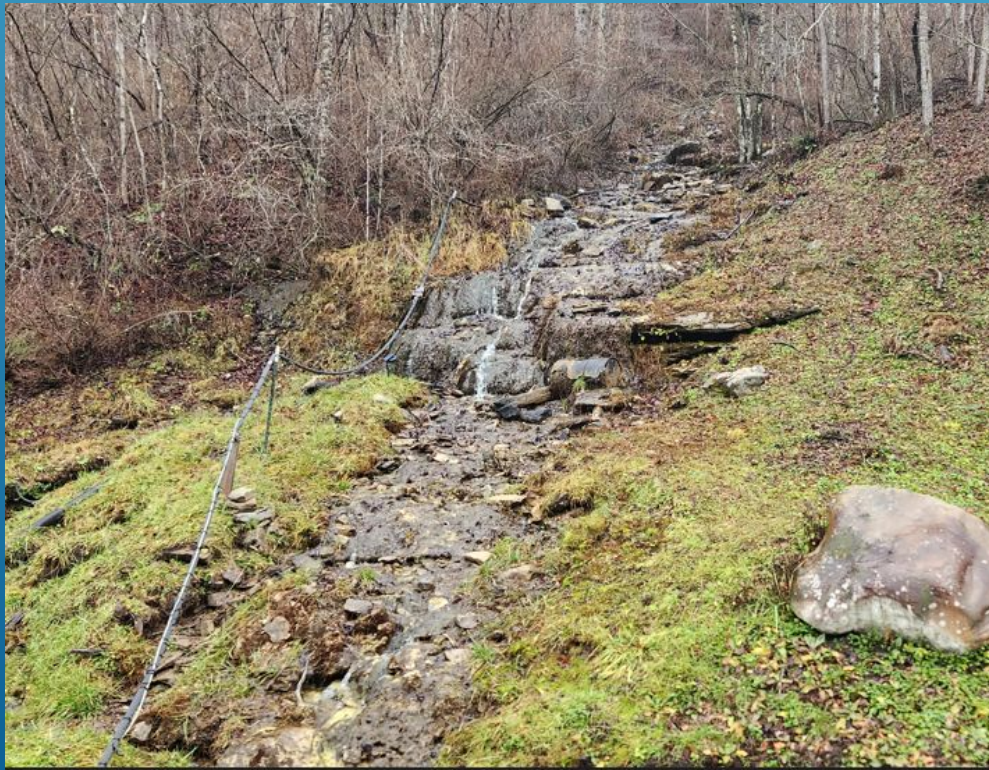
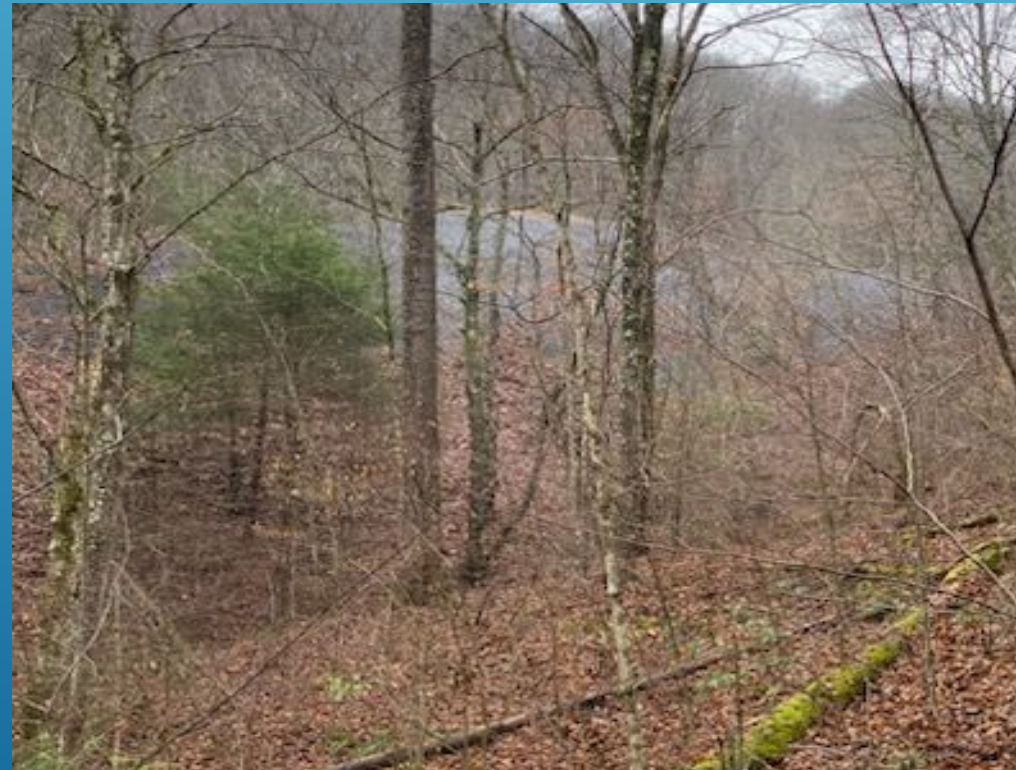
- THE DRAINING PORTALS ALONG THE BENCH AREA ARE PRODUCING A LARGE AMOUNT OF WATER AND COULD CAUSE DIFFICULTY DURING CONSTRUCTION.
- THE COMMUNITY BELOW THE BENCH AREA GET THEIR WATER FROM THE MINE AND THIS WATER SOURCE MUST BE MAINTAINED
- GASLINE BELOW THE REFUSE AREA MAY NEED RELOCATED
- ON SITE SOIL BORROW IS MINIMAL

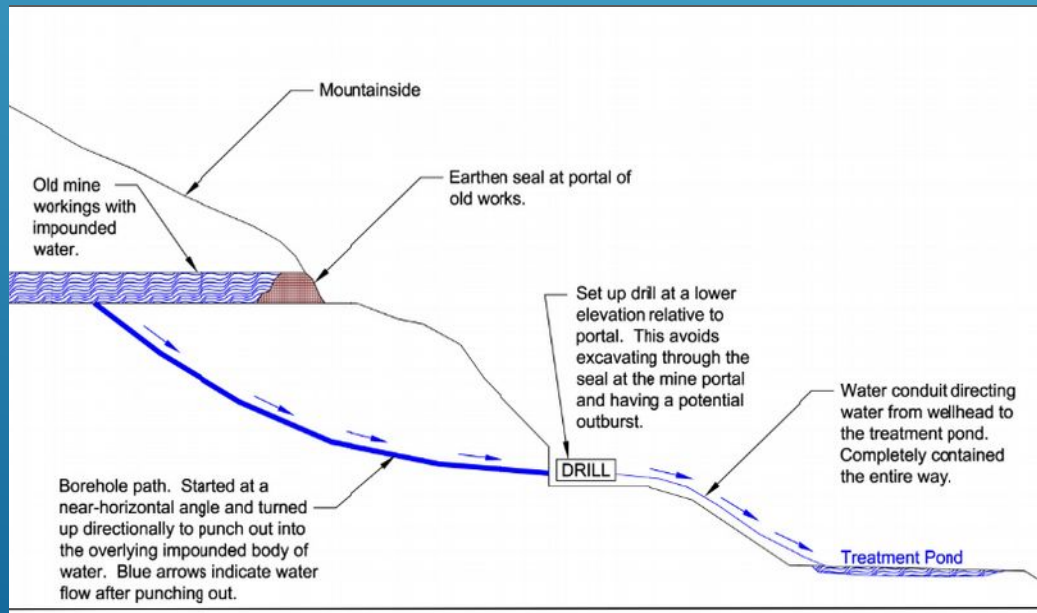
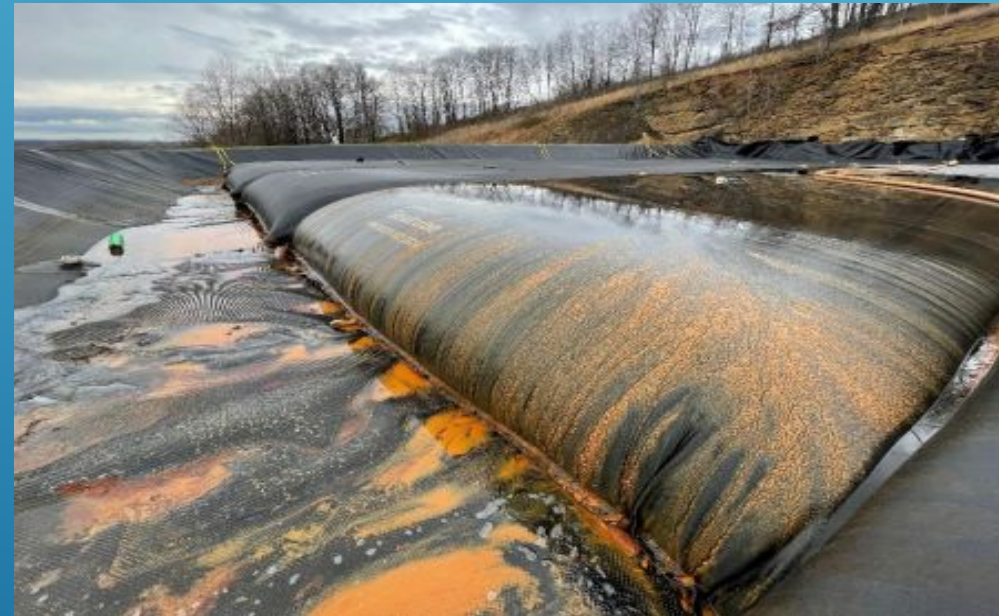
DREWS CREEK DANGEROUS IMPOUNDMENT OVERVIEW

- 1 DRAINING PORTAL
- 2 DIRECTIONAL BORINGS TO DEWATER THE MINE
- 1 GEOTUBE (SEDIMENT BAG) TO CONTAIN SEDIMENT FROM THE MINE DISCHARGE

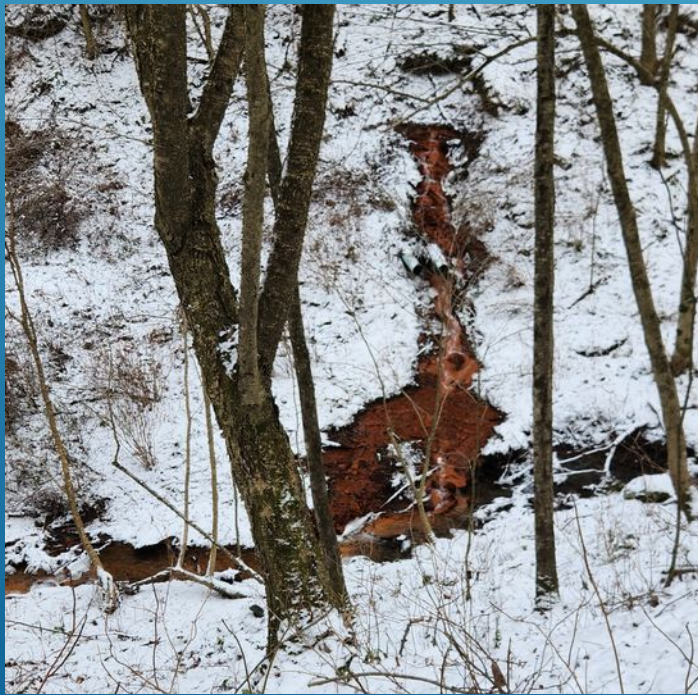
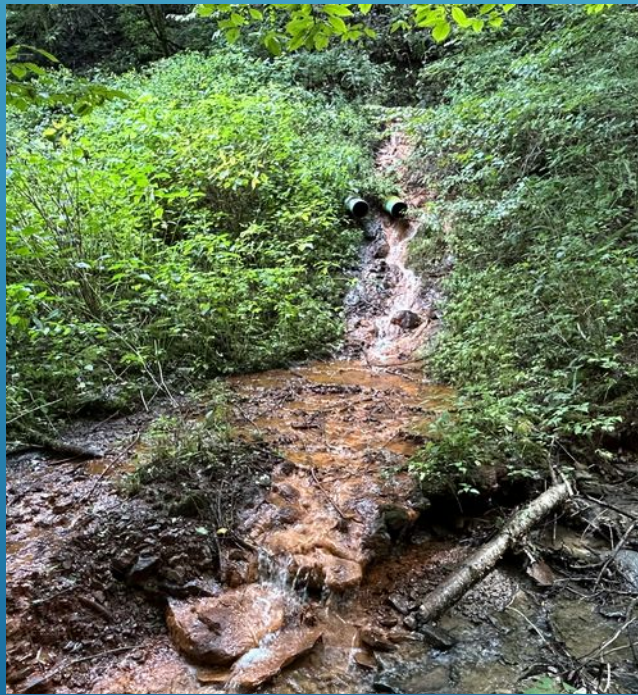
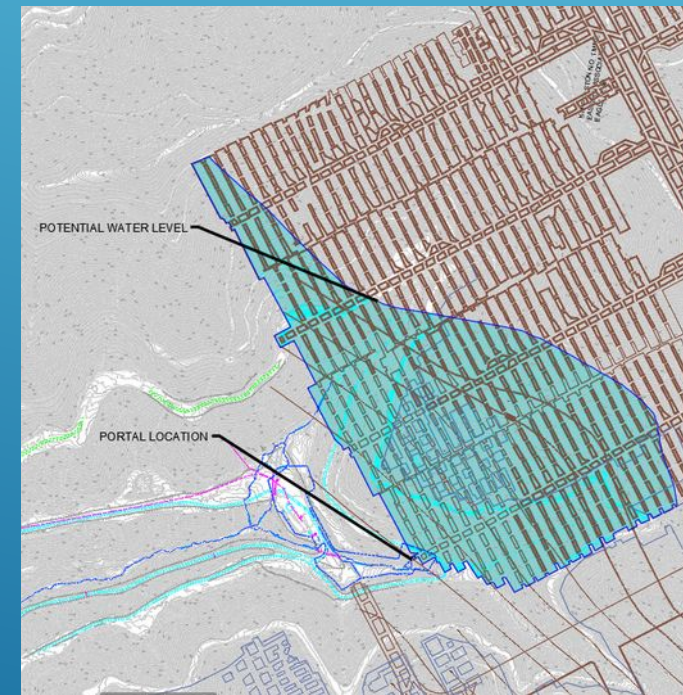
- THE DRAINING PORTAL IS IMPOUNDING MILLIONS OF GALLONS OF WATER
- DIRECTIONAL DRILL SUBCONTRACTOR WILL NEED TO BE UTILIZED
- THE MINE CONTAINS A LARGE AMOUNT OF SEDIMENT AND GEOTUBES (SEDIMENT BAGS) WILL NEED TO BE UTILIZED TO FILTER DISCHARGE FROM THE MINE.
- BECAUSE OF THE SEDIMENT BAGS, DEWATERING THE MINE COULD BE A SLOW PROCESS
- THE SITE IS CONSTRAINED BY GAS LINES AND HIGHWALLS SO WORK AREAS WILL BE TIGHT

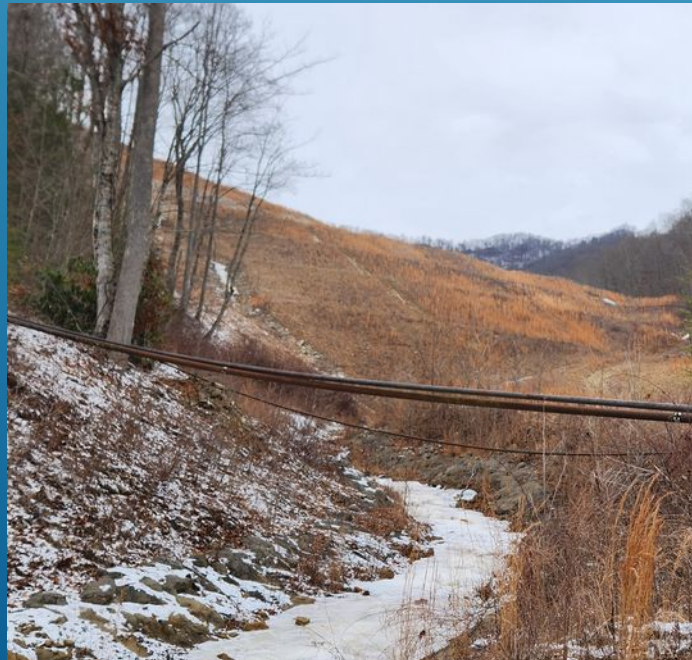
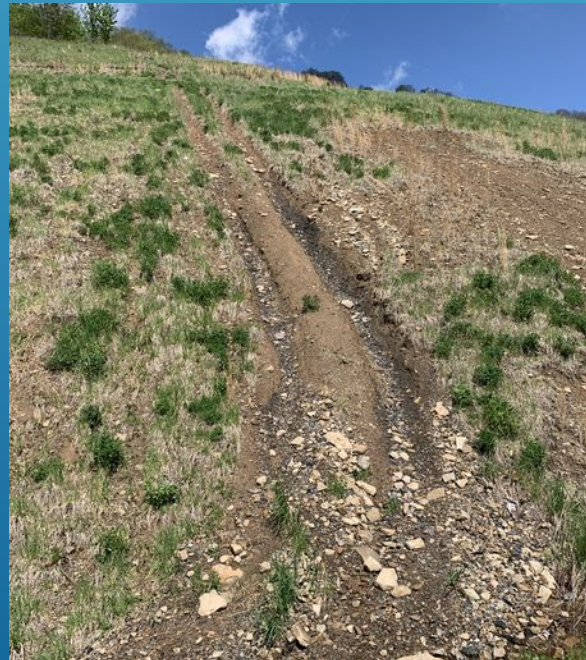
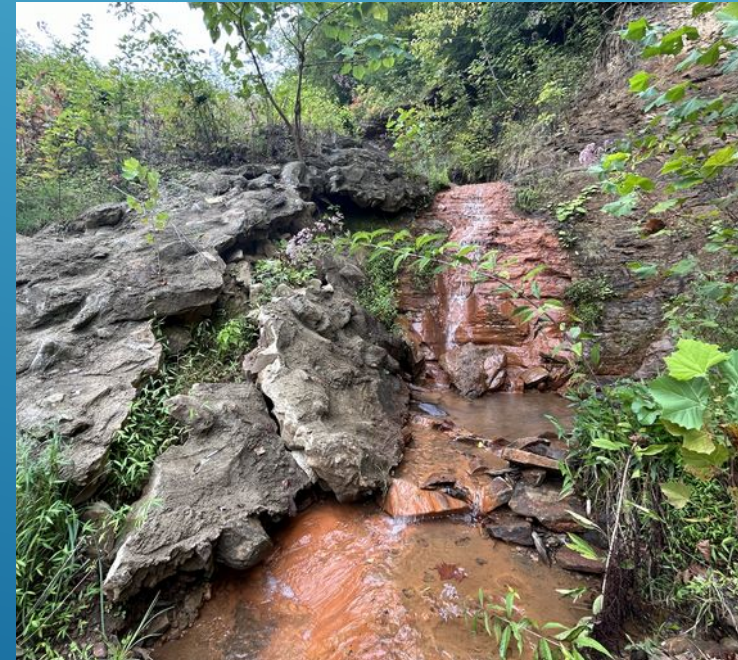
CRANY MINE DUMP (PHASE II) OVERVIEW

- LARGE REFUSE AREA PREVIOUSLY RECLAIMED AND NOW RESEMBLES A VALLEY FILL
- 7 BENCHES TO REGRADE IN ORDER TO CORRECT DRAINAGE ISSUES
- 2 ATV TRAILS ON THE FILL NEED RECLAIMED. THESE PATHS HAVE LEAD TO EROSION ISSUES
- 2 SLIP AREAS TO REPAIR
- 3 CLOGGED UNDERDRAINS TO REPLACE
- RIGHT SIDE GROIN DITCH TO BE REPAIRED

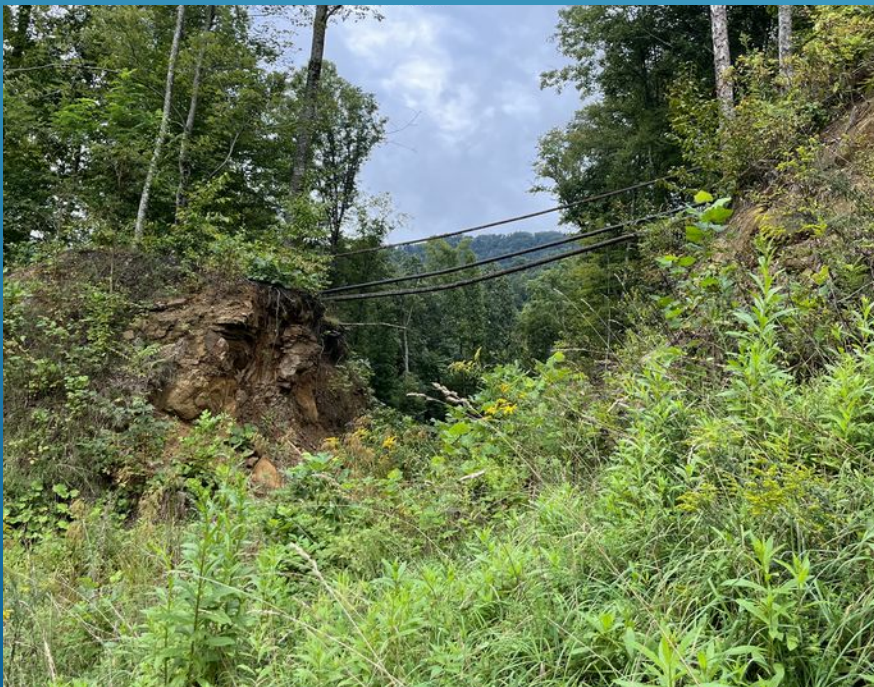
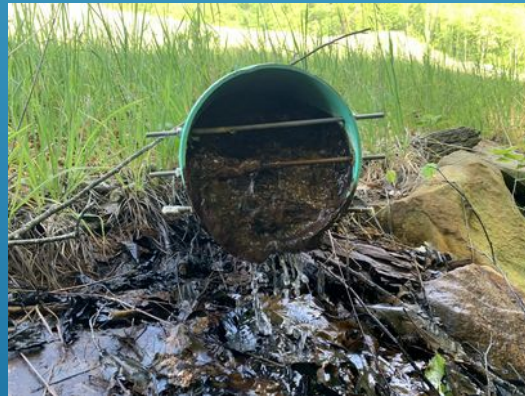
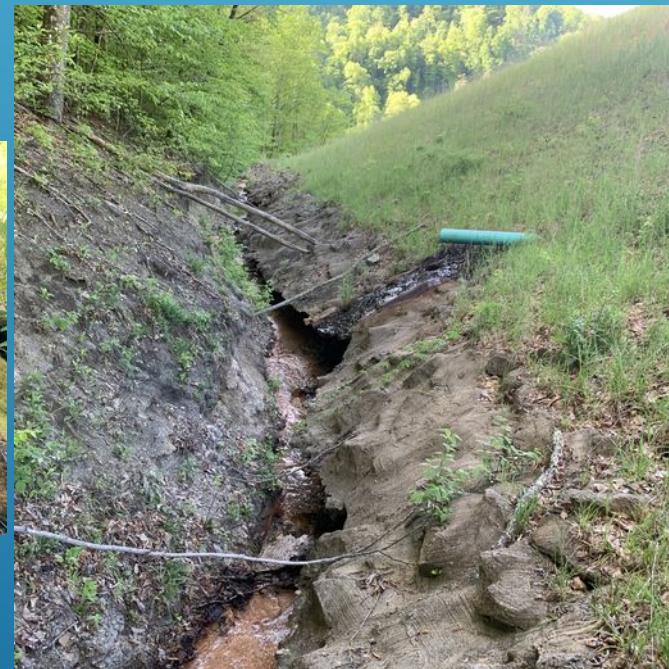
- THE TOTAL DEPTH OF THE 3 CLOGGED UNDERDRAINS IS NOT KNOWN. HOWEVER, AFTER COMPARING SURVEY DATA AND EXISTING MAPPING THEY DO NOT APPEAR TO BE VERY DEEP.
- GASLINES RUNNING UP THE LEFT SIDE OF THE FILL COULD RESTRICT ASSESS TO PROPOSED BORROW SITE.

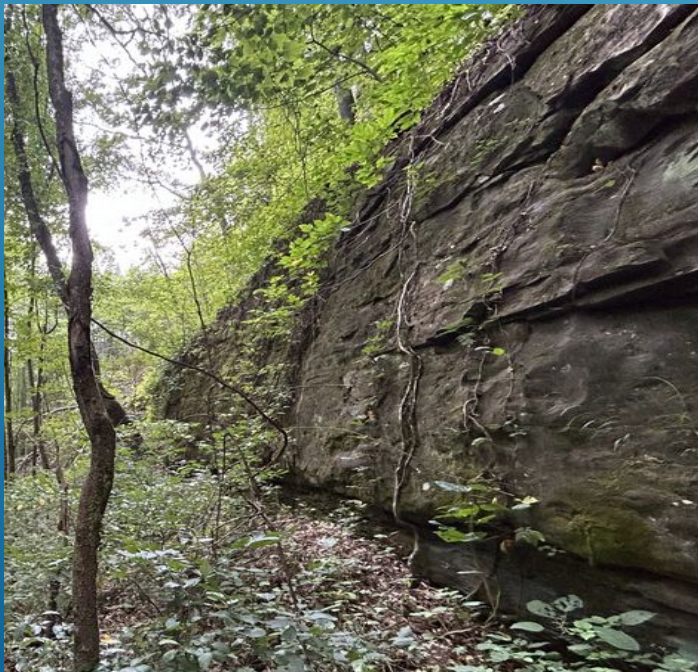
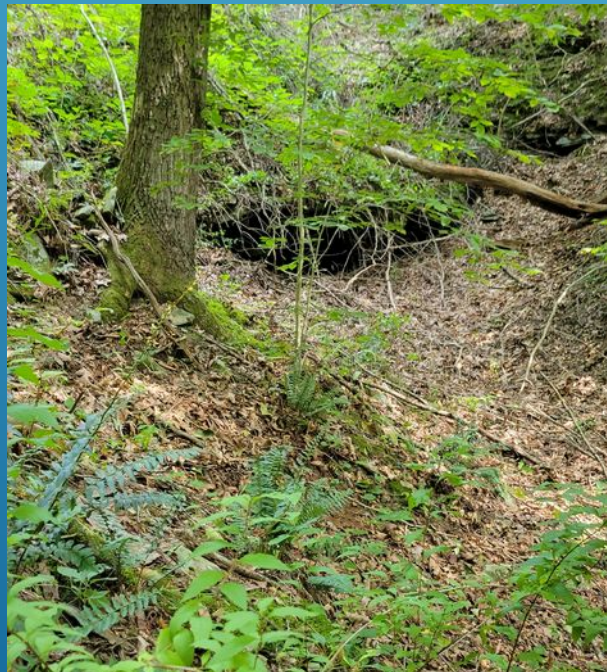
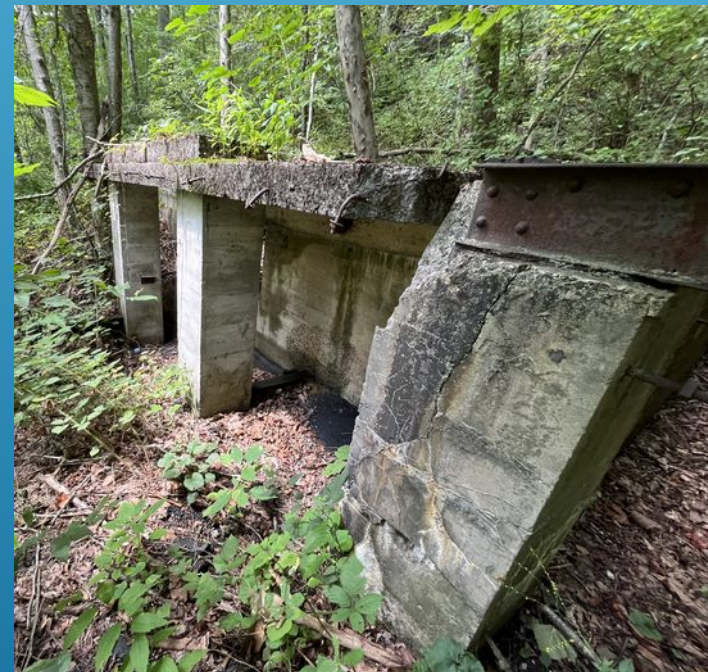
GILLIAM REFUSE PILE OVERVIEW

- 4 REFUSE AREAS TO REGRADE
- 3 DRAINING PORTALS TO SEAL
- 1 HIGHWALL TO RECLAIM
- 1 ACCESS ROAD TO CONDUCT SPOT IMPROVEMENTS ON
- THE HOLLOW THAT RUNS THROUGH THE PROJECT IS BADLY ERODED AND NEEDS REPAIR

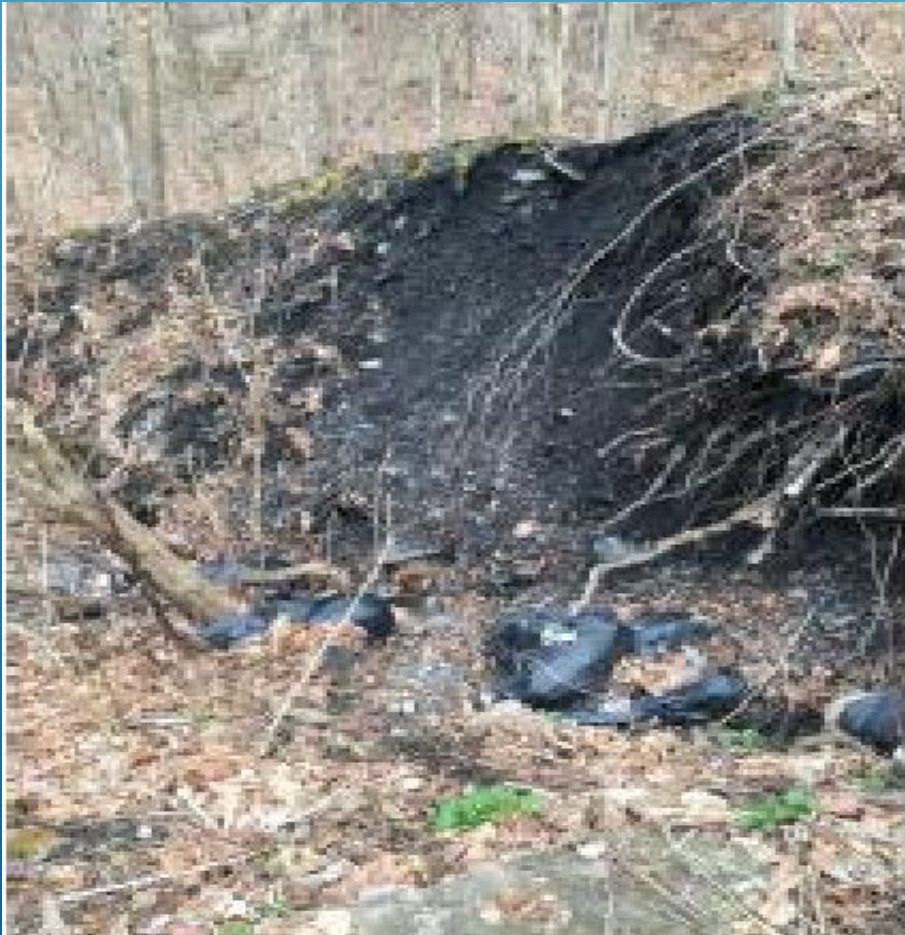
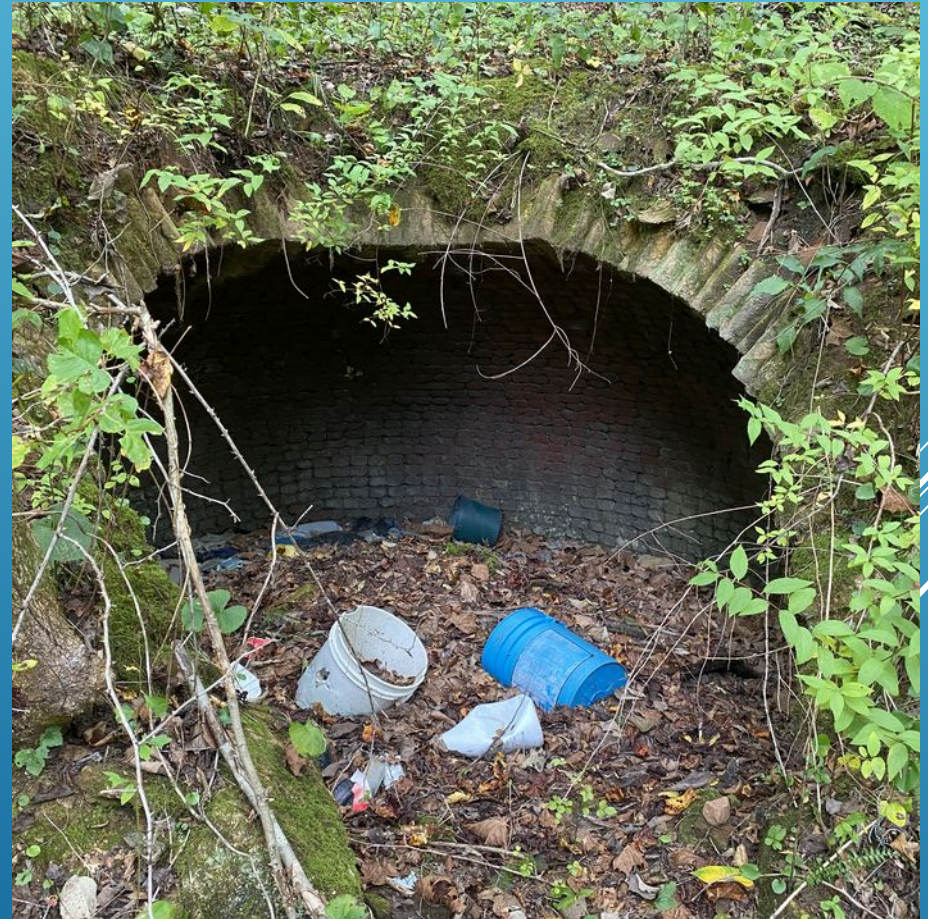
- FINDING SOIL TO RECLAIM REFUSE AREAS MAY BE DIFFICULT
- SITE HAS BEEN USED AS A DUMP AND MUST BE CLEANED UP

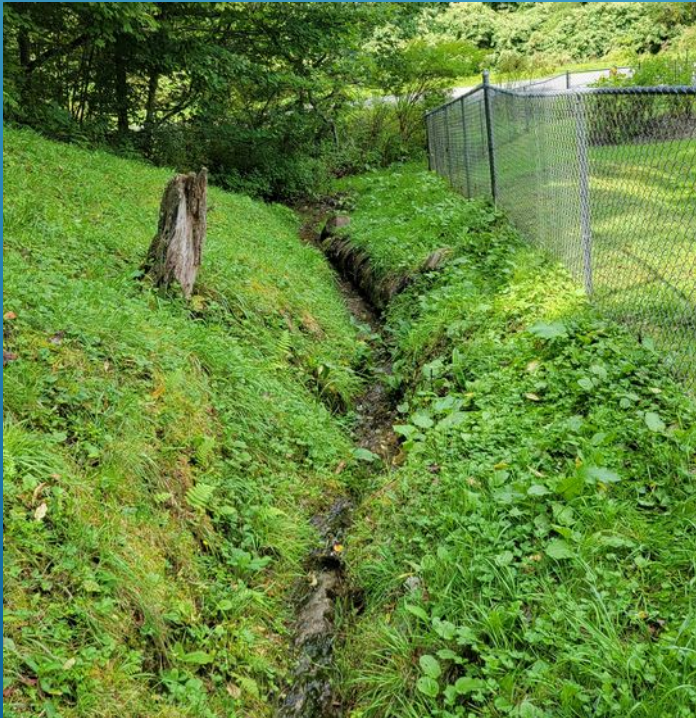
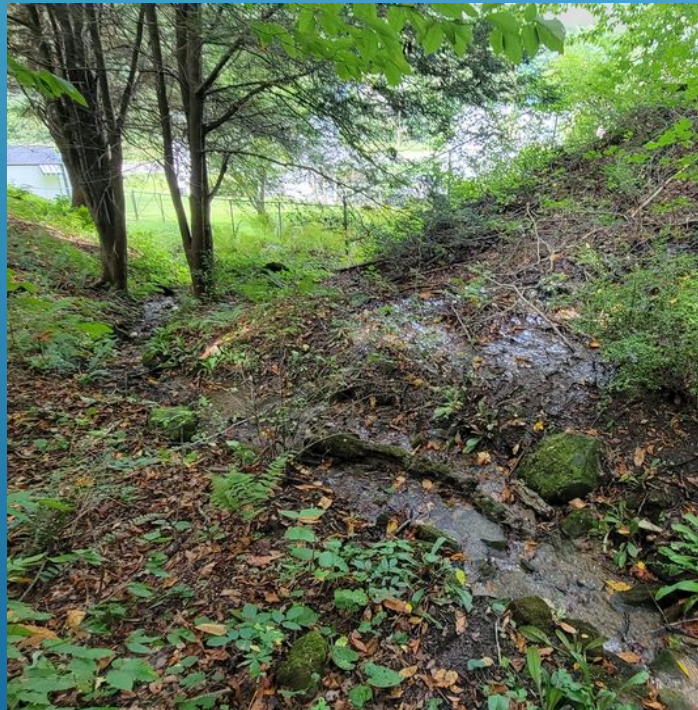
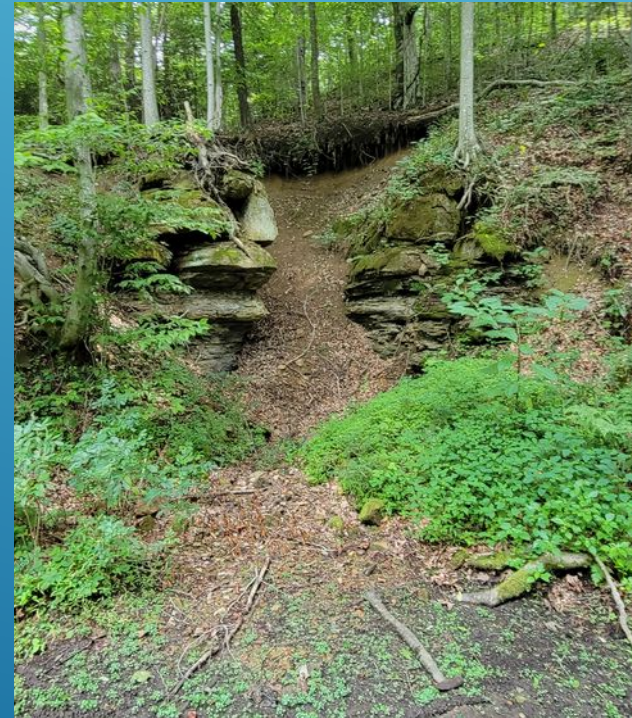
CRUMPLER (SCOTT) DRAINING PORTAL OVERVIEW

- 1 WETSEAL
- 1 CHANNEL TO REROUTE WATER AWAY FROM THE RESIDENCE BELOW
- 1 PREVIOUSLY GROUTED CHANNEL TO REPAIR

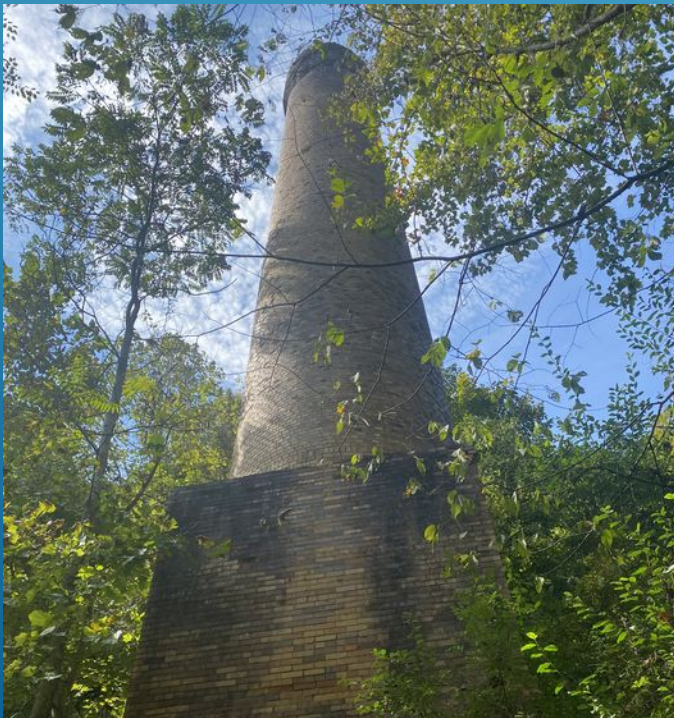
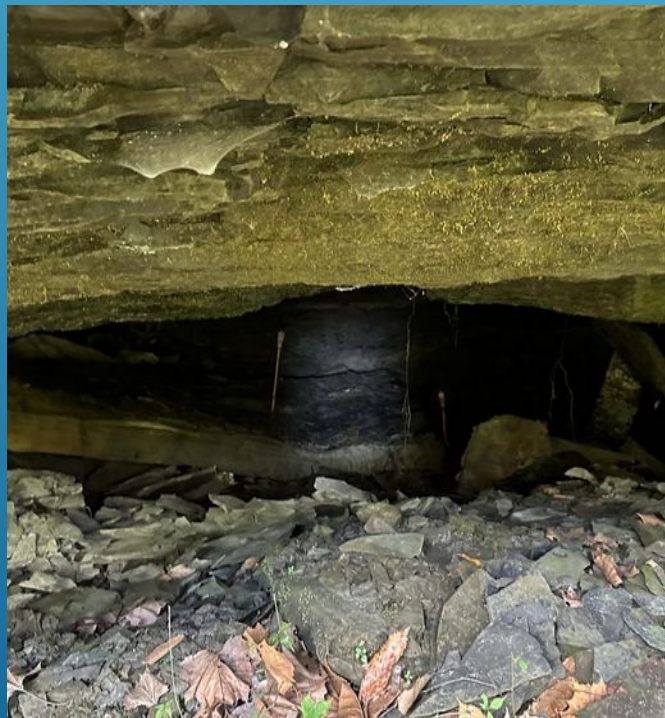
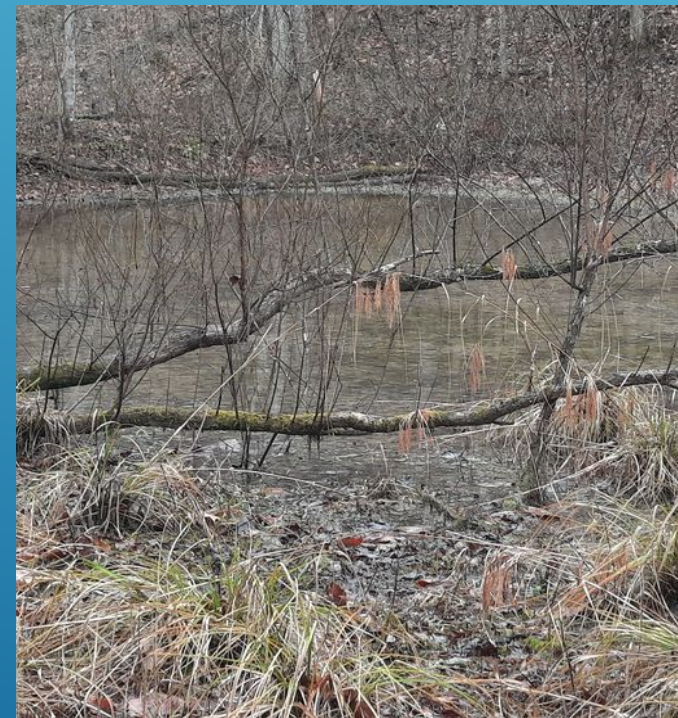
INDIAN CREEK (DILLON) PORTALS OVERVIEW

- 1 ABANDONED MINE POND TO BE FILLED IN (DRY AT TIME OF SURVEY)
- 6 WET SEALS AND 2 DRY SEALS TO INSTALL
- DUE TO THE BAT SURVEY SEVERAL PORTALS WILL BE CHANGED TO BAT GATES
- 1 EXISTING SMOKESTACK TO BE DEMOLISHED AND LIKELY USED TO FILL THE POND

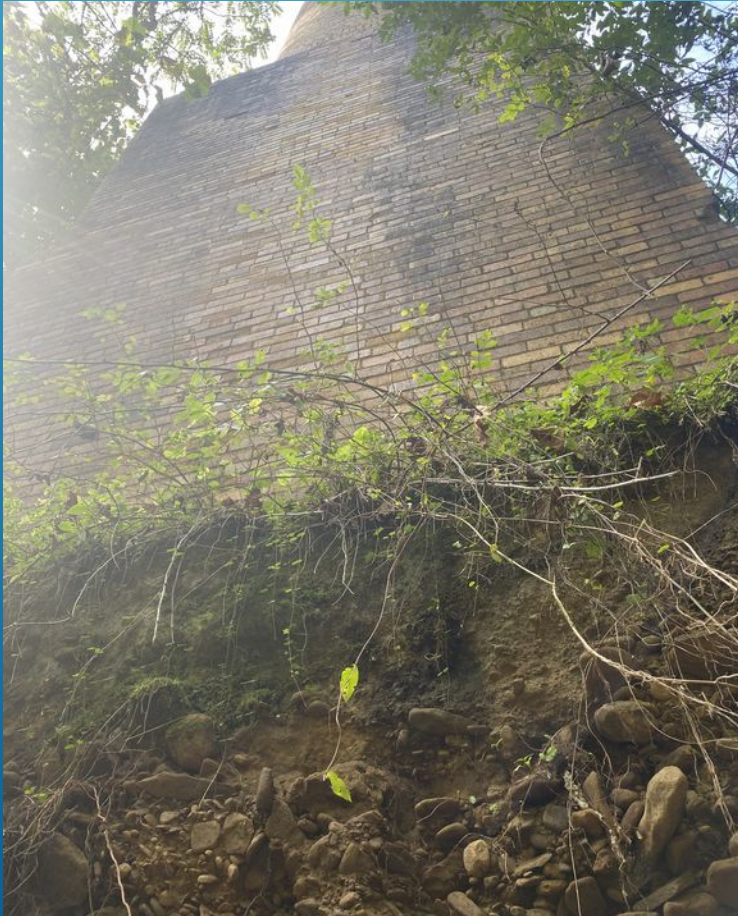
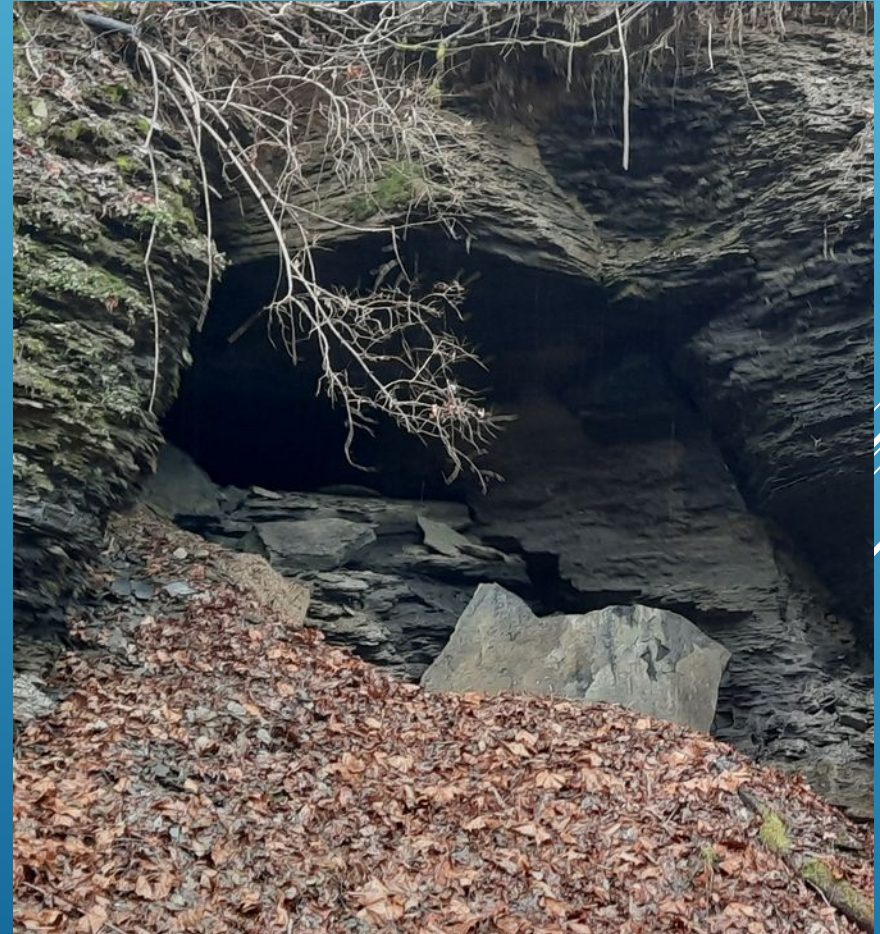
- SMOKESTACK HAS BEEN UNDERCUT BY RECENT STORM EVENTS AND HAS THE POTENTIAL TO COLLAPSE INTO THE STREAM
- PORTALS 1 AND 2 HAVE COLLAPSED INTERNALLY MAKING EXCAVATION AND INSTALLATION OF WETSEALS POTENTIALLY HAZERDOUS.
