# **Muddy Creek Watershed Restoration**

## **Biological Monitoring Status Report**

**May 18, 2021**

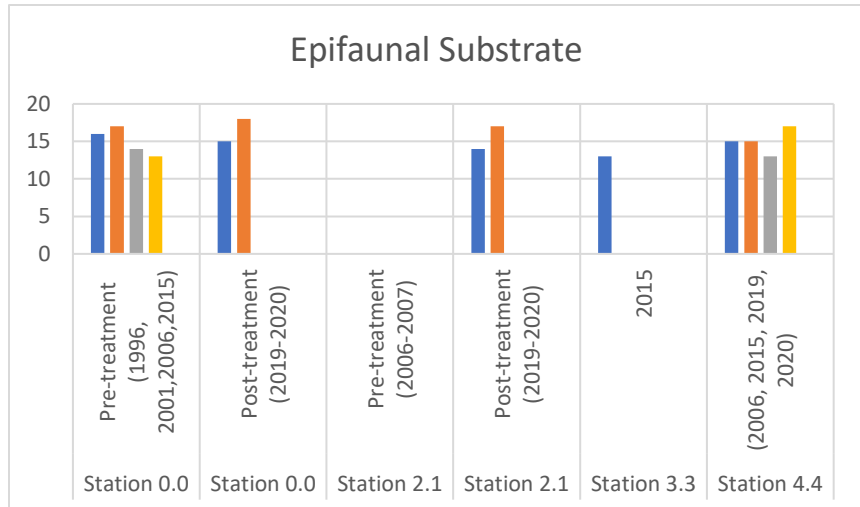
Figure 1- Pre- and post-treatment epifaunal substrate RBP ratings. Note: Multiple measurements taken across 2006 and 2007 due to monthly pre-TMDL monitoring.

stations exhibited scores in the middle sub-optimal category, with a few scores in the optimal category (Figure 1).

Epifaunal substrate/fish cover is a category that expresses the quality of physical habitats in a stream in relation to fish and aquatic macroinvertebrates. In general, a high score in this category offers fish and benthic macroinvertebrates a substantial amount of diverse, quality habitats. There were no notable differences between pre- and post-treatment epifaunal substrate scores between any of the sample stations. Most sample

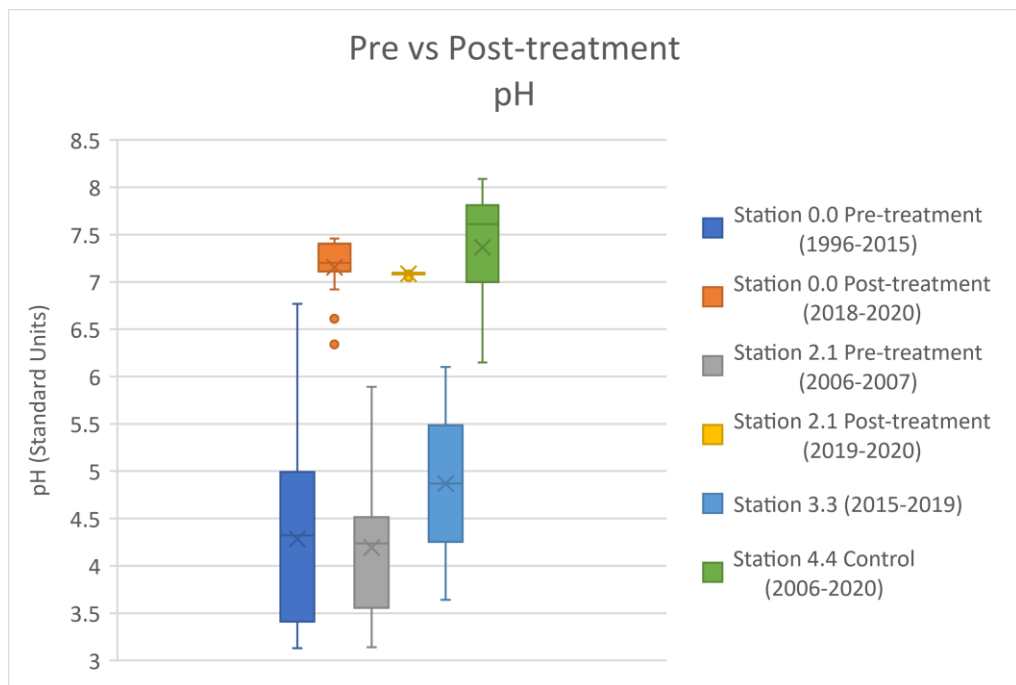
Figure 4- Pre- and post-treatment pH results.

A significant improvement in pH has occurred at Stations 0.0 and 2.1 following the onset of treatment. Post-treatment pH values at Stations 0.0 and 2.1 (downstream of treatment) closely resemble Station 4.4 values. Median pre-treatment pH at Station 0.0 was 4.32. Station 2.1

showed a pre-treatment pH median of 4.24. Post-treatment pH medians at these stations were significantly higher. As of September of 2020, Station 0.0 and 2.1 median pH values were 7.2 and 7.09, respectively. In comparison, Station 4.4 pH median was 7.61 (Figure 4).

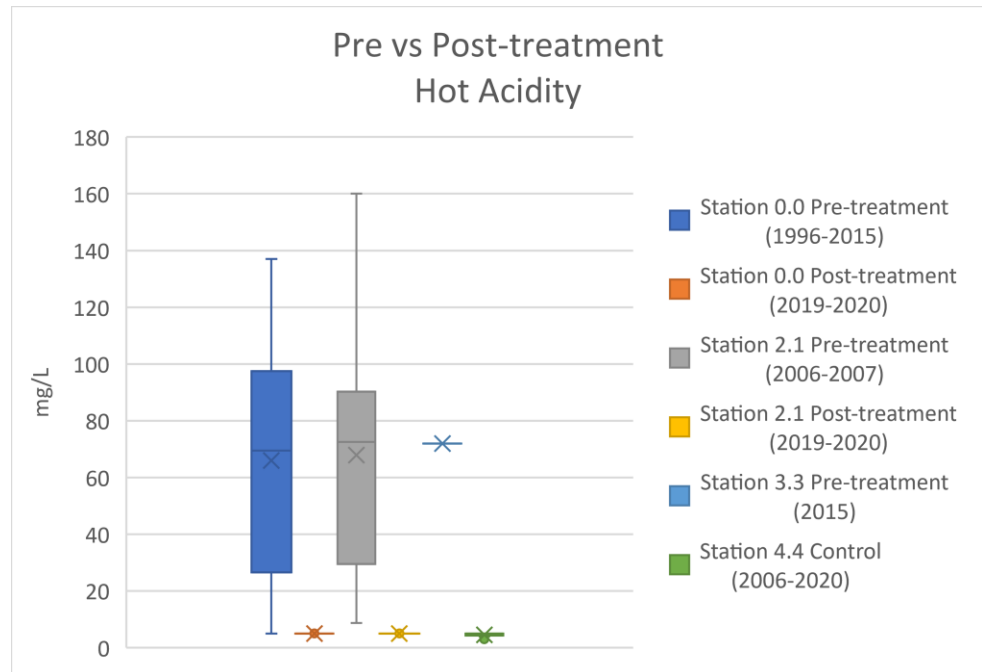
Figure 5- Pre- and post-treatment hot acidity results.

In addition to the increase in pH, hot acidity concentrations were substantially reduced. Station 0.0 showed pre-treatment median concentrations of hot acidity to be 69.5 mg/L, with a maximum concentration of 137 mg/L collected during one sampling event. Station 2.1 showed very similar characteristics. Station 2.1 had a median concentration of 72.5 mg/L, with a maximum concentration of 160 mg/L collected. Post-treatment samples at these stations mirror conditions of Station 4.4. The minimum detection limit (MDL) of less than 5 mg/L have been achieved at Stations 0.0 and 2.1 (Figure 5).

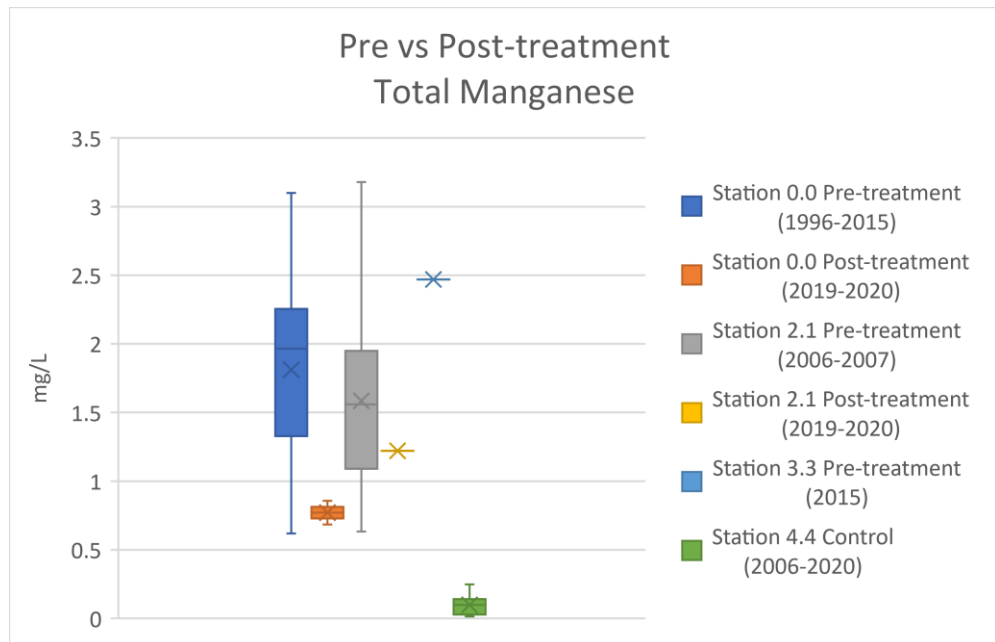
Figure 9- Pre- and post-treatment total manganese results.

Similar to aluminum and iron, total manganese concentrations were also reduced. Pre-treatment samples at Stations 0.0 and 2.1 had median concentrations of 1.97 mg/L and 1.56 mg/L, respectively. After treatment, two samples from Station 0.0 had values of 0.685 mg/L and 0.856 mg/L. Station 2.1 had a post-treatment concentration of 1.25 mg/L. Station 4.4 had a sample median of 0.099 mg/L (Figure 9).

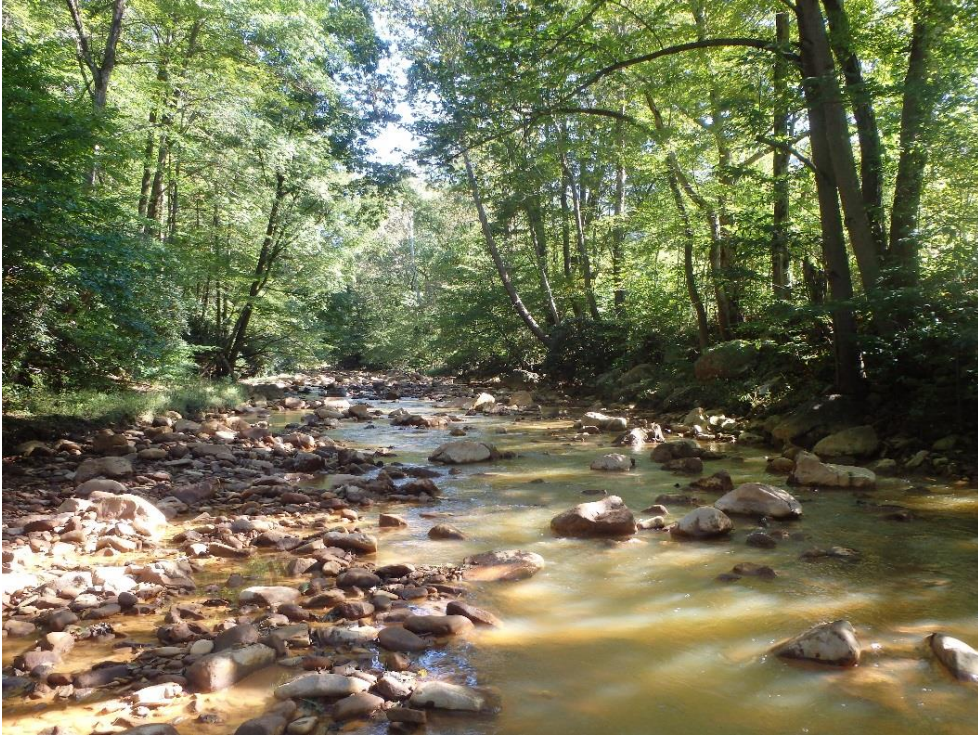
*Figure 15-Looking upstream from Station 0.0 in 2015.*

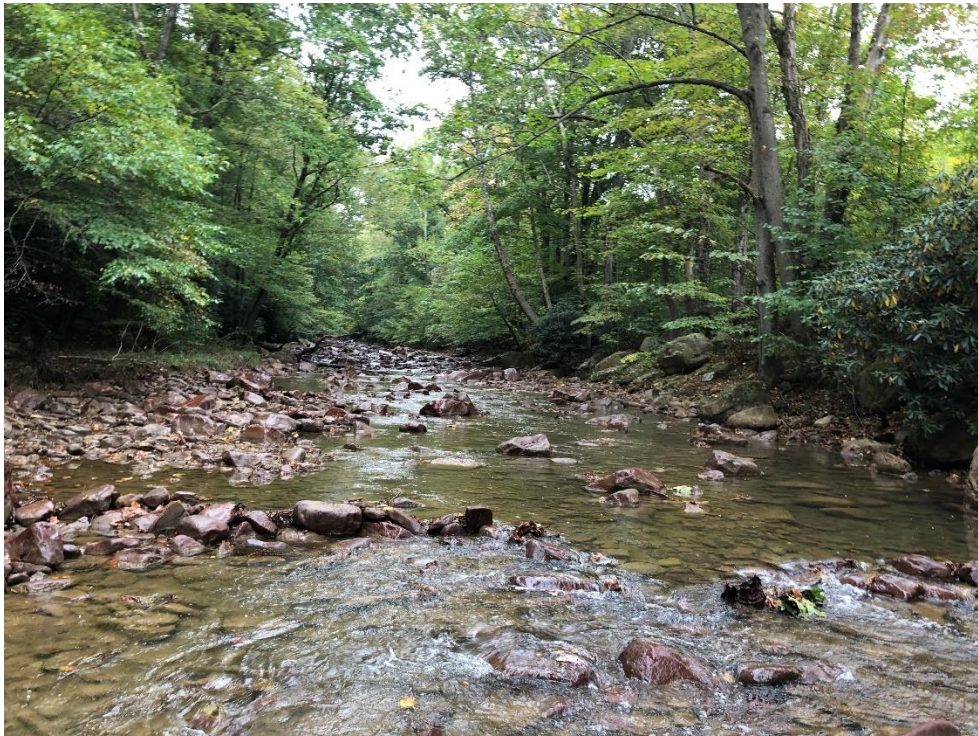
*Figure 16- Looking upstream from Station 0.0 in 2019.*

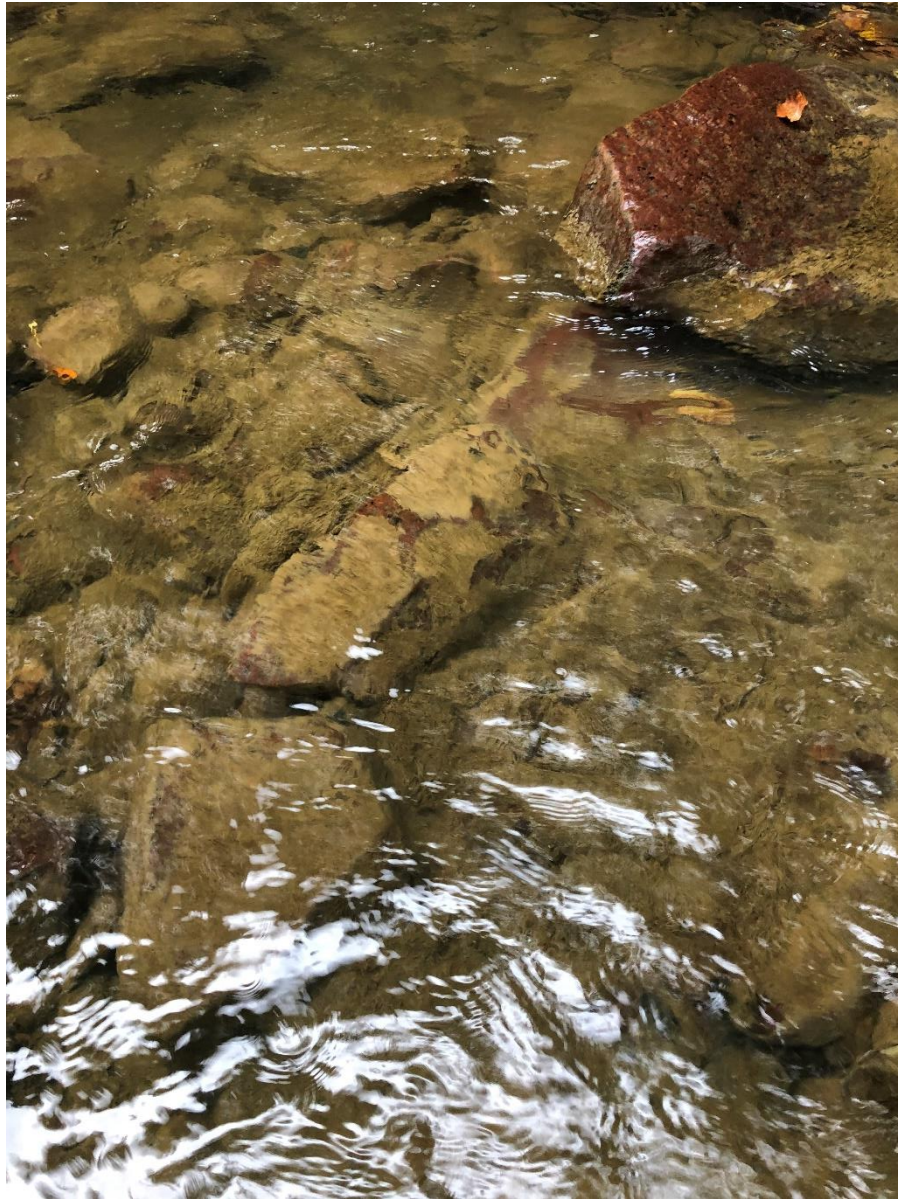
In 2019, WAB and OSR staff observed a precipitate formation on the substrate at Station 0.0. This precipitate is commonly found in treated systems and usually consists of metals, periphyton/algae, and sediments. A sample was taken by OSR staff and analyzed in a lab. Total aluminum, iron, and manganese concentrations were extremely high. A total aluminum concentration of 4,366 mg/kg was reported. Total iron and total manganese concentrations

In September of 2020, WAB staff noted that precipitate formation was still prevalent at station 0.0. Samples were not taken in 2020. It is likely that similarities would exist between what was seen in 2020 with what was sampled in 2019.

*Figure 17-Precipitate mix at Station 0.0.*

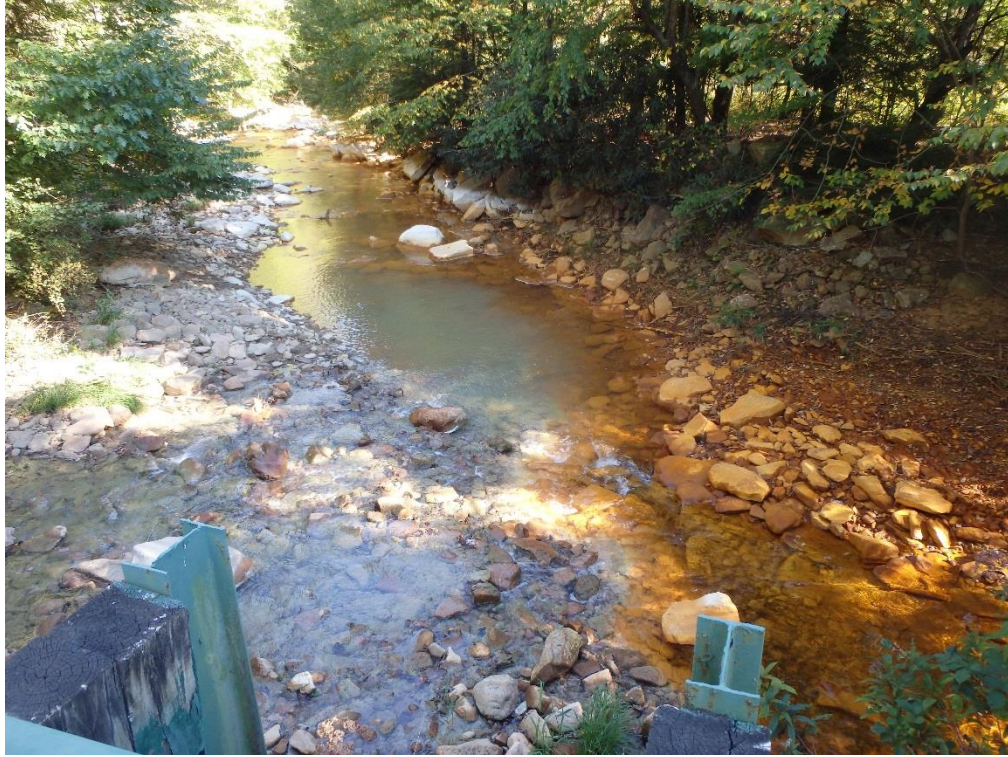
*Figure 20-Confluence of Martin Creek and Muddy Creek in 2015.*

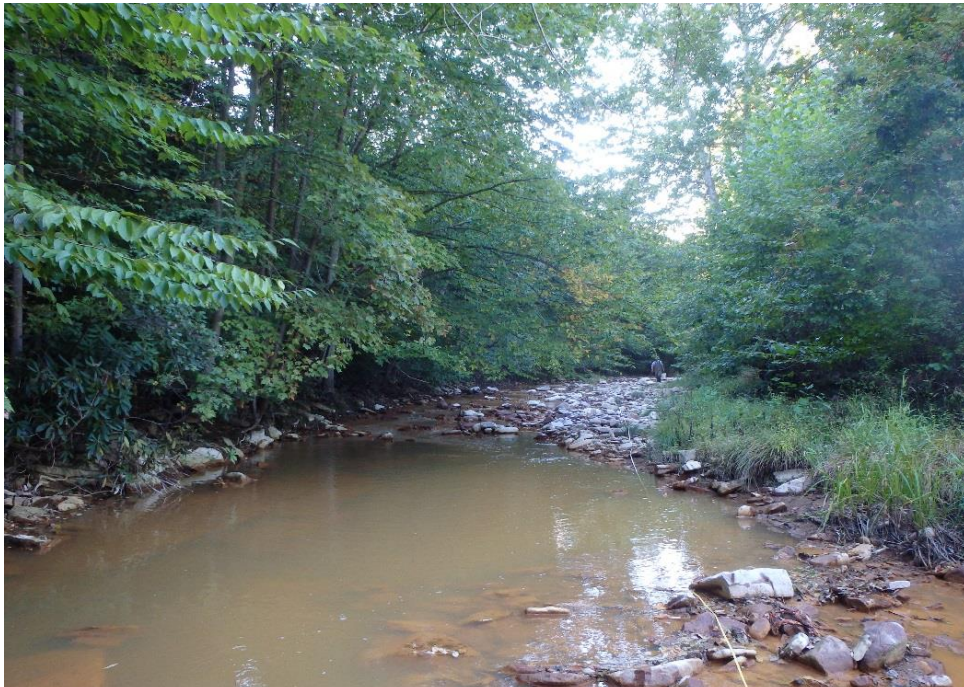
*Figure 21-Looking upstream of station 3.3 in 2015.*
