Three Fork Creek Watershed Restoration Status Report Biological Monitoring Results

**WV Department of Environmental Protection
Division of Water and Waste Management
Watershed Assessment Section**

February 6, 2020

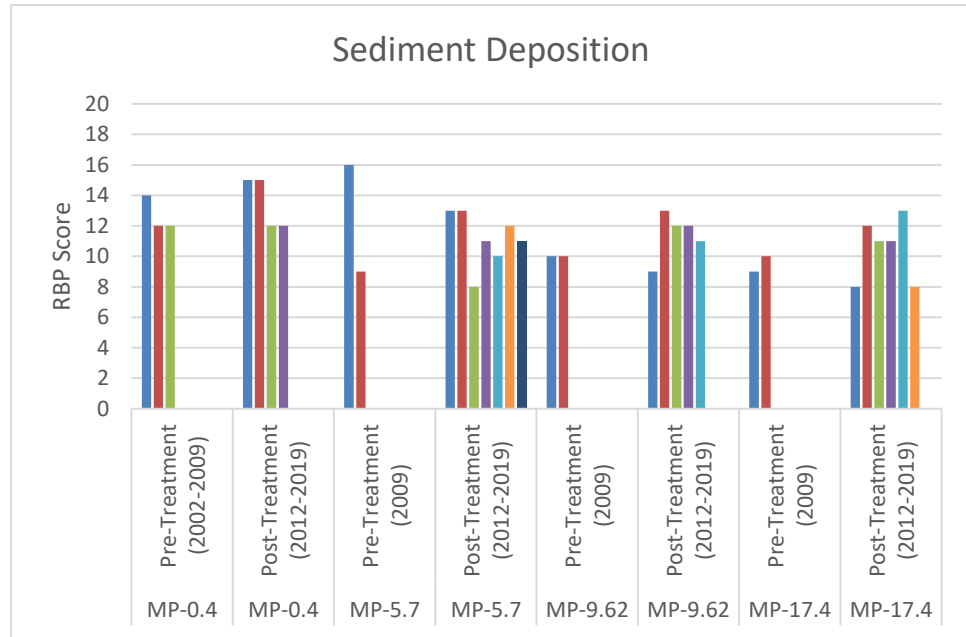
Figure 2- Pre- and post-treatment sediment deposition RBP ratings.

The sediment deposition category measures the amount of fine sediments that accumulate within typical depositional areas. This category focuses primarily on pool and run habitat deposition. Increased sediment deposits can be detrimental to aquatic organisms and serve to decrease habitat complexity. In general, there were

no notable differences between pre- and post-treatment sediment deposition scores. Figure 2 displays

the results of pre- and post-treatment sediment deposition scores. Sediment deposition scores at all the sample stations tended to fall in the low to mid sub-optimal range, with some visits scoring in the mid to upper marginal category. Similar to epifaunal substrate, sediment deposition scores can be variable based on seasonal flow rates as well as human disturbances in the watershed above the sample stations.

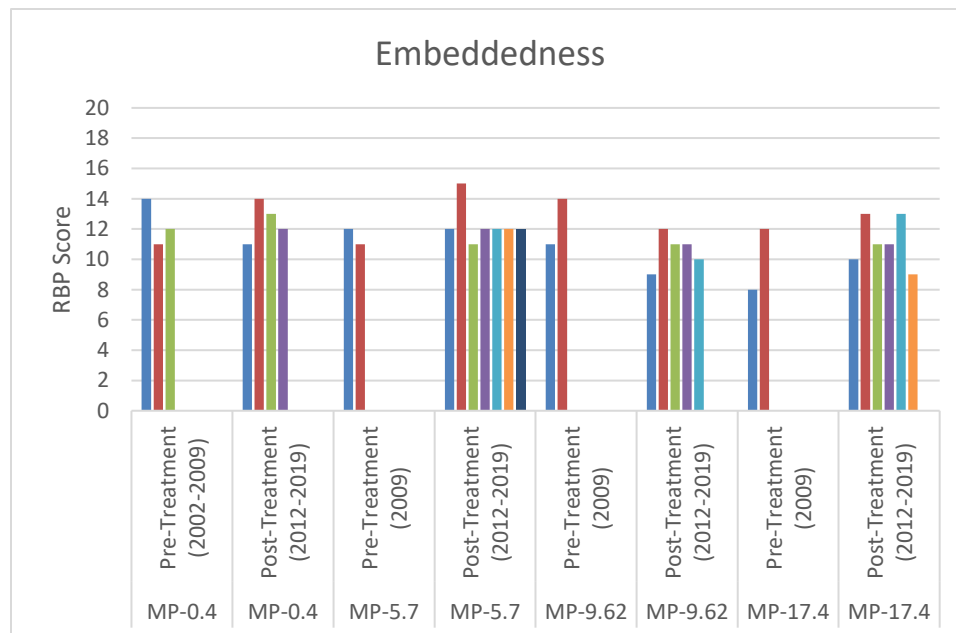
Figure 3- Pre- and post-treatment embeddedness RBP ratings.

The embeddedness category is a measure of the amount of interstitial space within riffle and run habitats. This is a very important category because it directly impacts the amount of usable space that benthic macroinvertebrates and benthic fishes have to function. In general, there were no significant differences between pre- and post-treatment embeddedness scores. Figure 3 shows a comparison of these scores. This category responds similarly to epifaunal and sediment deposition in terms of seasonal variability and flow dynamics.

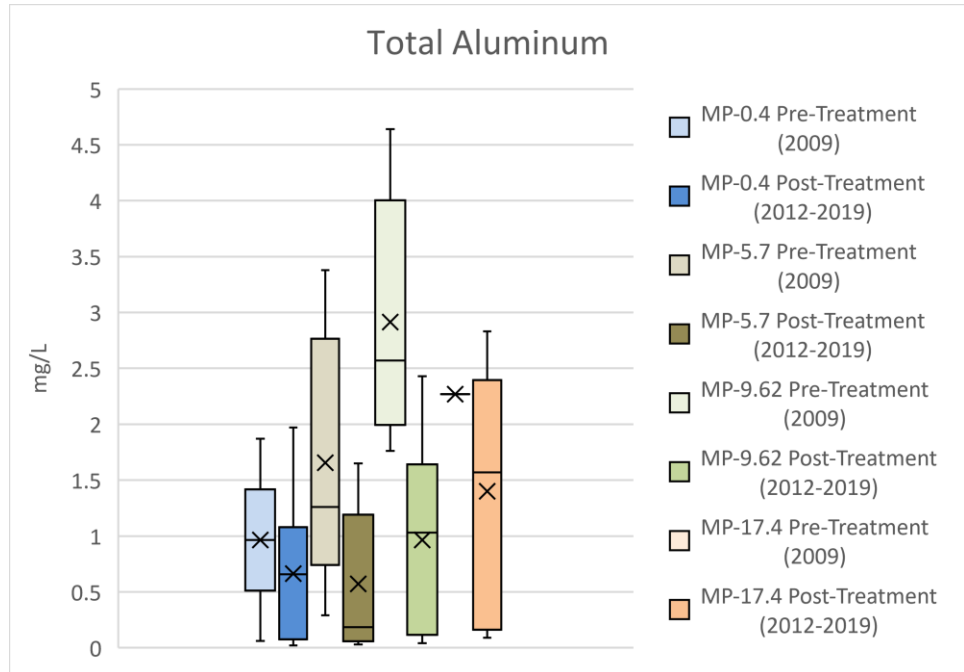
aquatic organisms. Pre-treatment samples from Three Fork Creek exhibited high levels of metals, most notably aluminum and manganese. Median pre-treatment total aluminum concentrations exceeded 2.5 mg/L. Some individual samples, such as one taken at mile point 9.62, were well over 4 mg/L concentration. It is important to note that the MDL for total aluminum is 0.02 mg/L. Post-treatment samples revealed varying levels of total aluminum concentrations, however reductions in total

Figure 7- Pre- and post-treatment total aluminum results.

aluminum were observed (Figure7).

One possible explanation for the post-treatment variability of total aluminum levels could be related to total suspended solids (TSS). Metals such as iron, aluminum, manganese, etc. are present in soils and sediment. These metals are often chemically bound to sediments. These compounds are typically inert and are

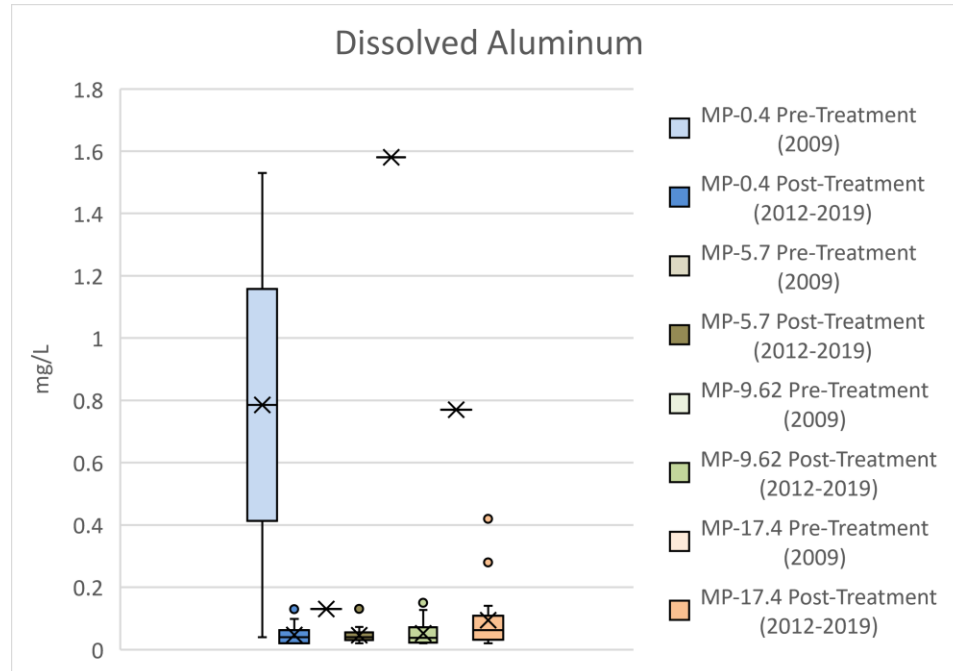
Figure 8- Pre- and post-treatment dissolved aluminum results.

Only five pre-treatment samples, two from station 0.4 and one from the remaining stations, exist in the pre-treatment dataset. This does not allow for a comprehensive review of this constituent, but the data is useful, nonetheless. Of the five pre-treatment samples, the highest levels of dissolved aluminum were observed at station 0.4 and station 9.62.

Station 0.4 had a concentration of 1.53 mg/L and the station 9.62 exhibited a concentration of 1.58 mg/L. Post-treatment median concentrations of dissolved aluminum for stations 0.4, 5.7, 9.62, and 17.4 were 0.04 mg/L, 0.04 mg/L, 0.038 mg/L, and 0.062 mg/L, respectively. Figure 8 is a comparison of pre- and post-treatment dissolved aluminum concentrations.

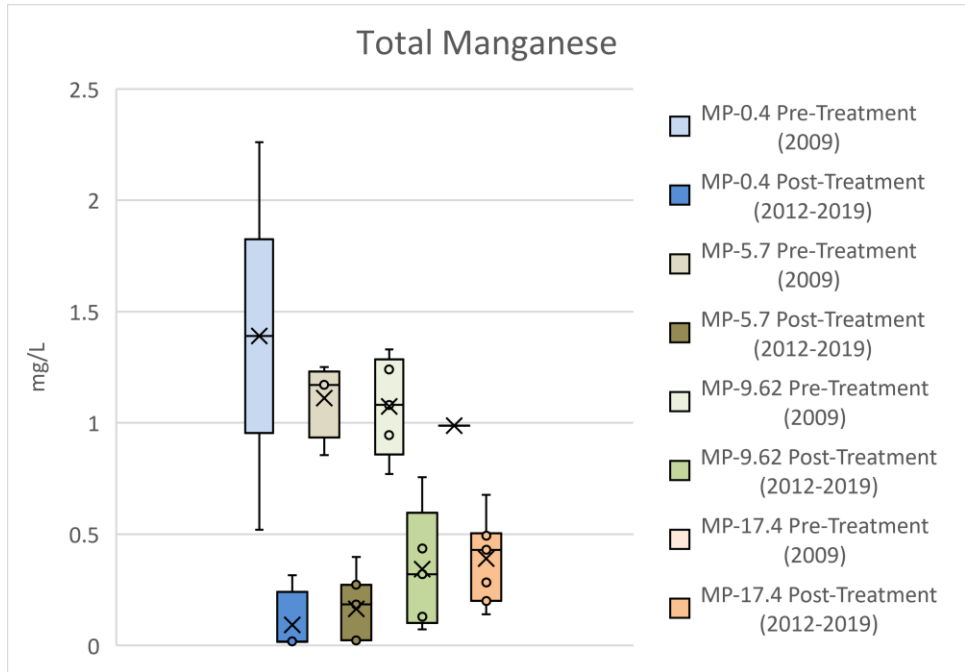
Figure 9- Pre- and post-treatment total manganese results.

High manganese concentrations can also have a detrimental impact on aquatic organisms. Pre-treatment concentrations of manganese tended to be high. The highest concentration from the dataset was collected at mile 0.4 at a concentration of 2.26 mg/L. All other stations exhibited high pre-treatment concentrations as well. Post-treatment sample concentrations were found to be significantly lower (Figure 9).

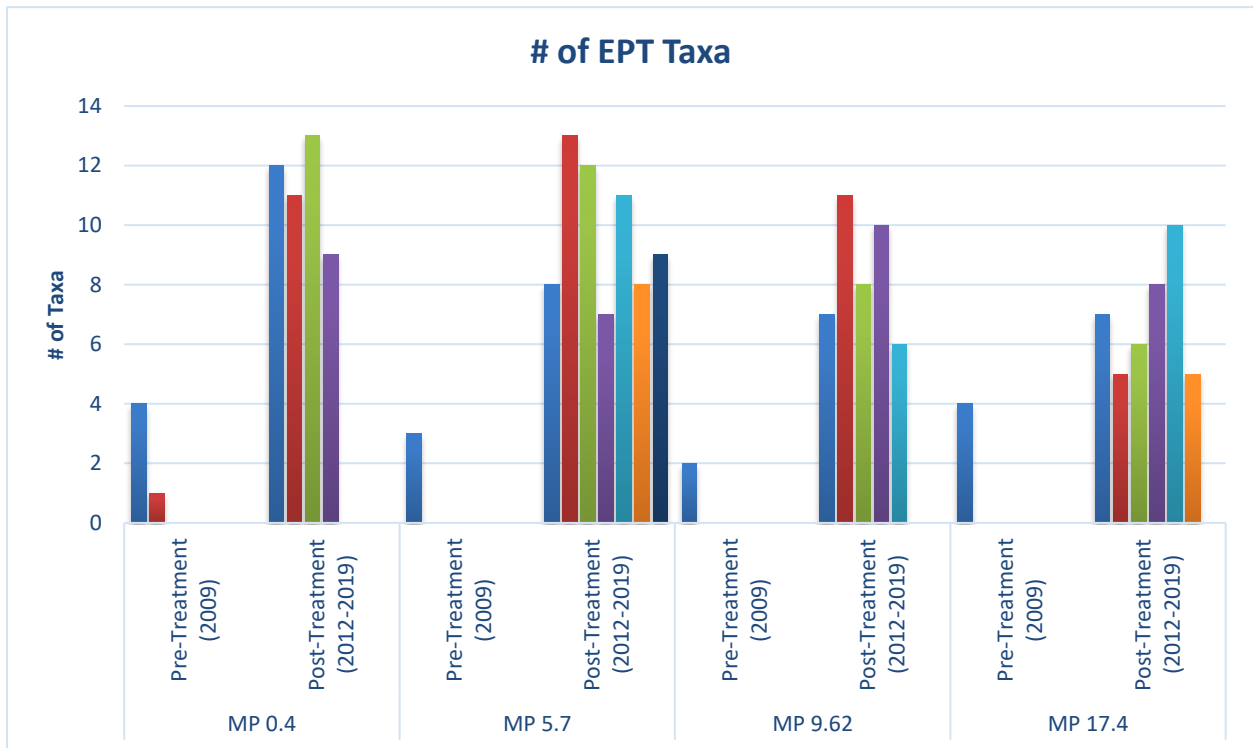
Figure 11-Pre- and post-treatment EPT taxa richness.

Another benthic metric often examined when comparing stream samples, especially pre- and post-treatment samples, are numbers of Ephemeroptera, Plecoptera, and Trichoptera (EPT) taxa. Although differences in pollution tolerances exist among these groups, EPTs are often regarded as the most sensitive to pollution. This means that degraded streams usually have a lower amount of EPTs than

higher quality streams. In 2009, station 0.4 had only one EPT taxa collected in the benthic sample. Post-treatment median EPT taxa was 12. Similar post-treatment patterns arose among the other stations as well (Figure 11).

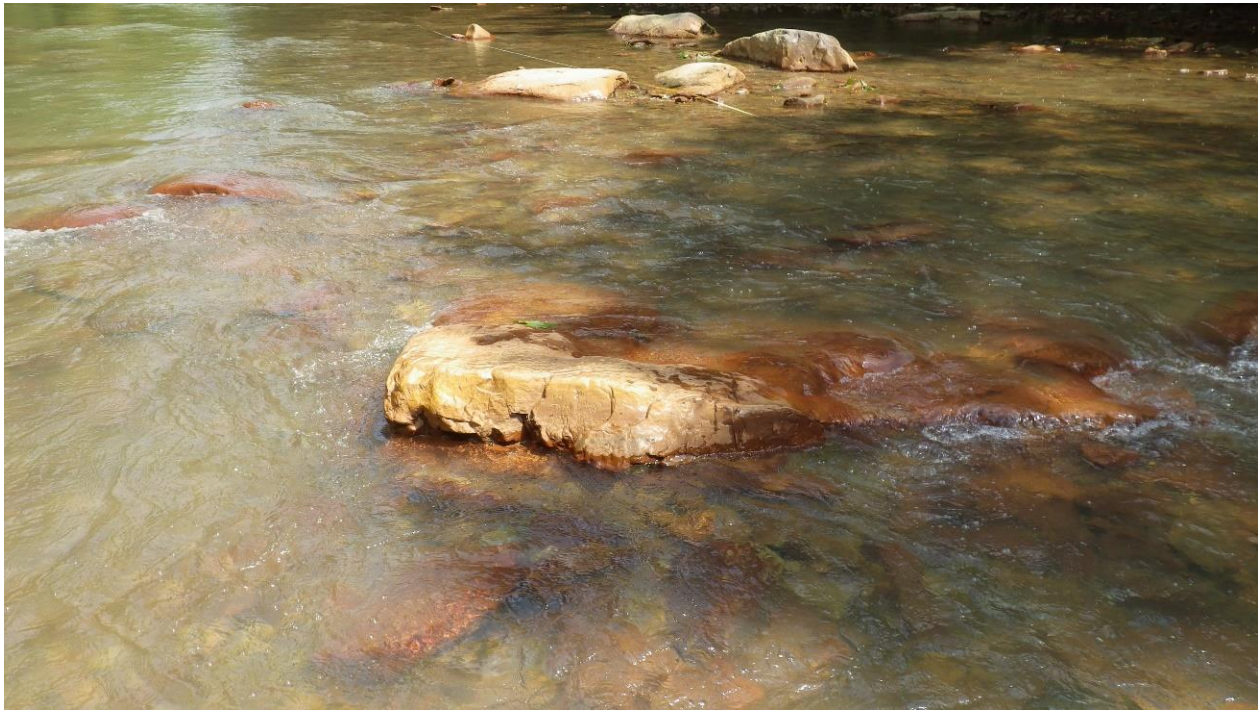
After treatment began, stations 9.62 and 17.4 began to develop areas with an increased amount of precipitate deposition. Especially in years with low flows, this precipitate was noted in slow moving areas and tended to create a thick blanket over the substrate in these areas. WAB staff collected this material at one primary sample location, mile 9.62, and one secondary station, mile 18.6, and had it analyzed by a laboratory (Tables 2 and 3). Analysis found that it was a mixture of inorganic sediments, periphyton, algae, and metals. This is a byproduct of the treatment process that can have negative impacts on benthic macroinvertebrate communities and benthic fishes.

Figure 12-Example of iron staining at mile 9.62.

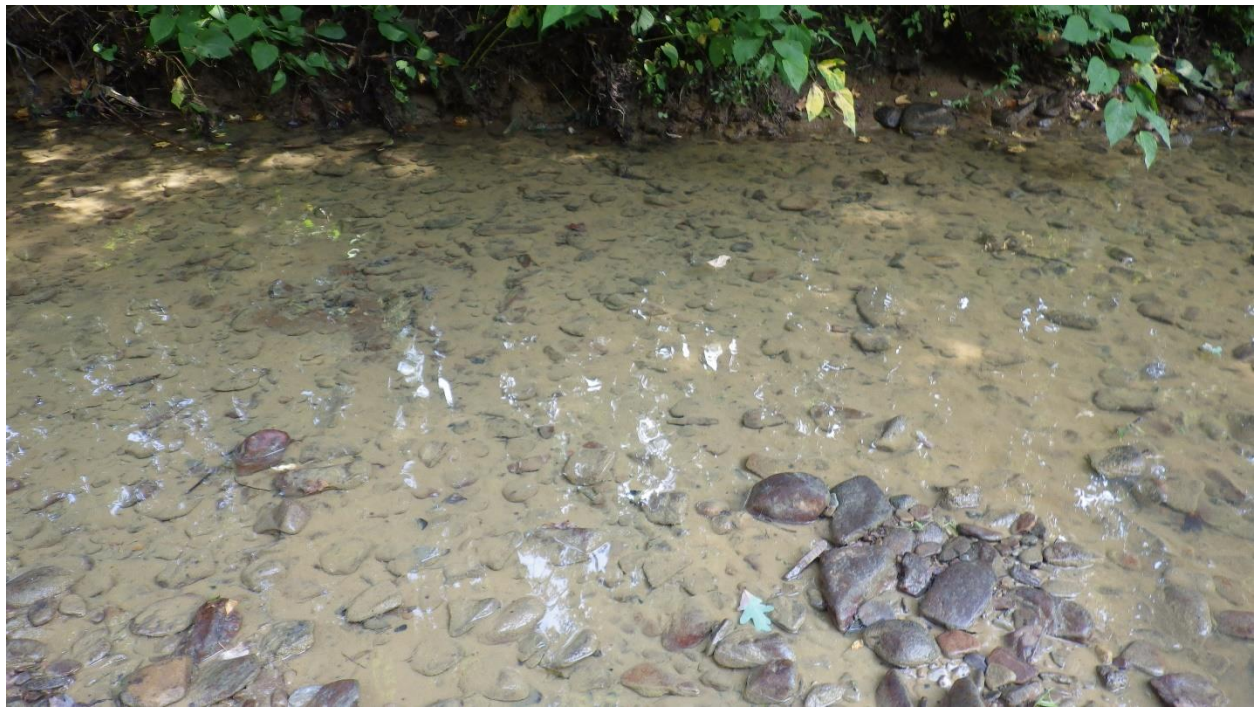
Figure 13-Example of precipitate mixture at mile 9.62.

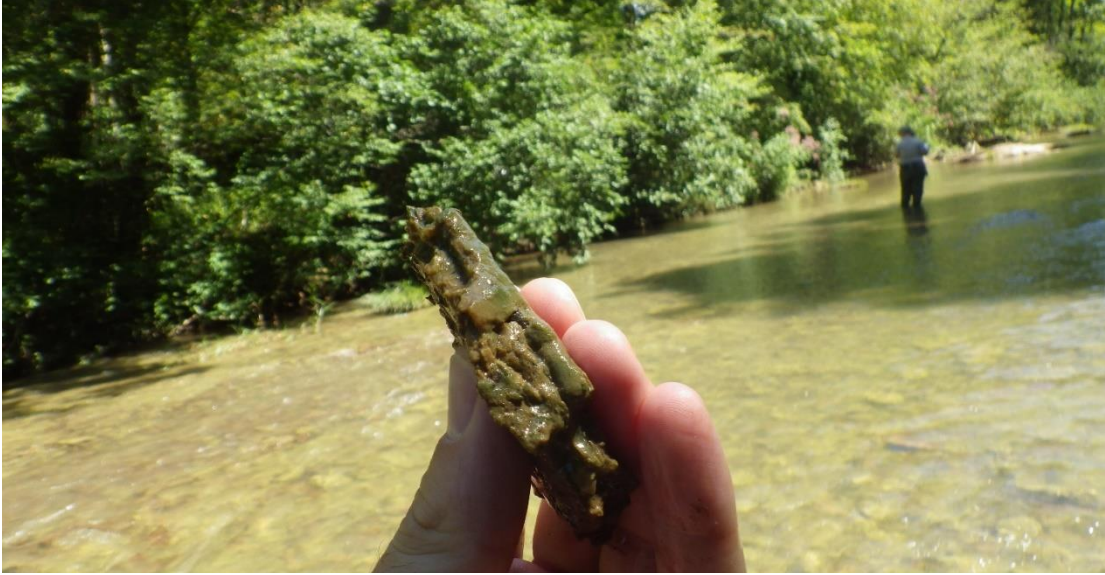
Figure 14-Precipitate mixture collected from mile 17.4.

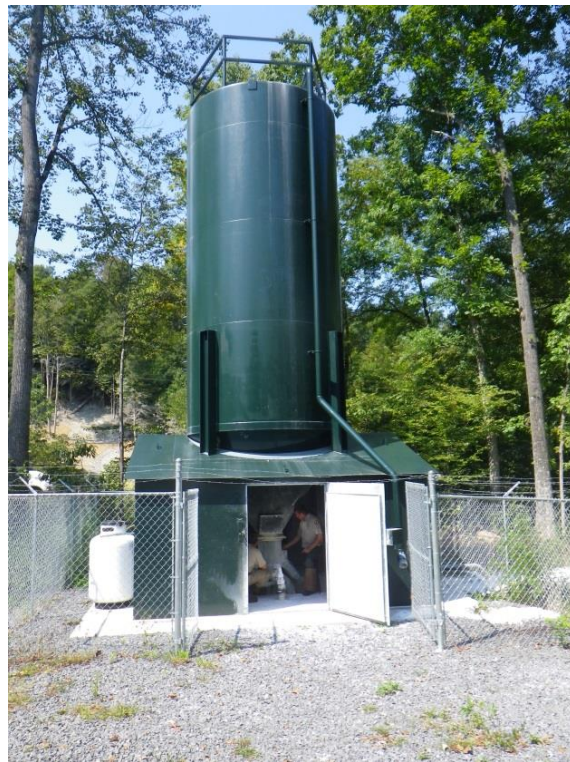
The AML program has successfully installed four treatment stations in the Three Fork Creek watershed that release alkaline material into streams that neutralize the effects of acid mine drainage. These treatment stations apply either calcium oxide or calcium hydroxide to the affected water using stream water to actuate release mechanisms that dispense the material. Figure 19 in Appendix A shows a typical design for a treatment station. These stations are located on four tributaries of Three Fork Creek where data has shown substantial contributions of AMD have negatively affected the watershed. These streams are Birds Creek, un-named tributary (UNT) of Birds Creek at river mile 0.64, Squires Creek, and Raccoon Creek. Figure 21 of Appendix B shows the treatment station locations. Table 5 in Appendix B includes Lat/Long coordinates for the treatment stations.

Figure 19-Typical design of an AMD treatment station.

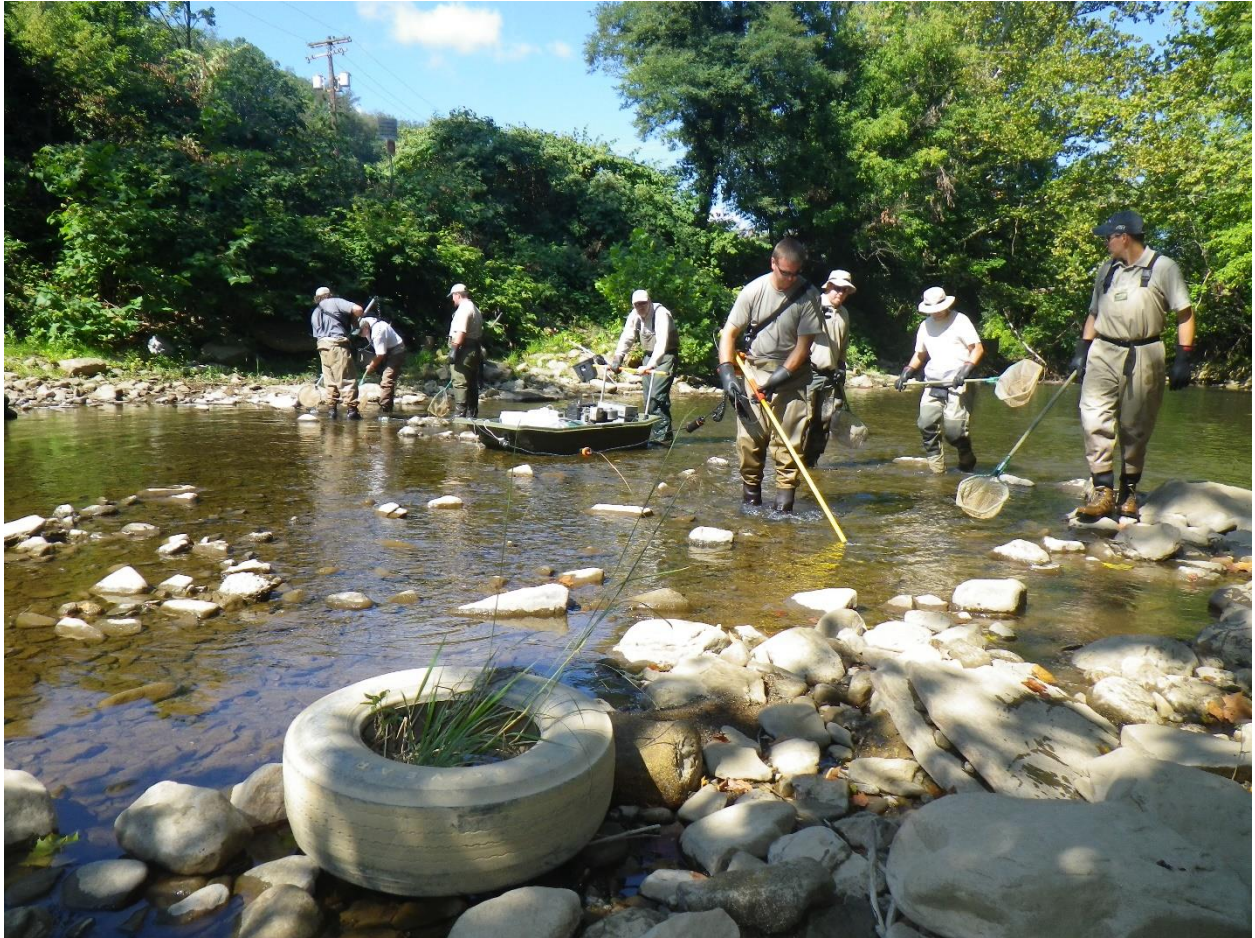
The community of fish species residing at each station was sampled using a standardized wadeable stream, electroshocking technique established by WAB. The four Three Fork Creek stations were established by following a 40 x the average channel width methodology. Thus, a 400 m stream reach was electroshocked at mile 0.4, a 300 m reach at mile 5.7, a 300 m reach at mile 9.62, and a 270 m reach at mile 17.4. A Smith-Root, Inc. tote barge and Smith-Root, Inc., backpack electrofishing unit(s) was used to collect fish by beginning at the downstream end of each reach and slowly proceeding in an upstream direction alternating bank to bank, including all side channels and backwater pools. Figure 20 of Appendix A shows a tote barge electrofishing setup. The technique involves a thorough sampling of all available habitats (riffles, runs, pools) and netting all fish observed for placement into a temporary holding bucket for identification and enumeration. All fish specimens that were positively identified in the field were processed, enumerated, and released if they were in suitable condition (*i.e.*, not dead or dying) except those that were retained for voucher or reference collections. Specimens retained for voucher or reference collections were placed in a one-gallon Nalgene container, appropriately preserved in a formalin-based solution, and returned to the laboratory to be identified and enumerated. The species lists and counts for the field released specimens were then added to the ones processed in the laboratory to obtain final results for each station.

Figure 20-Example of electrofishing survey using a Smith-Root Inc. tote barge.

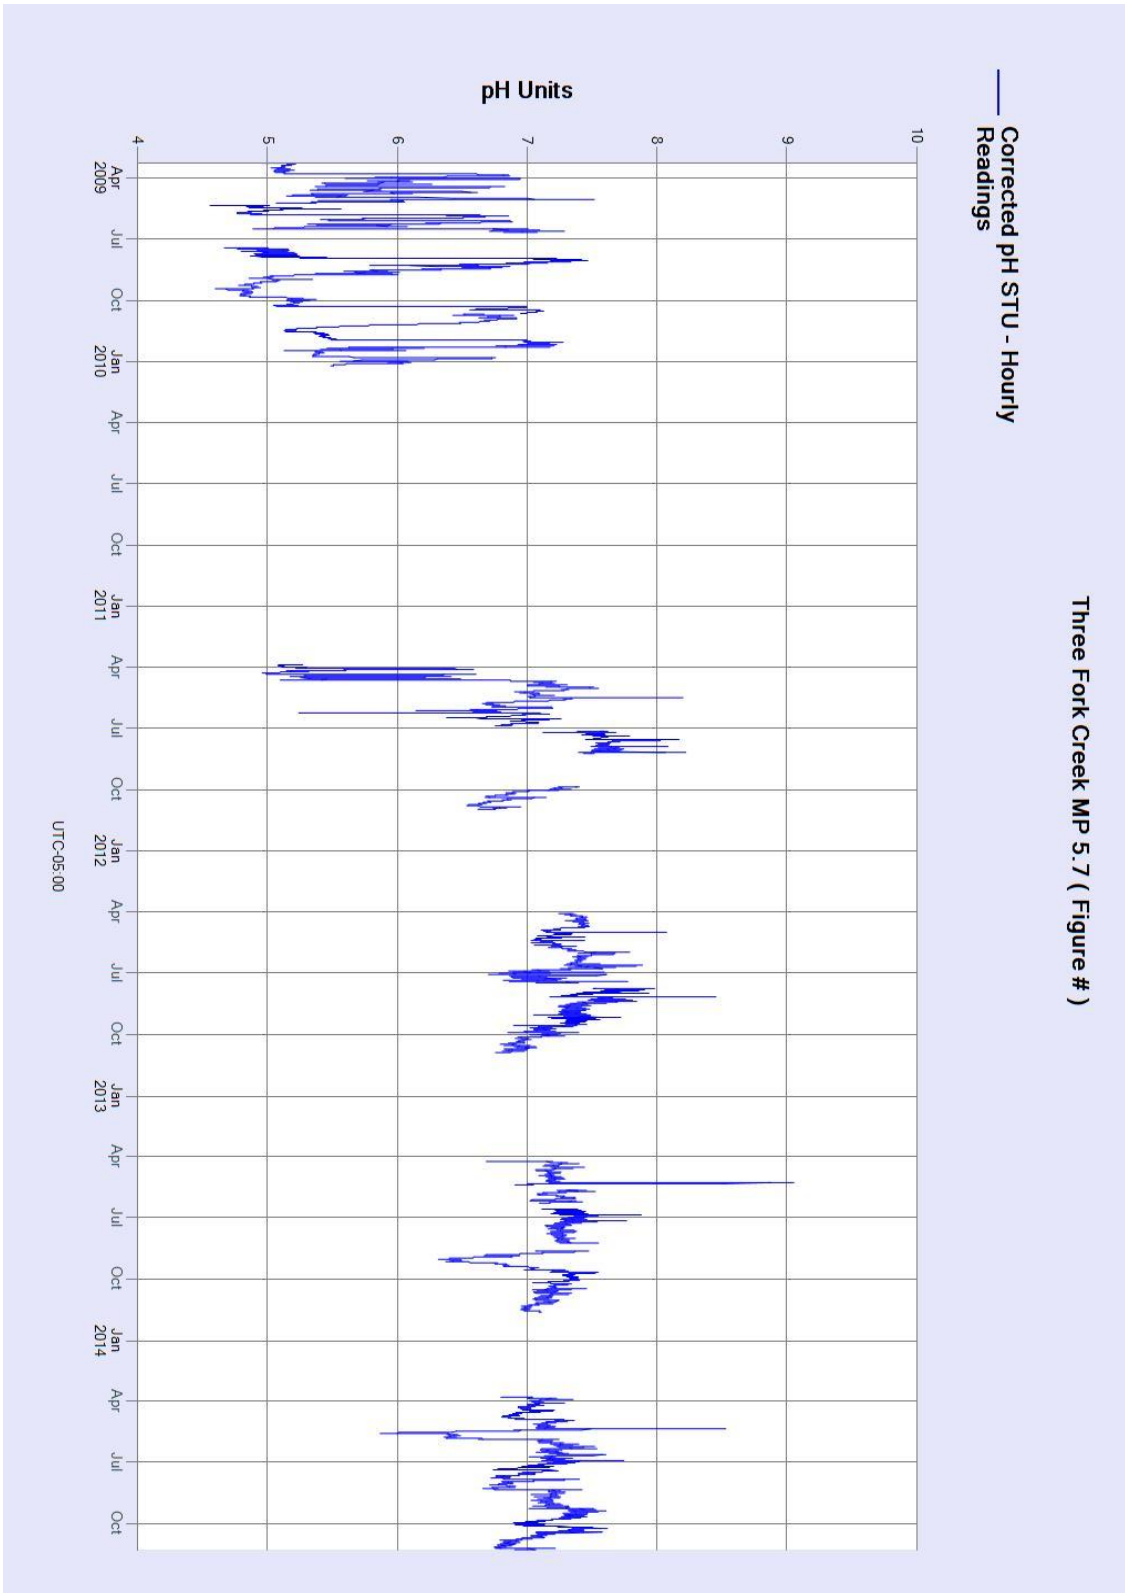
Continuous water quality data using deployable meters was collected at two sample locations from 2009 to 2014. Data loggers were placed at stations 5.7 and 17.4 and recorded pH values every hour, typically from April to November. Continuous monitoring data is more powerful than single-day grab values for most parameters, especially pH, a parameter that can exhibit substantial daily and seasonal variability. Data from the deployable logger at mile 5.7 showed high variability in pre-treatment pH values (Appendix C, Figure 22). Swings of 4.5 to 7.5 occurred often. When treatment began in April of 2011, data shows some initial high variability, but pH ranges tightened up after a few months of operation and rarely dropped below a value of 6.5 after that. The period of variability after treatment began was most likely related to treatment station calibration.

Figure 22-Continuous pH monitoring data for station 5.7.

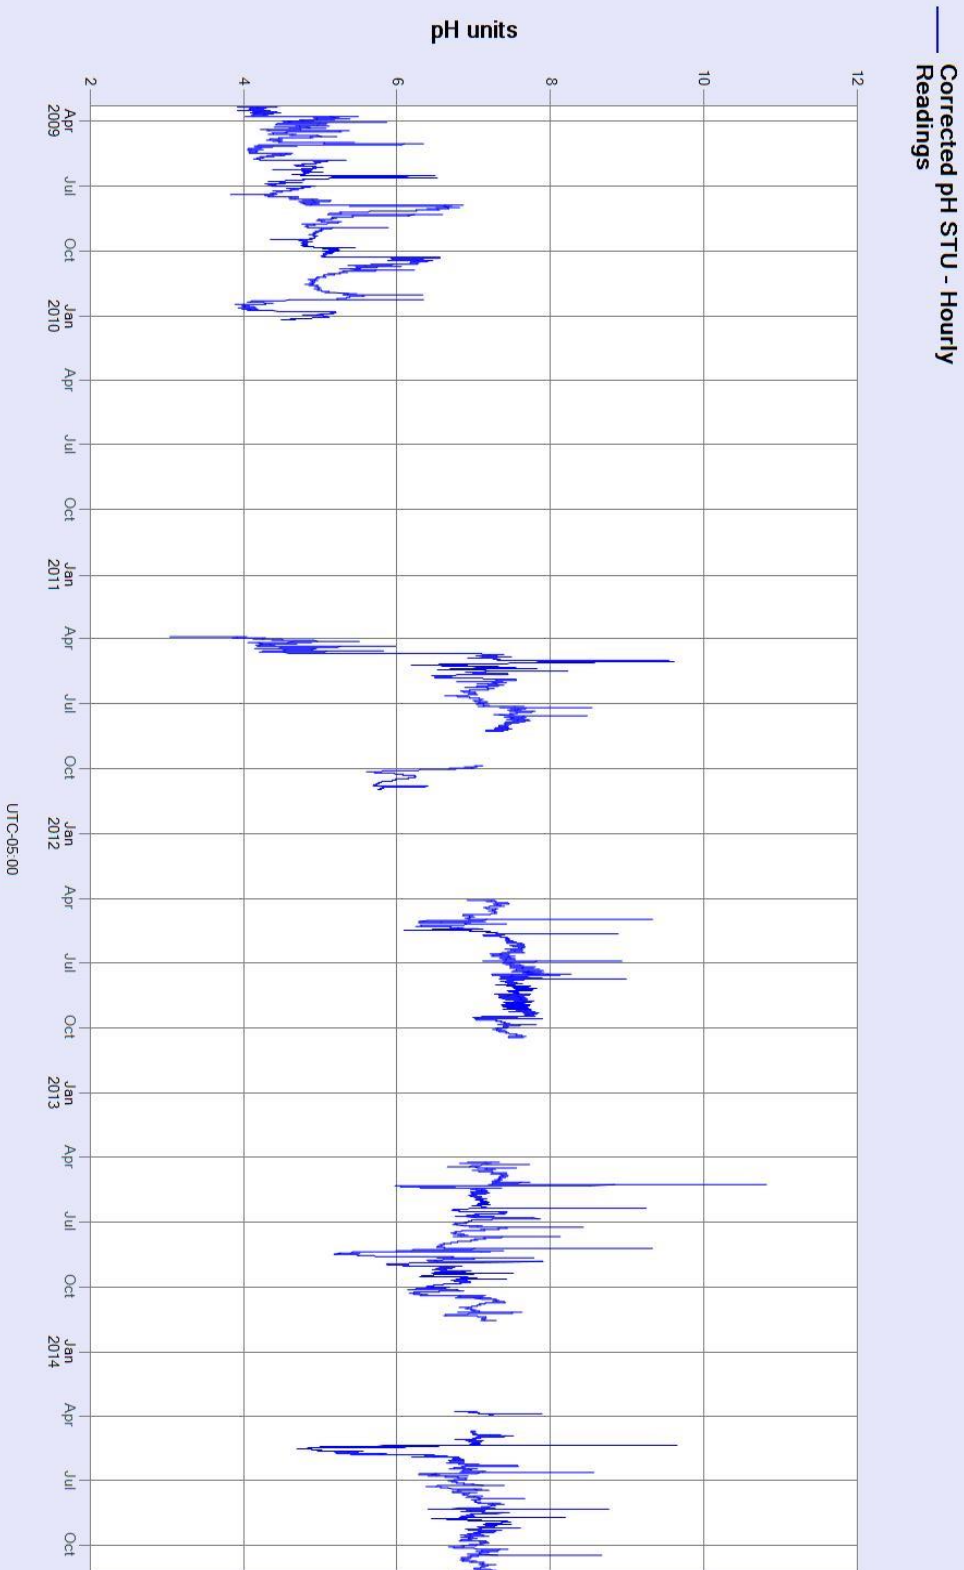
Three Fork Creek MP 17.4 (Figure #)

The data logger at the station 17.4 showed similar characteristics (Appendix C, Figure 23). Pre-treatment data showed fluctuations between a pH value of approximately 4 to values in the 6.5 range. After treatment began in April of 2011, a similar period of variability followed, then transitioned into a tighter range between a pH of 7 and 8. It is interesting to note that in 2013 and 2014 highly variable pH characteristics were observed. There were a few large spikes and declines of pH values during these years. One reading spiked to a pH of over 10 and a few declines to a pH in the 5 range. One decline even extended into the high 4 range. One possible explanation for the times of high variability could be related to stream flow and proximity to upstream treatment stations. Examination of USGS stream gage data showed highly variable flows during these deployment periods. It is surmised that because the treatment stations operate based on stream flow, that these high flow periods could have caused the variability of pH values. Some issues with stream debris obstructing the intakes of treatment stations have been seen, causing the facility to function improperly. Also, the proximity of this sample station to three treatment stations likely exacerbated the effects.

Figure 23-Continuous pH monitoring data for station 17.4.
