Department of
ENVIRONMENTAL
PROTECTION

2022 AML Contract 2 Project South
Update

December 8, 2023

CONTRACT 2

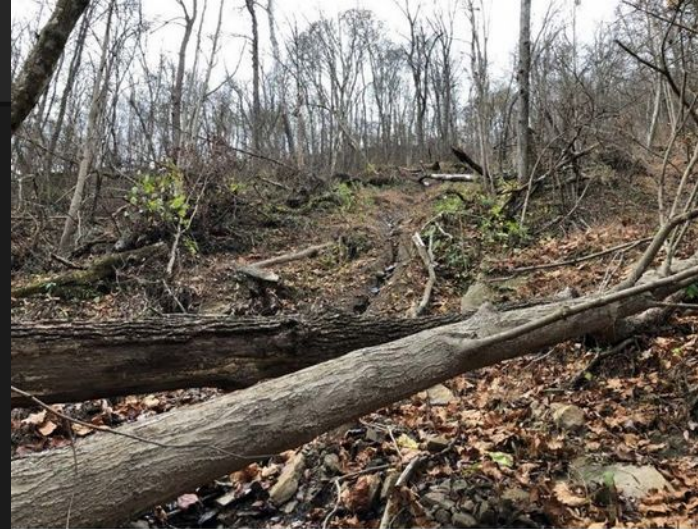
Main Active Landslide

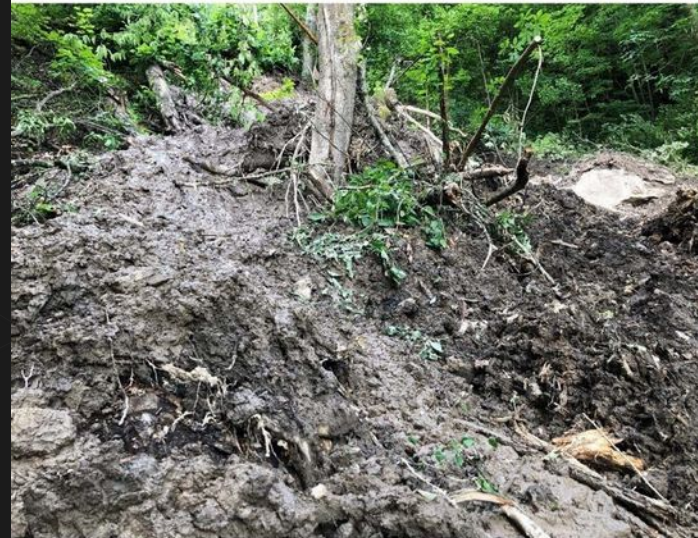
Main Active Slide Material

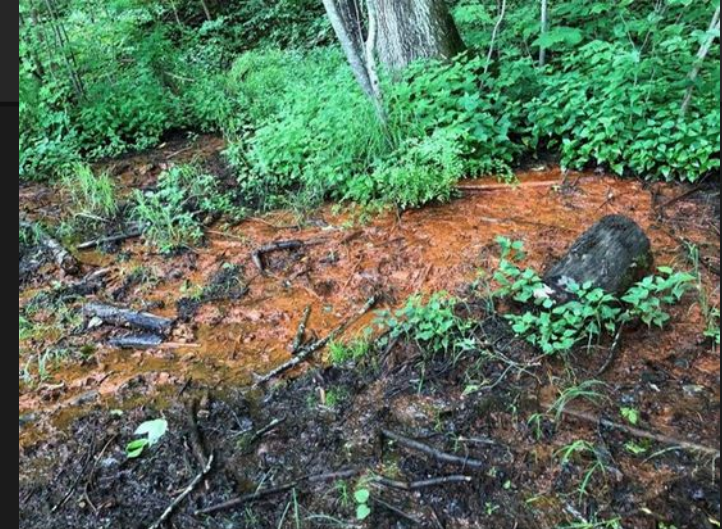
Collapsed and Draining Entry-Iron Laden Drainage

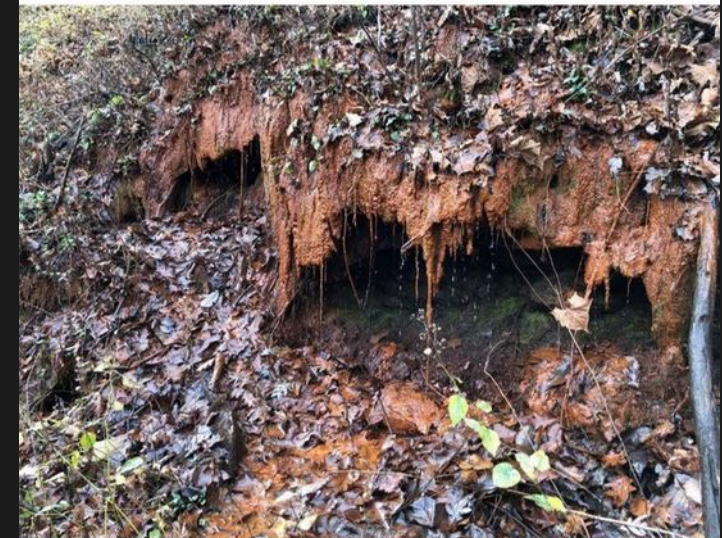
Collapsed and Draining Entry-Top of Main Slide

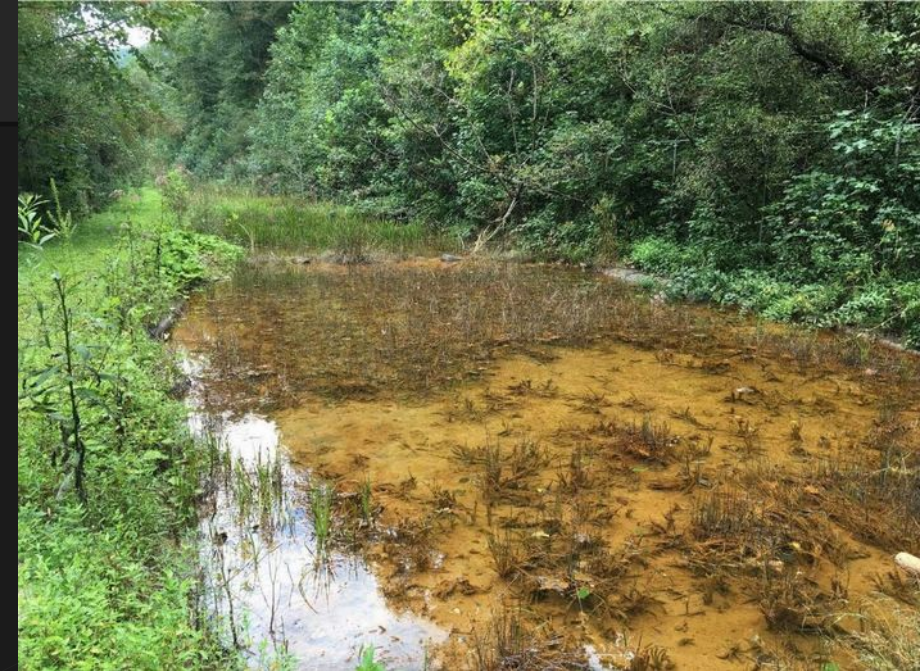
- / Failure in passive AMD treatment system (3 ponds) that was installed in 2014
- / AMD coming from multiple sealed mine entries

- / Currently Conducting Water Testing
- / Remove/Upgrade existing system
- / Construct New System (Possibly Active)
- / Extend electrical lines

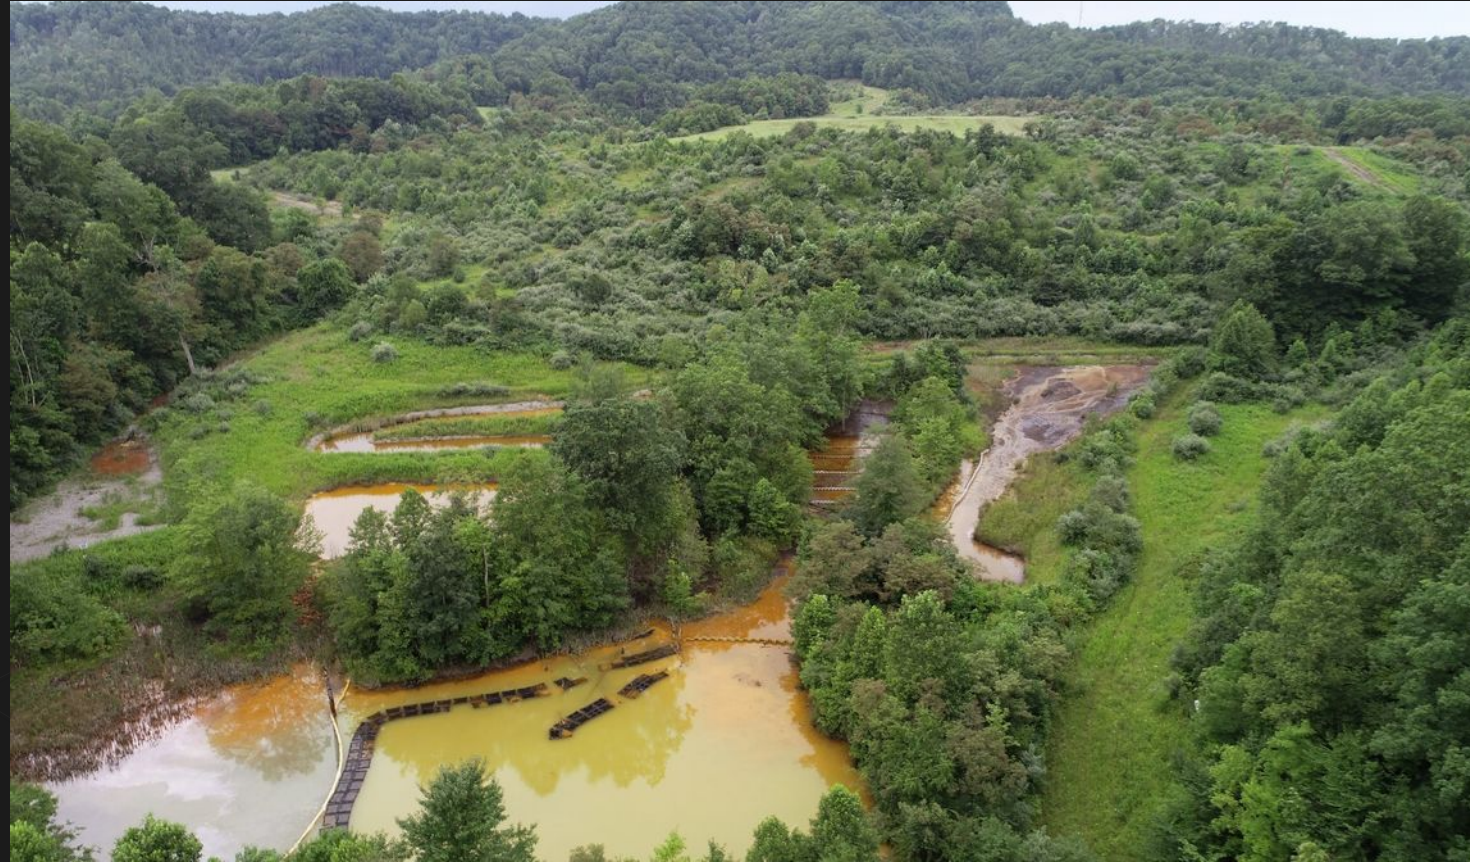
- / Existing Passive Treatment Failing
 - / Highly acidic surface runoff and mine drainage from refuse pile
 - / 3-4 GPM surface runoff
 - / AMD flowing freely into Wolf Creek of the New River
 - / Clogged with iron sludge and debris

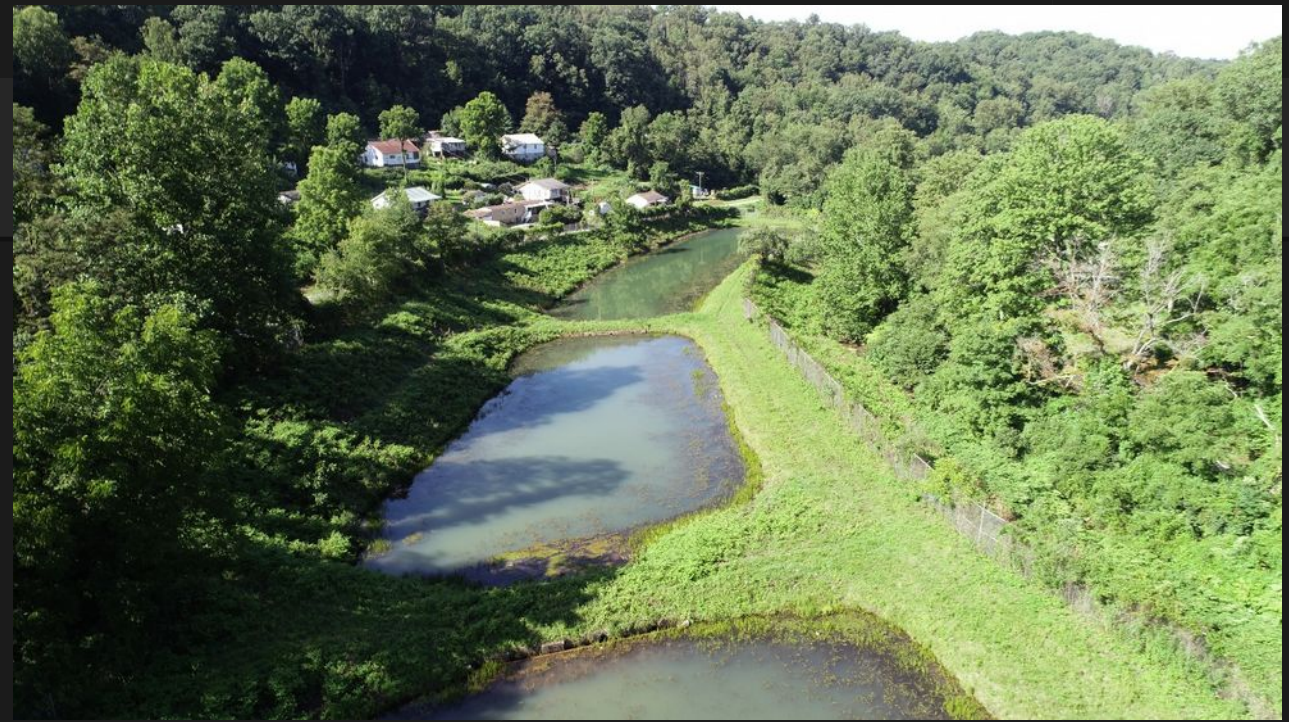
- / 4 Sediment Ponds original installed for iron settling no longer working
- / Previous AML project
- / Maintenance rounds have been completed at the site
 - / Berm
 - / Dike
 - / Dipping

- / Survey Completed
- / Water and Sludge Test
- / Remove Sludge Material and Disposal in Land Fill
- / Maintenance on Pond Embankments

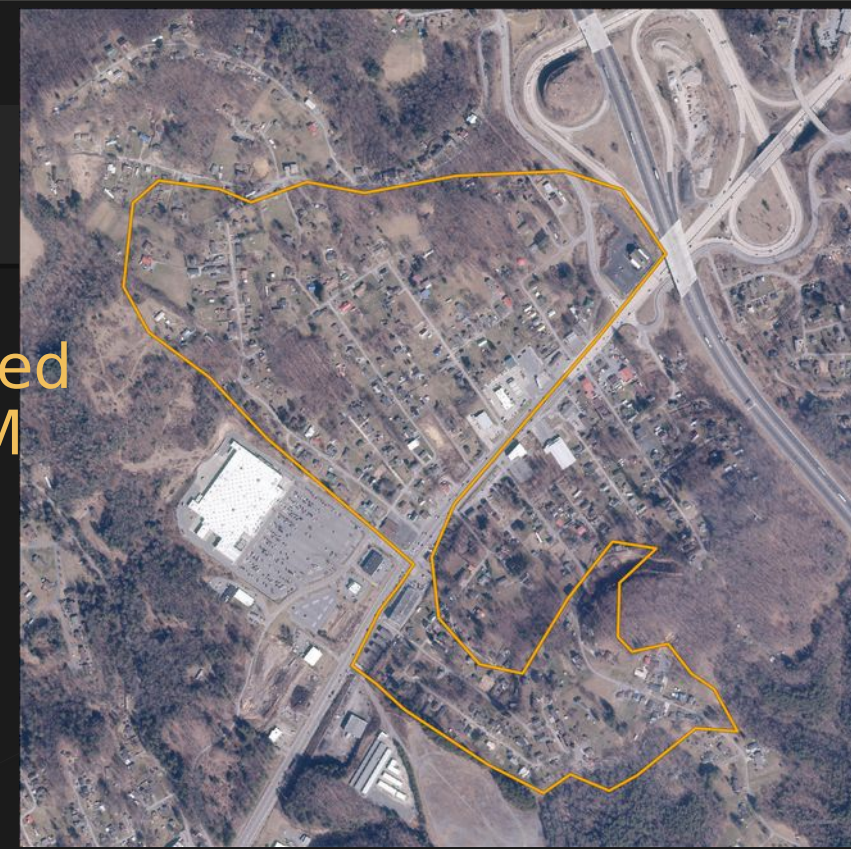
- / Subsidence
 - / Extensive history of subsidence
 - / 40' - 80' of cover between mine and ground surface
 - / Phase I and II AML projects have already been completed

- / 21 Exploratory Drill Holes Completed
- / Geological Model Completed
- / Grouting Underground Mine Works
