West Virginia Department of Environmental Protection

2022 AML Contract 8 Project North Project – Brownton Refuse #2
CEOI 0313 DEP2200000017

Office of Abandoned Mine
Lands and Reclamation

December 8, 2023

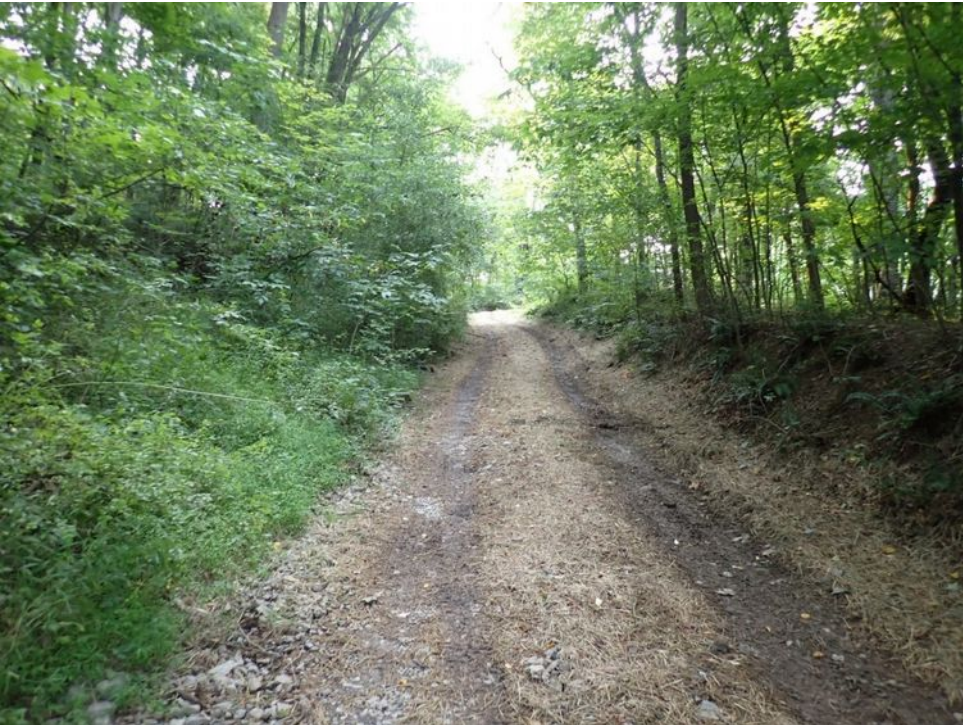
- Access Improvements

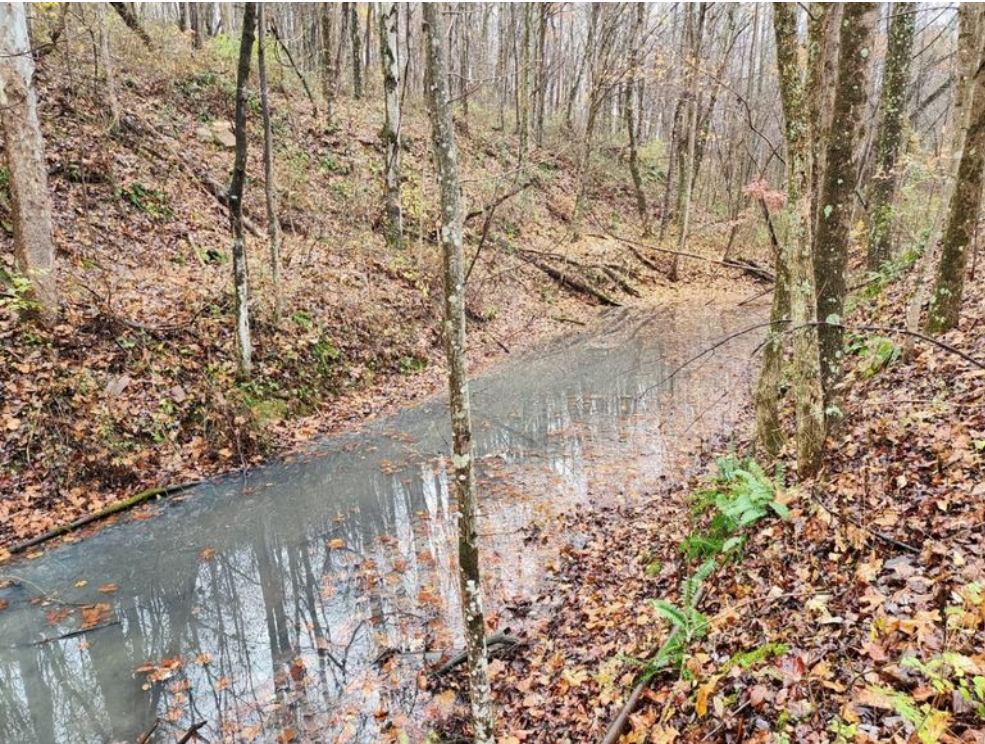
- Dewatering

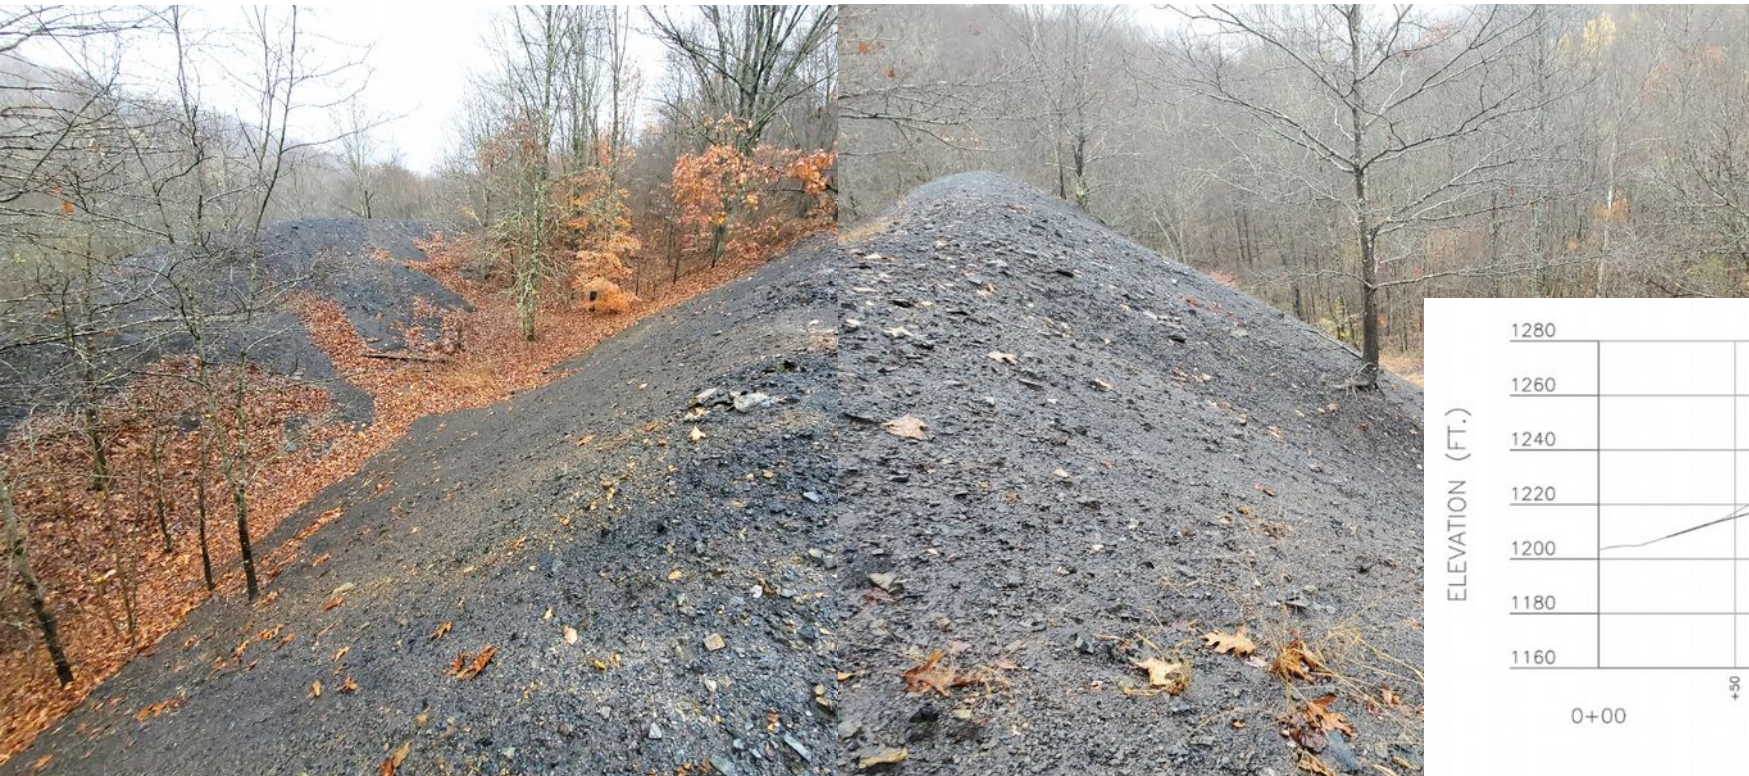
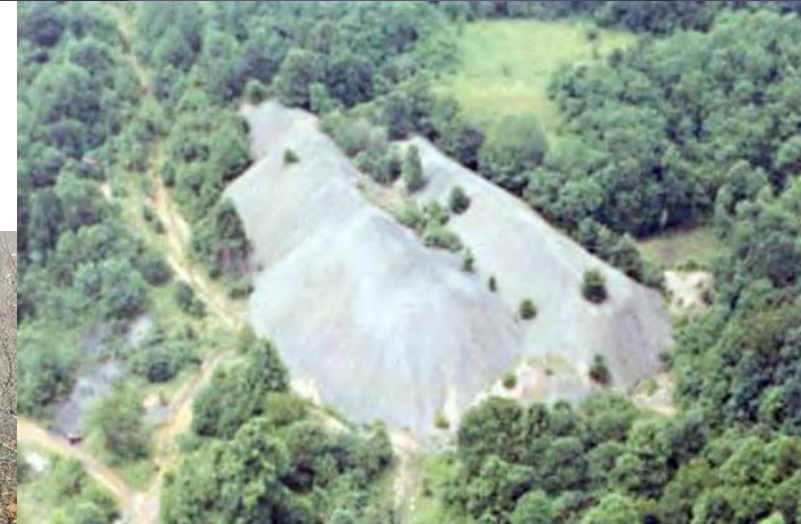
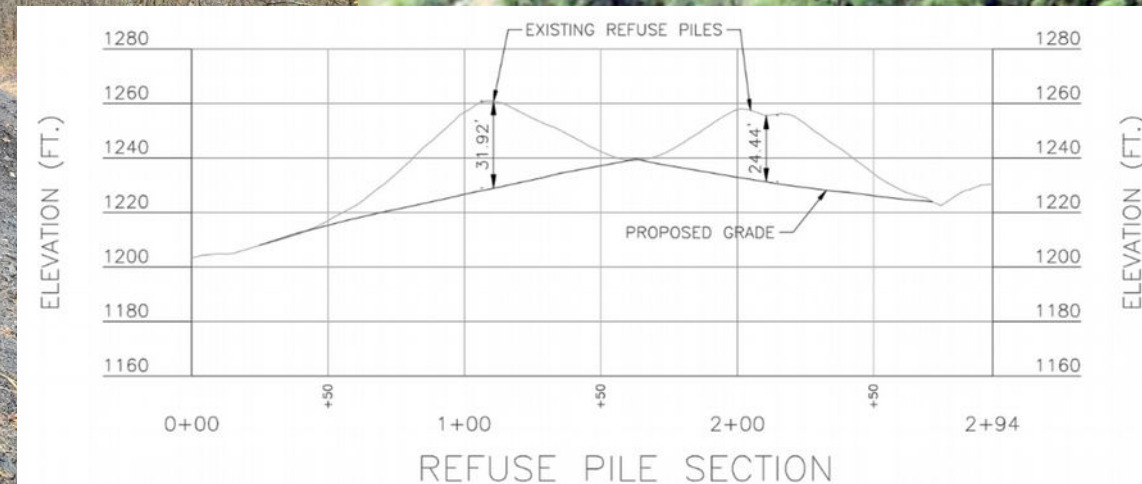
- Refuse remediation

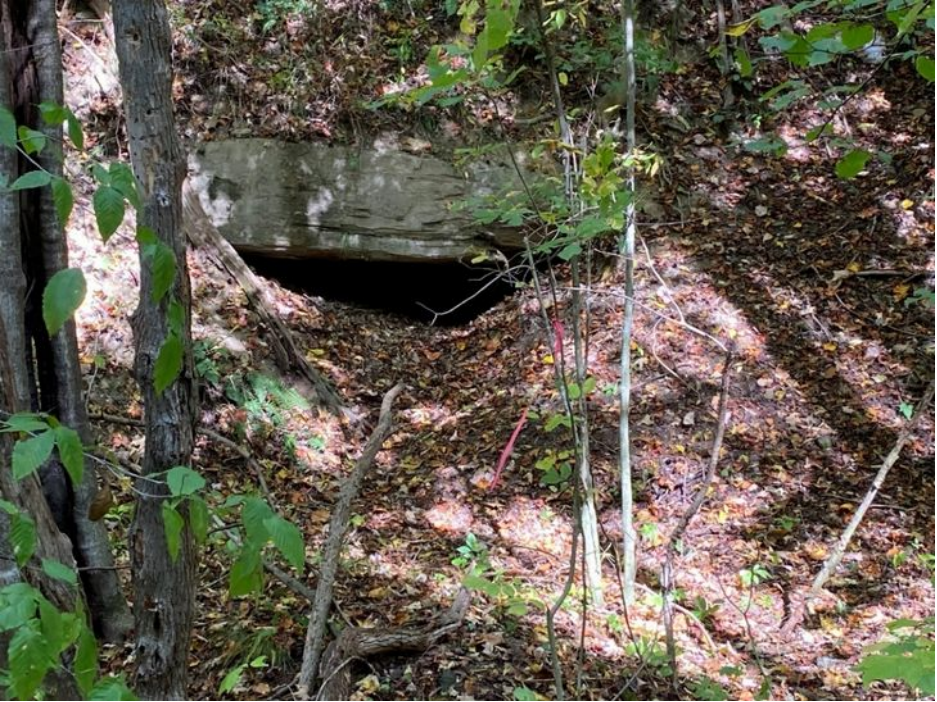
- Dry Mine Portal Closure

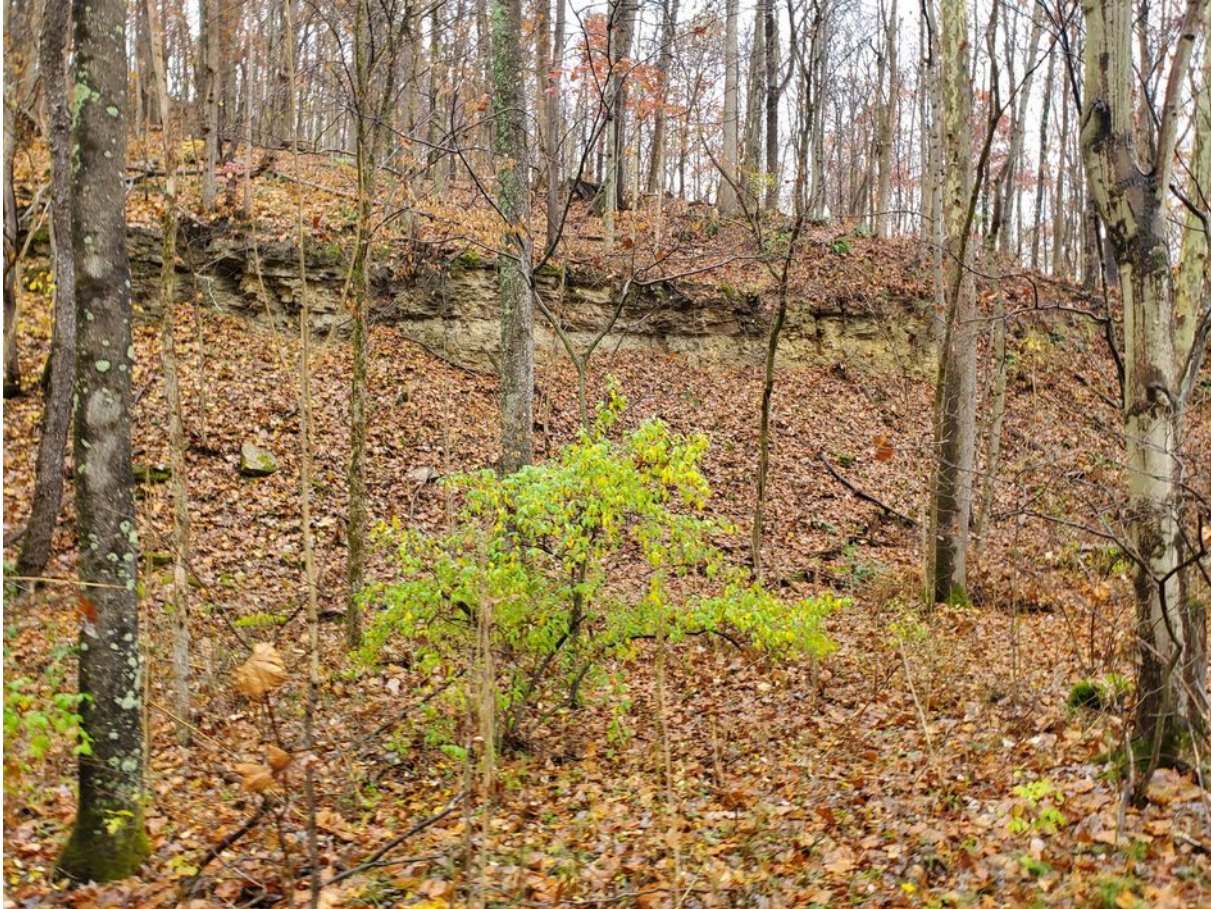
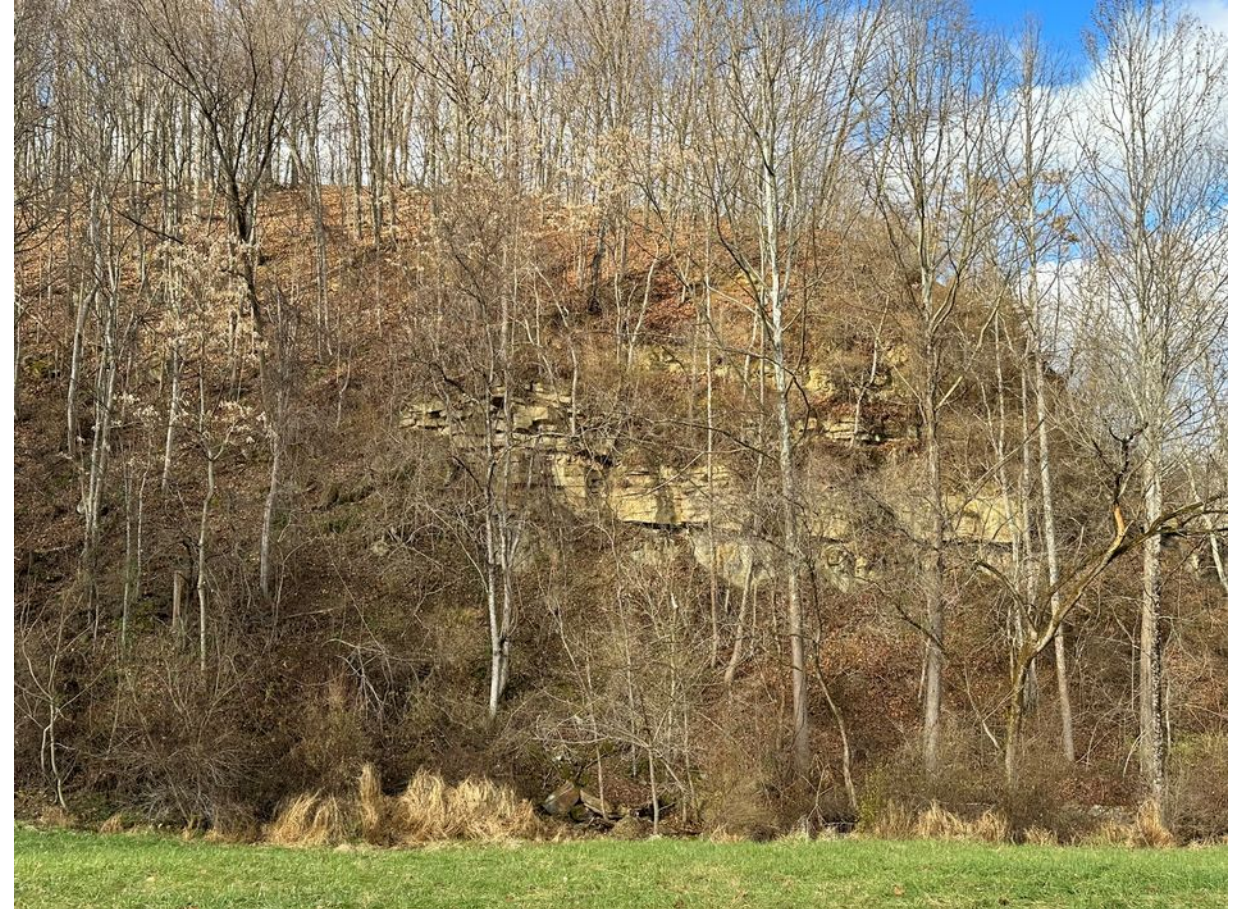
- High Wall Remediation

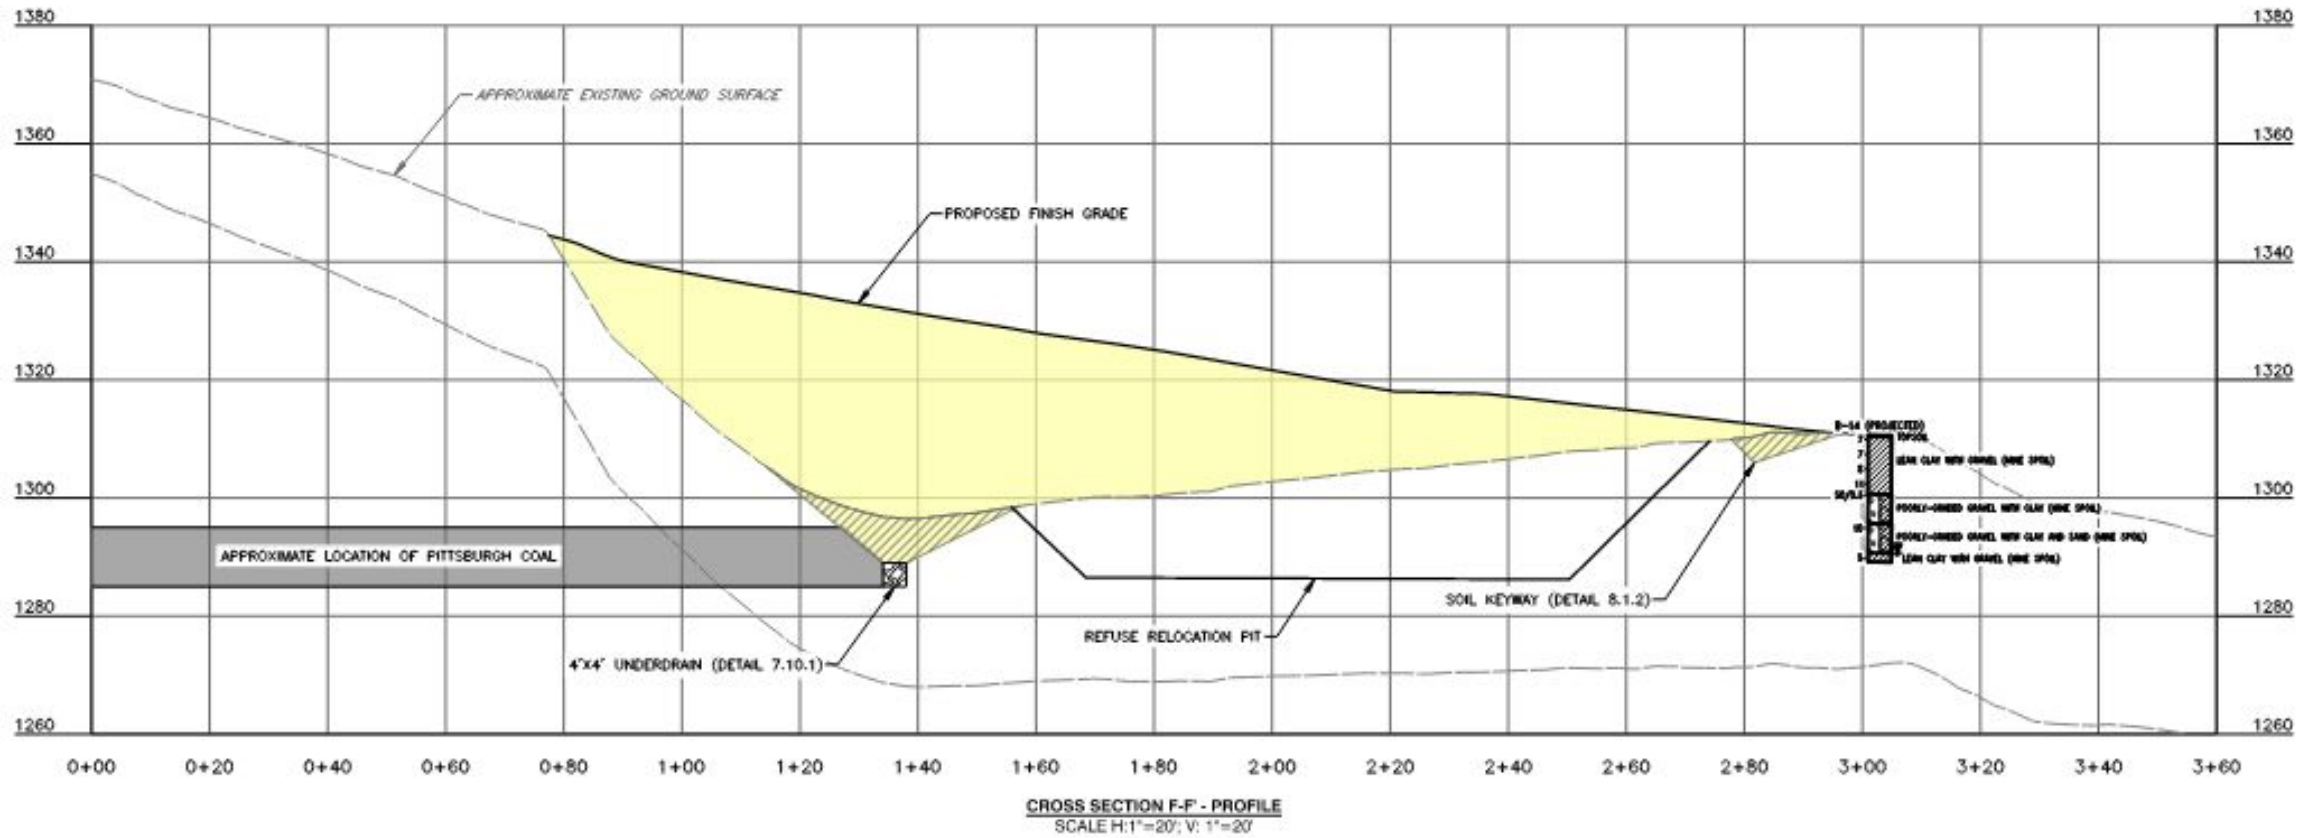
- Priority 2 High Wall – Section

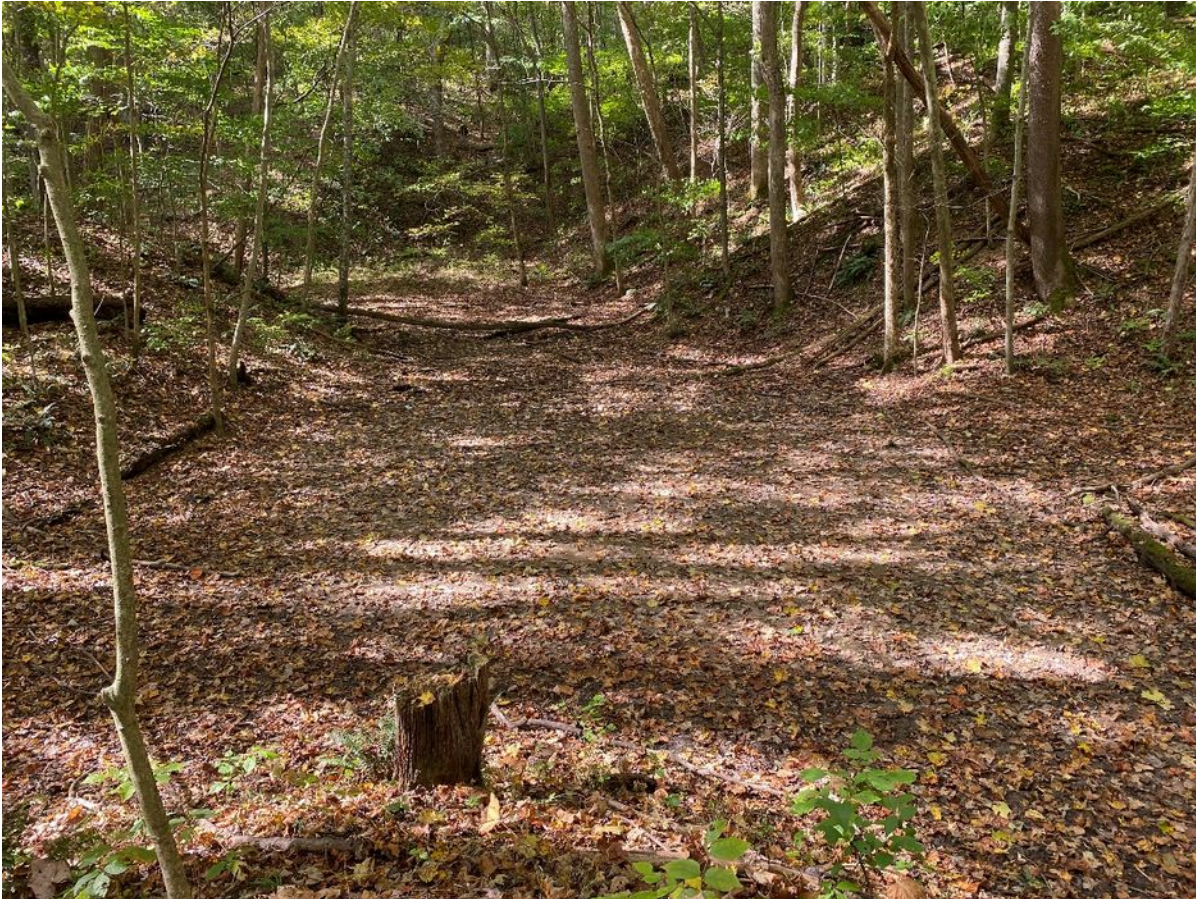
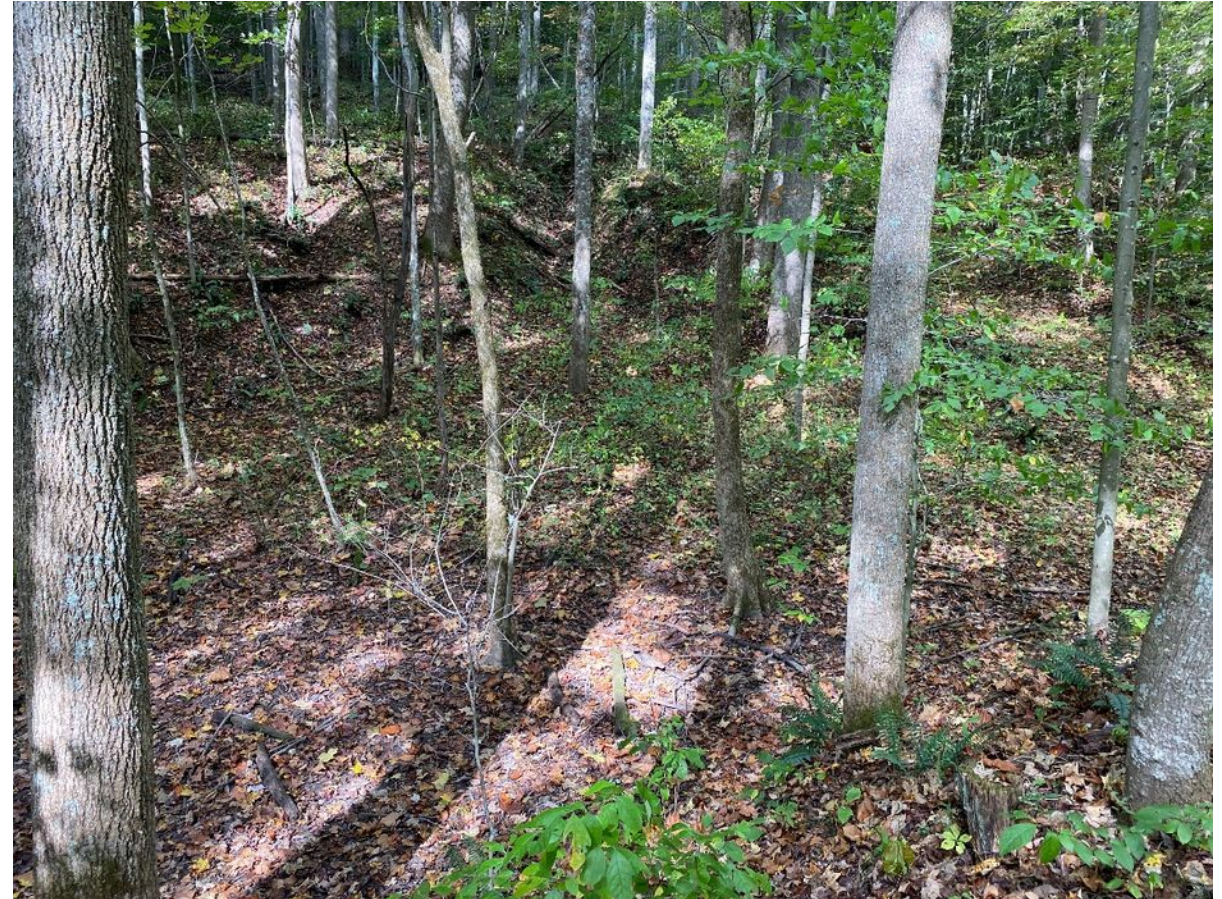
- Blocked Stream Drainage Improvement
