Kempton Refuse and AMD AML Project

Kempton, Tucker County, WV

■ **Responsible agency for reclamation:**
West Virginia Department of Environmental Protection
Office of Abandoned Mine Lands and Reclamation

■ **Design engineer:** Michael Baker Jr., Inc.

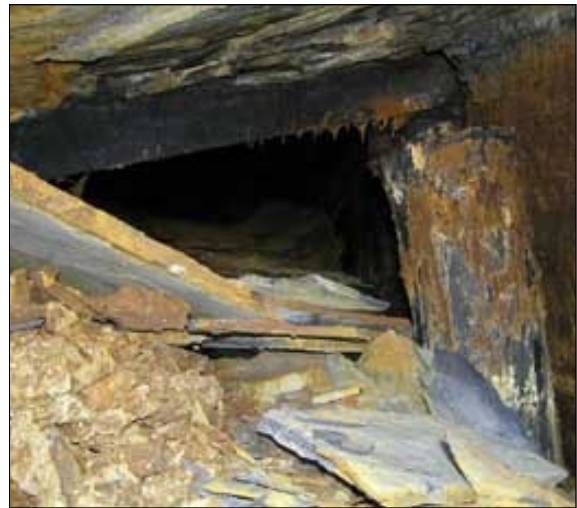
Collapsed mine portal

Mine portals, ranging in various states of collapse, are always a hazard as they tend to entice the curious to enter or get dangerously close. Wetseals were installed in both mine openings and the drainage piped and channeled to a passive water treatment system. The mine openings were then backfilled in conjunction with the surrounding highwall.

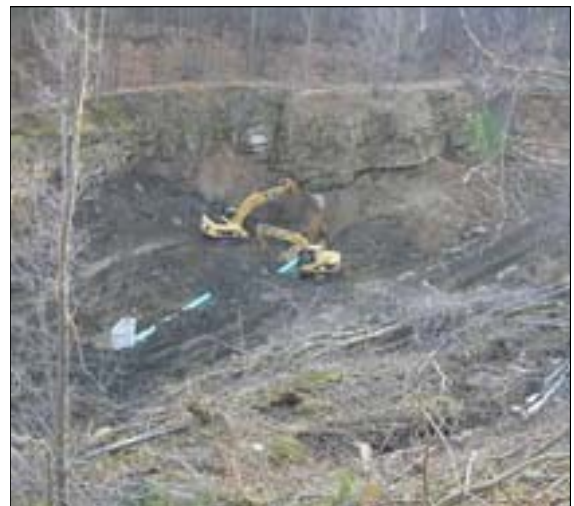
Exposed high wall

Dangerous highwall varied in height from 25 to 75 feet throughout the project. The possibility of someone slipping from the top edge of the highwall or being struck by loose rocks falling from the face of the highwall posed an impending liability. Because the project area is leased for hunting by a club with several thousand members, foot travel and ATV use are heavy, increasing the probability of someone being hurt. Backfilling, regrading, and vegetating the highwall eliminated this danger by replacing a sheer face with a stable, sloped surface.

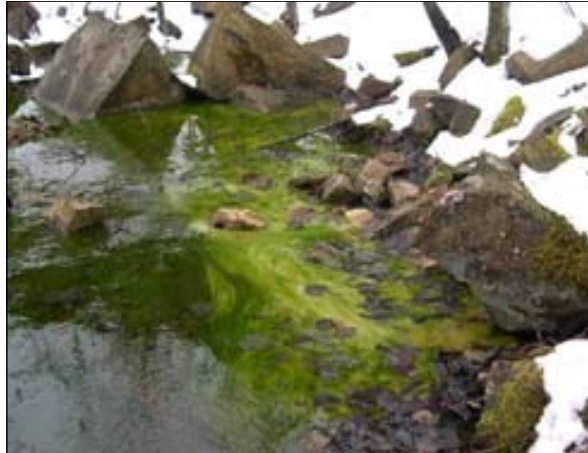
Except for small portions of the disturbed area that nature reseeded over time, most of the project was barren or sparsely vegetated. Mine spoil, consisting of coal refuse and toxic shale associated with the coal seam, was scattered and piled across the site. The overburden was sandstone that ranged from inert (with no neutralizing potential) to acid-producing. Large boulders littered the landscape. This unconsolidated surface material contributed to water quality degradation of tributaries of the North Branch Potomac River headwaters which flow within the project drainage area. Surface runoff during precipitation events increased sediment and acid loads to the receiving streams. Numerous drainage seeps existed within the project boundaries. Some were from collapsed mine portals and some were from the mined-out stream channels flowing below the porous material.

Example of water quality degradation

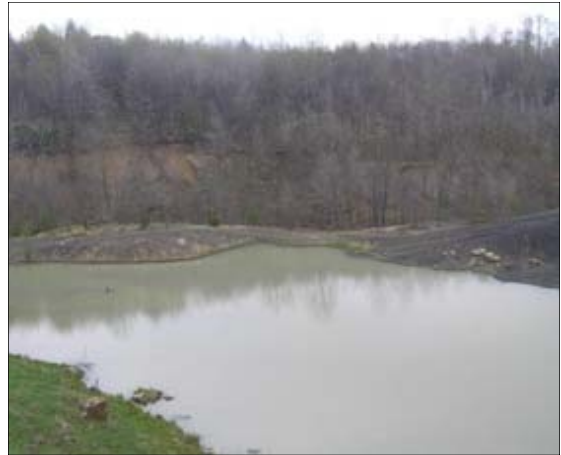
Surface impoundment

Two surface impoundments on opposite ends of the project were easily accessible. An un-gated road passing through the project area within feet of both impoundments invited foot and vehicle traffic. The water level in one of the impoundments fluctuated between five and six feet, creating a safety hazard. The impoundments were drained and incorporated into the regraded area.

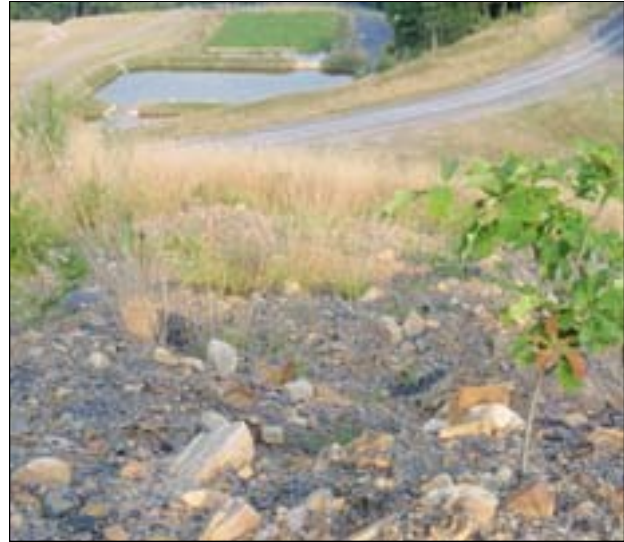
Close to 2,500 trees were planted

Tree selection was influenced by the ongoing effort to conserve and restore the red spruce ecosystem in the Potomac Highlands. Much of the red spruce habitat was replaced by hardwoods after extensive logging and fires in West Virginia. Remaining acreage, important for several rare, threatened and endangered species, is small and scattered. Concerned groups are collecting local seed cones, having the seeds grown by a commercial nursery, and selling the plugs for reforestation, primarily at elevations above 3,500 feet. In the spring of 2008 a five-acre area of this project was loosened to a depth of four feet by a large excavator. One thousand of these red spruce seedlings, as well as a mixture of Northern Red and White Oaks, Black Cherry, Sugar Maple, Black Locust, Eastern Red Bud, Dogwood and Black Walnut, totaling 2,500 trees, were planted.

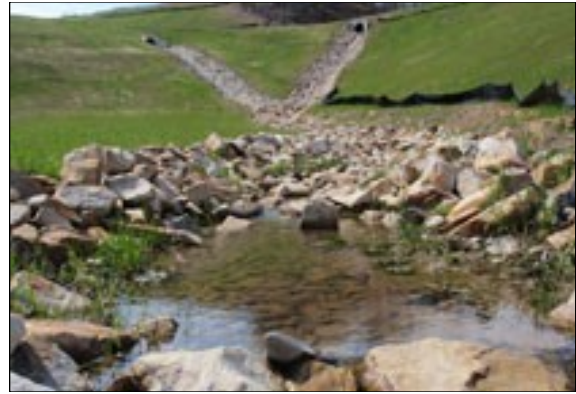
Stream channel design reduced acidities by one-third

As the tributaries were relocated and basic substrate established, natural stream channel design techniques were incorporated to establish sinuosity, stabilize stream banks, develop habitat, and improve water quality. Native inert sandstone was placed along the stream banks for stabilization. A mix of the sandstone and limestone was placed in the stream channel along with log cross vanes to direct flow; create step pools, riffles, runs, and glides and increase alkalinity. A one-time post construction water sampling showed the alkalinity increased slightly in the relocated tributaries when comparing upstream to downstream locations within each tributary. When compared to pre-existing conditions, the acidities were reduced by one-third.

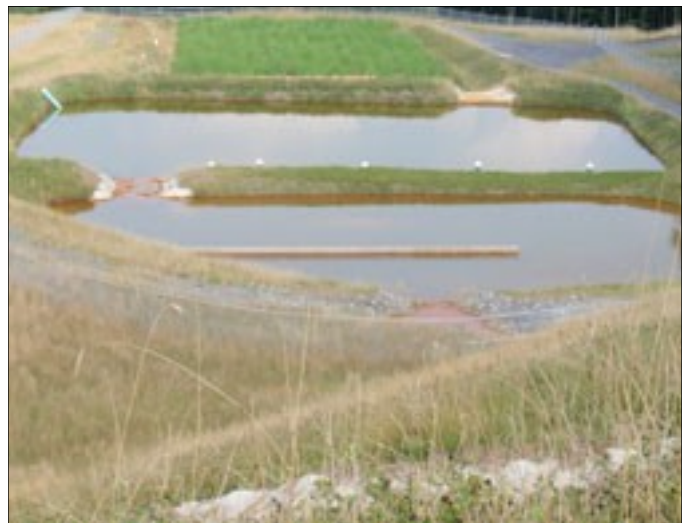
Passive system is successfully treating mine drainage

All drainage leaving the project prior to reclamation was acidic with that originating from the two mine portals being the worst. Drainage from the portal with the largest flow was also of the poorest quality with a pH value less than three. The average acid concentration was 286 mg/l. In addition, aluminum at this source was as concentrated as 23 mg/l at times. A passive treatment system was designed and installed to treat the combined drainage of the two portals. This system consists of a series of cells intended to treat the drainage in phases. The drainage is first captured in an “equalization pond” to

settle solids before flowing from top to bottom through an alkaline producing cell containing a layer of mushroom compost over a limestone bed. The drainage is then collected by perforated pipes in the limestone substrate and channeled through an aerobic wetland. Quarterly sampling indicates the system is successfully treating the mine drainage. Not only is all of the acid neutralized, but the system continues to discharge an effluent exceeding 50 mg/L alkalinity. It successfully treats mine drainage ranging in pH from 2.8-3.4 to a pH ranging from 6.5 to 7.4. In addition, aluminum and iron concentrations are nearly zero. Appalachian Clean Streams Initiative funding of \$439,292 was used to help pay for the construction of the passive water treatment system.

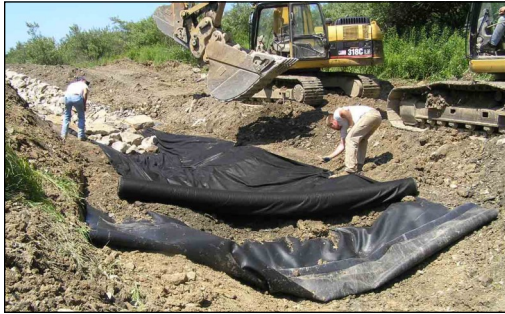
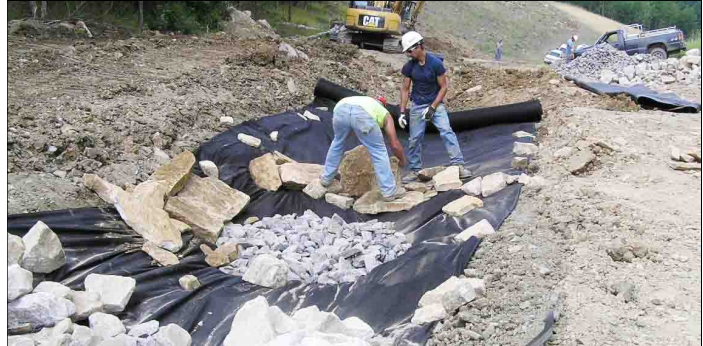
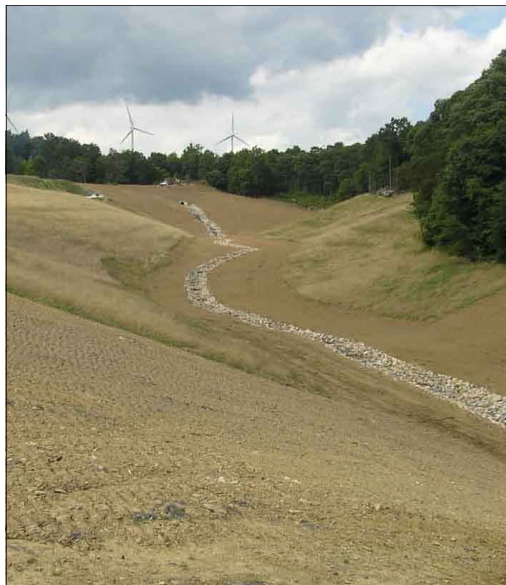
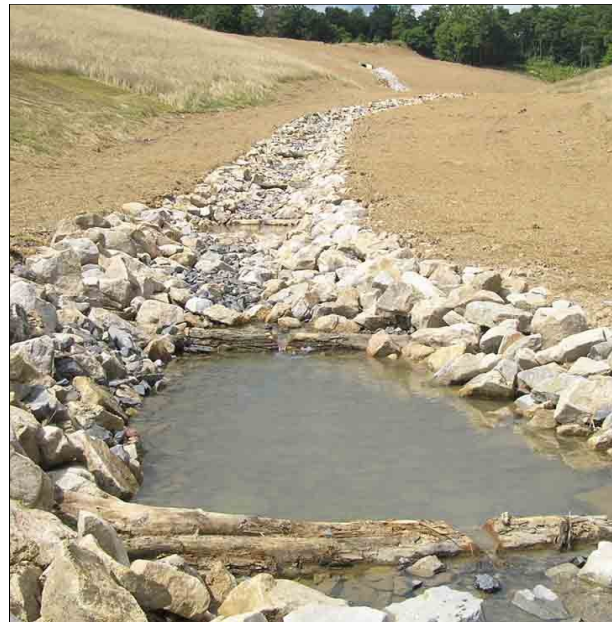
Stream restoration

Installation of relocated
impervious lined channel

Tributaries meandered through the project boundaries in disjointed fashion. Unconsolidated surface material allowed the stream to sink into the soils and rocks, and then resurface or infiltrate groundwater pools. This made measuring stream flows difficult. To correct the loss of flow from the stream channel, approximately one stream mile was relocated and contained within an impervious liner. A new substrate was created in the streambed by covering the liner with six inches of soil stabilized with filter fabric.

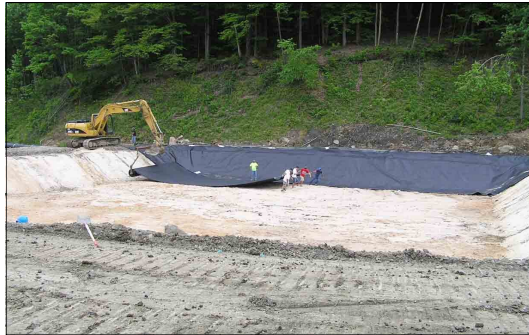
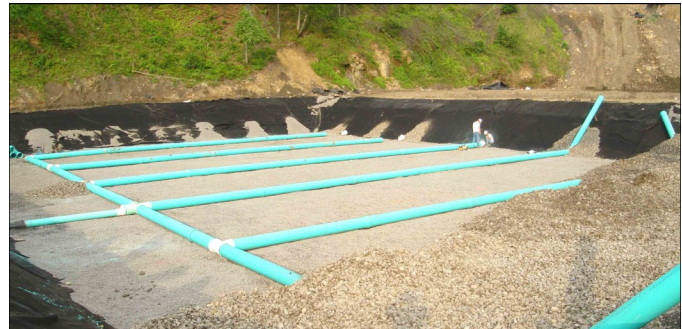
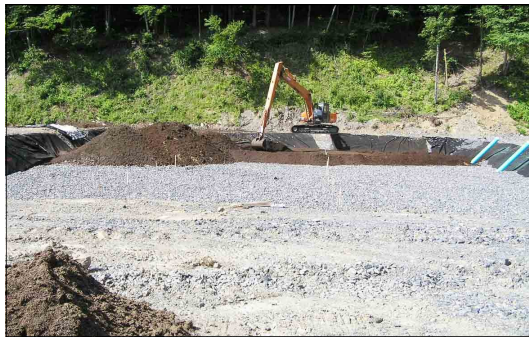
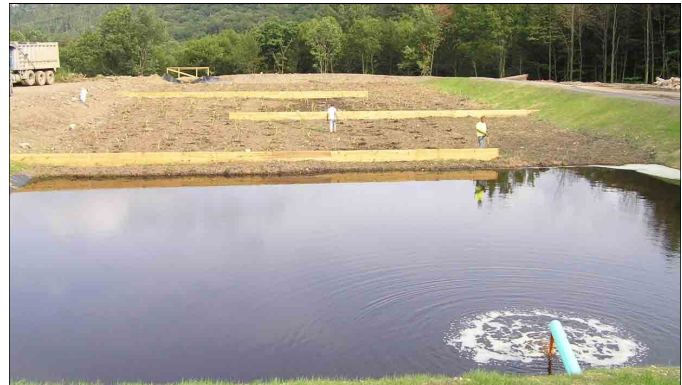
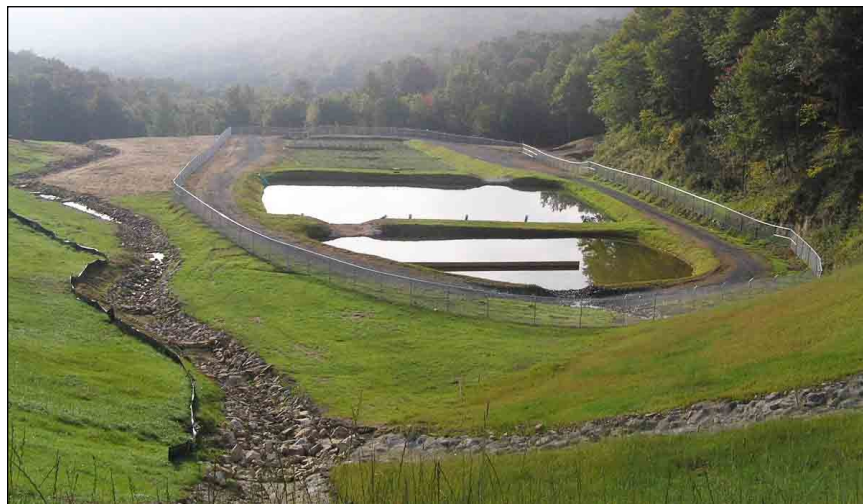
Passive water treatment

System designed and installed to treat combined acid mine drainage from two mine portals
