Three Fork Creek Watershed Restoration Project

Preston County, WV

Introduction

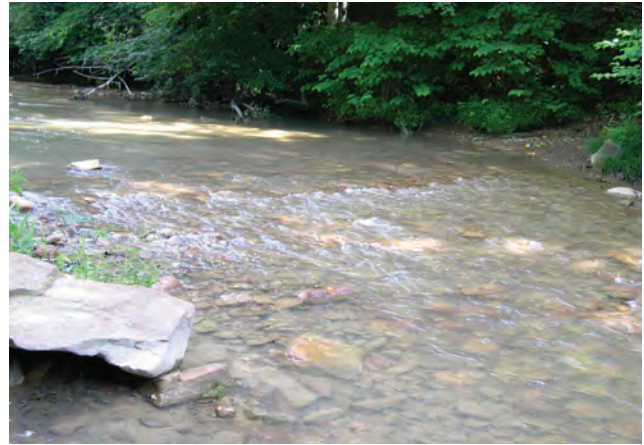
Aluminum-laden tributary

Mine drainage associated with Upper Freeport and Middle Kittanning seams in the headwater tributaries of Three Fork Creek is characteristically low in pH and high in metals. The Bakerstown seam produces higher pH discharges, but is also high in metals. The table below summarizes 106 water quality samples collected at 26 seep and portal discharge locations.

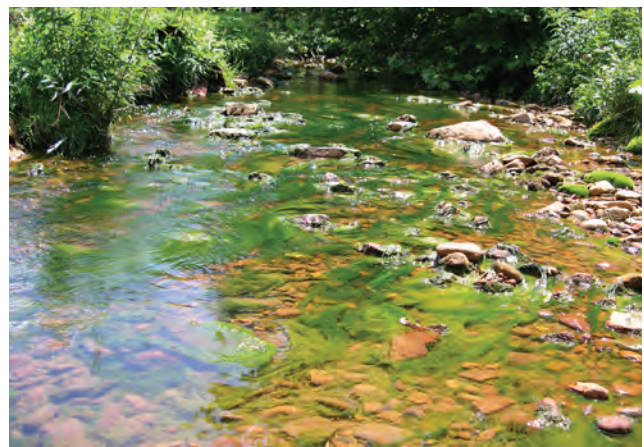
Iron-laden tributary

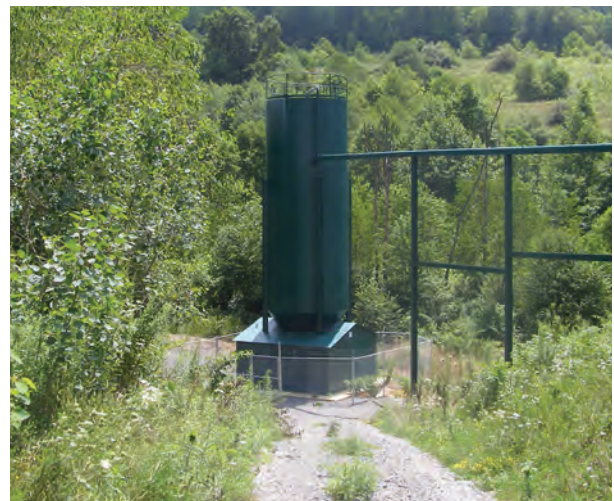
Squires Creek doser

Construction of the dosers was initiated in July 2010. Each doser includes an intake located on the edge of the stream that diverts water from the stream to the doser via an underground pipe, the actual doser mechanism enclosed in a steel building, a steel lime storage silo, and an outlet leading to the stream. Two types of dosers were utilized: one using a water-powered tipping bucket to dispense lime at each tip, and three using a water wheel to turn an auger, dispensing lime. Each system was completed and actively treating water by April 2011.

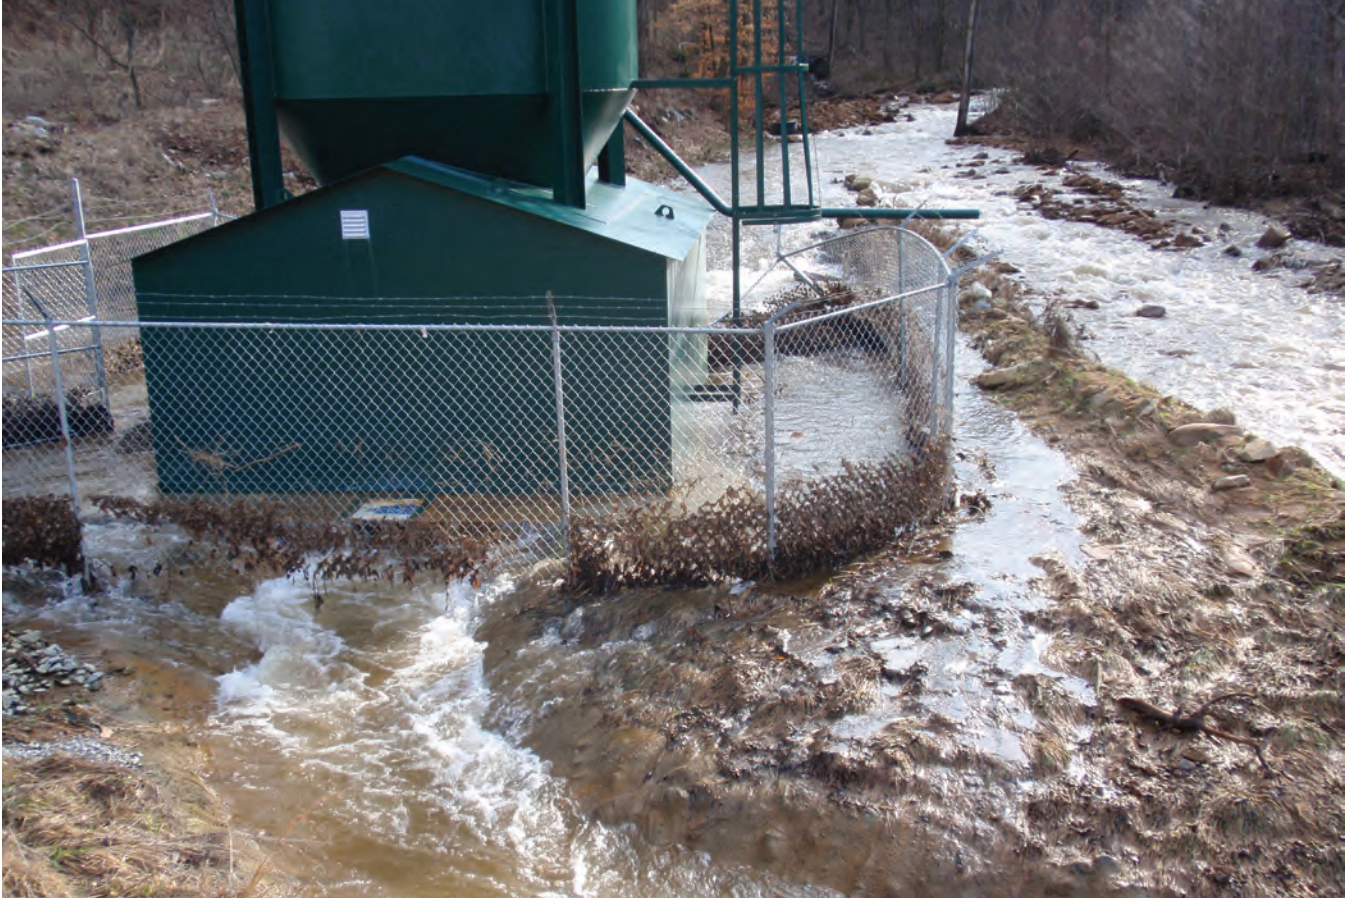
- Types of treatment material to utilize: AML tried three types of material: granulated lime (CaO), a smaller diameter granulated lime, and hydrated lime (Ca(OH)_2). Each reacted differently depending on the site and weather conditions. Ultimately, the smaller diameter granulated lime worked best.
- Stream Flow: The constant fluctuations in stream flow require routine adjustment to the treatment systems to maintain steady water quality downstream.
- Major storm events: Swift, high streams move sediment, boulders, and debris changing the stream channel and at times damaging the doser system.

Squires Creek doser after flood

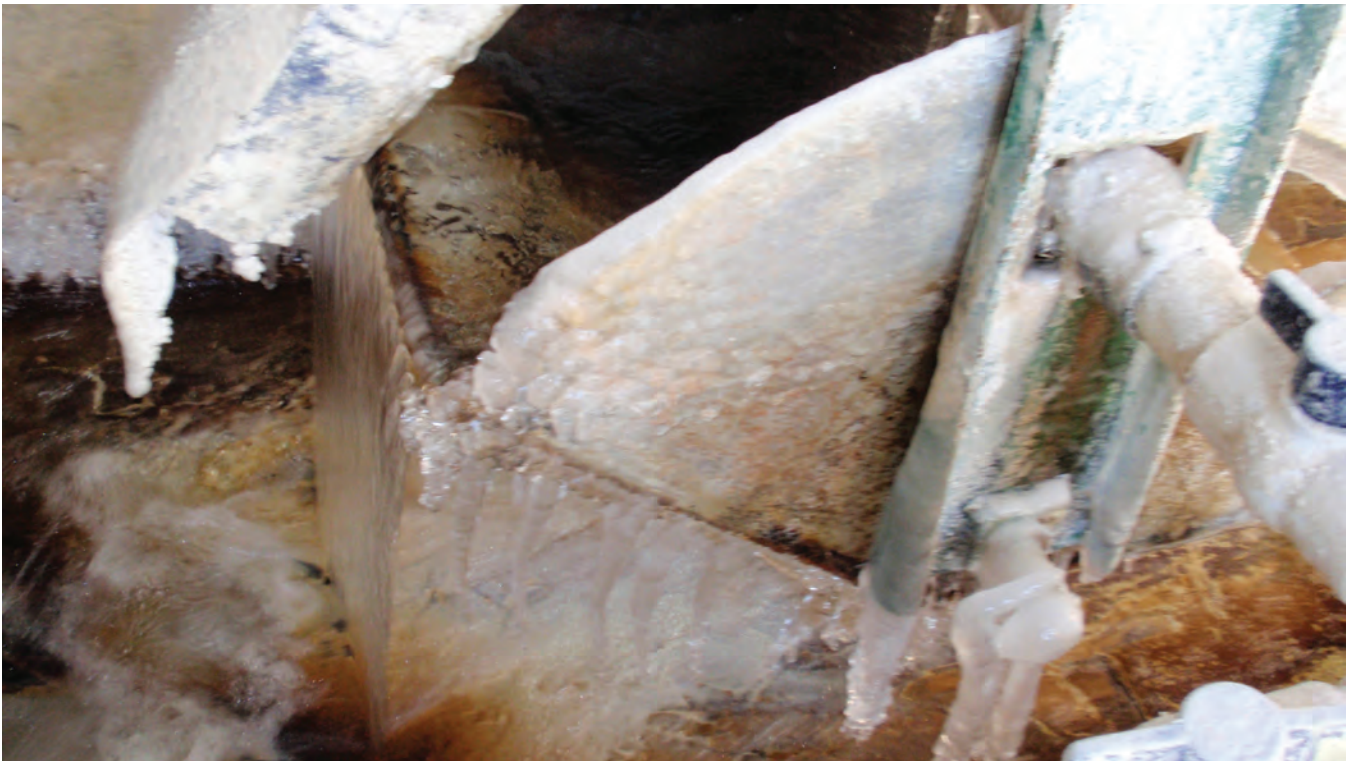
- Cold Weather: The granulated lime initially utilized during warmer seasons does not provide the same amount of neutralization/chemical reaction when the water temperature drops. AML utilized hydrated lime during the winter months, though this material is much more difficult to handle than granulated lime. Another problem experienced during the winter months is freezing, which shut systems down on occasion.

Ice on tip bucket of doser

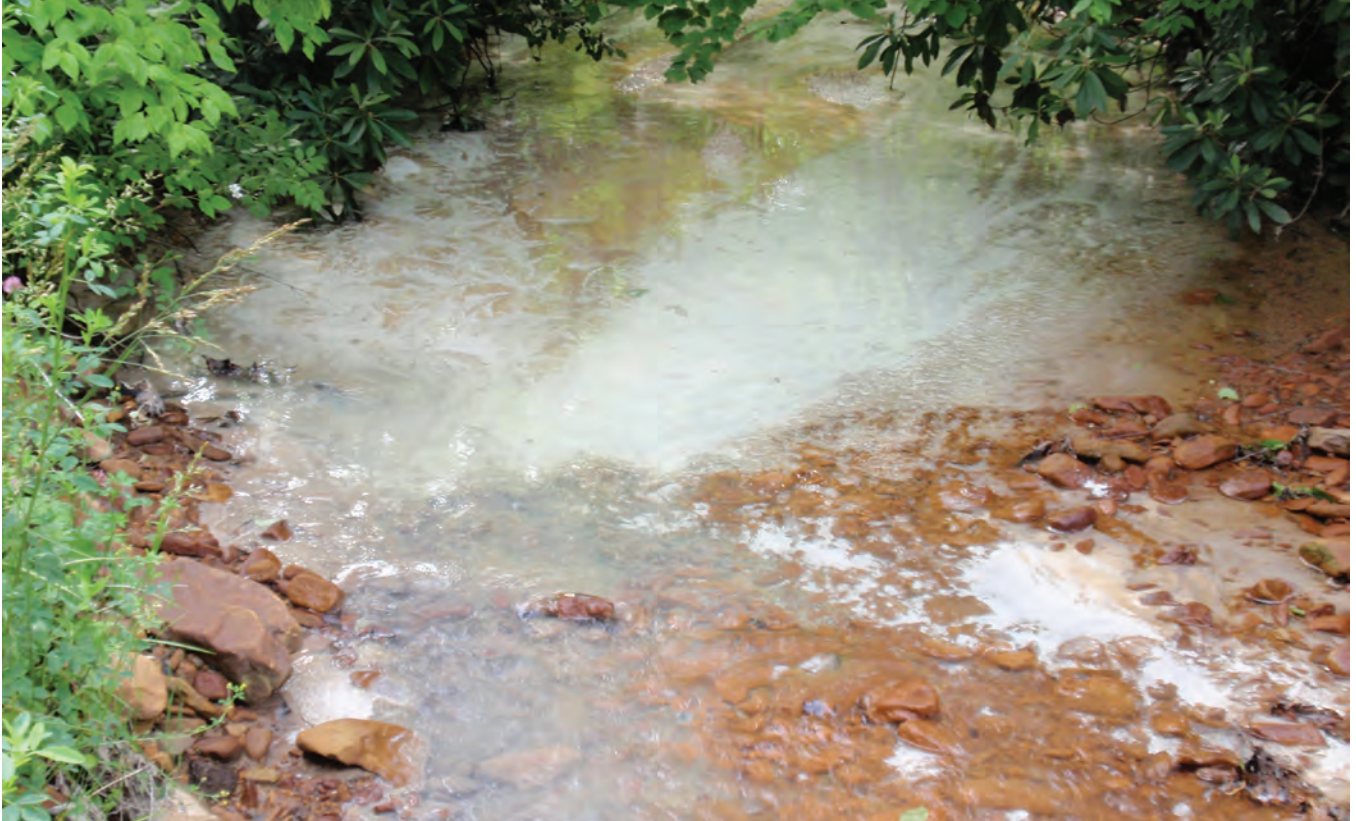
Undissolved lime downstream of the North Fork doser

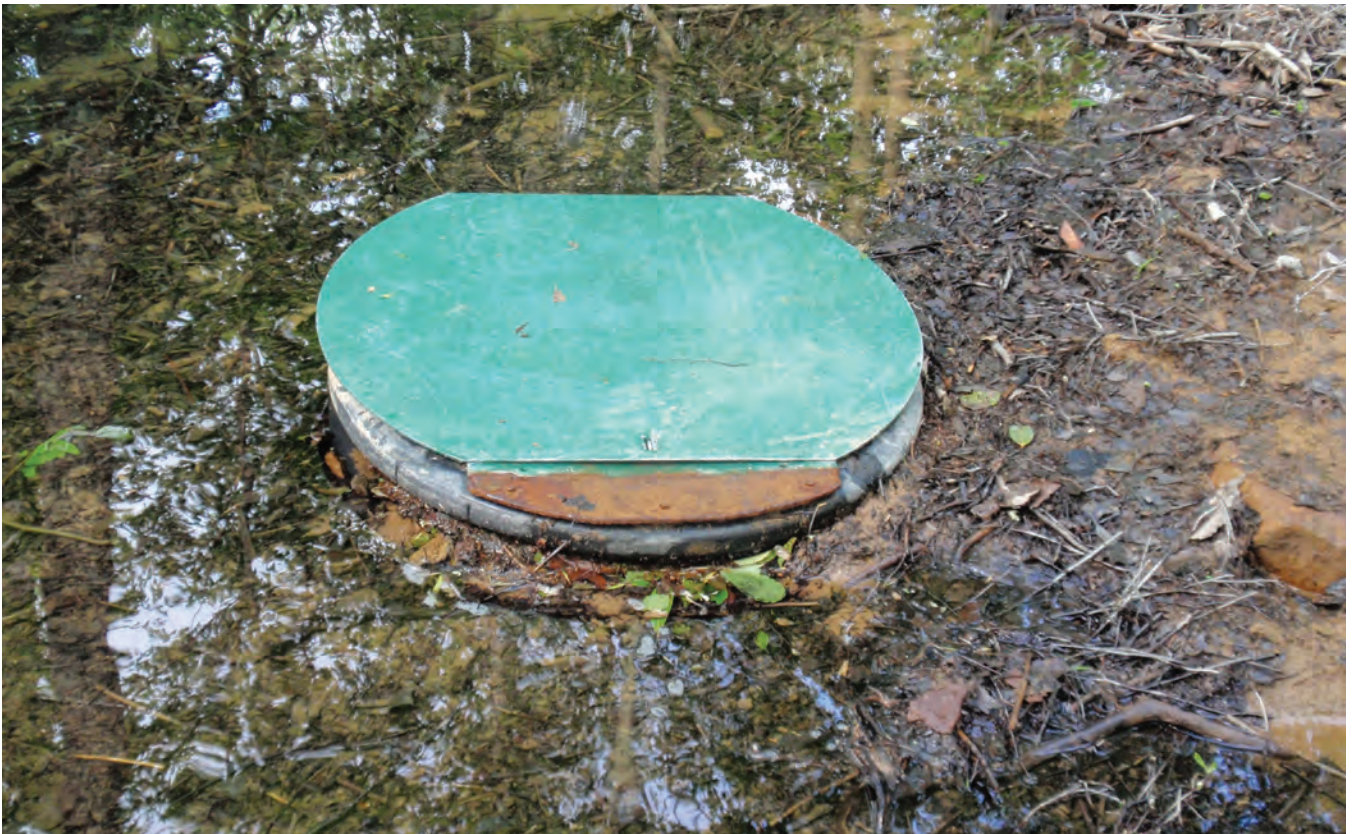
- Intakes and Lines: Leaves, sediment and other debris, normally carried through the stream channel, can clog the intake, not allowing enough water to flow into the system. Iron buildup in the lines themselves has created water flow issues as well.

Debris clogging intake of the North Fork doser

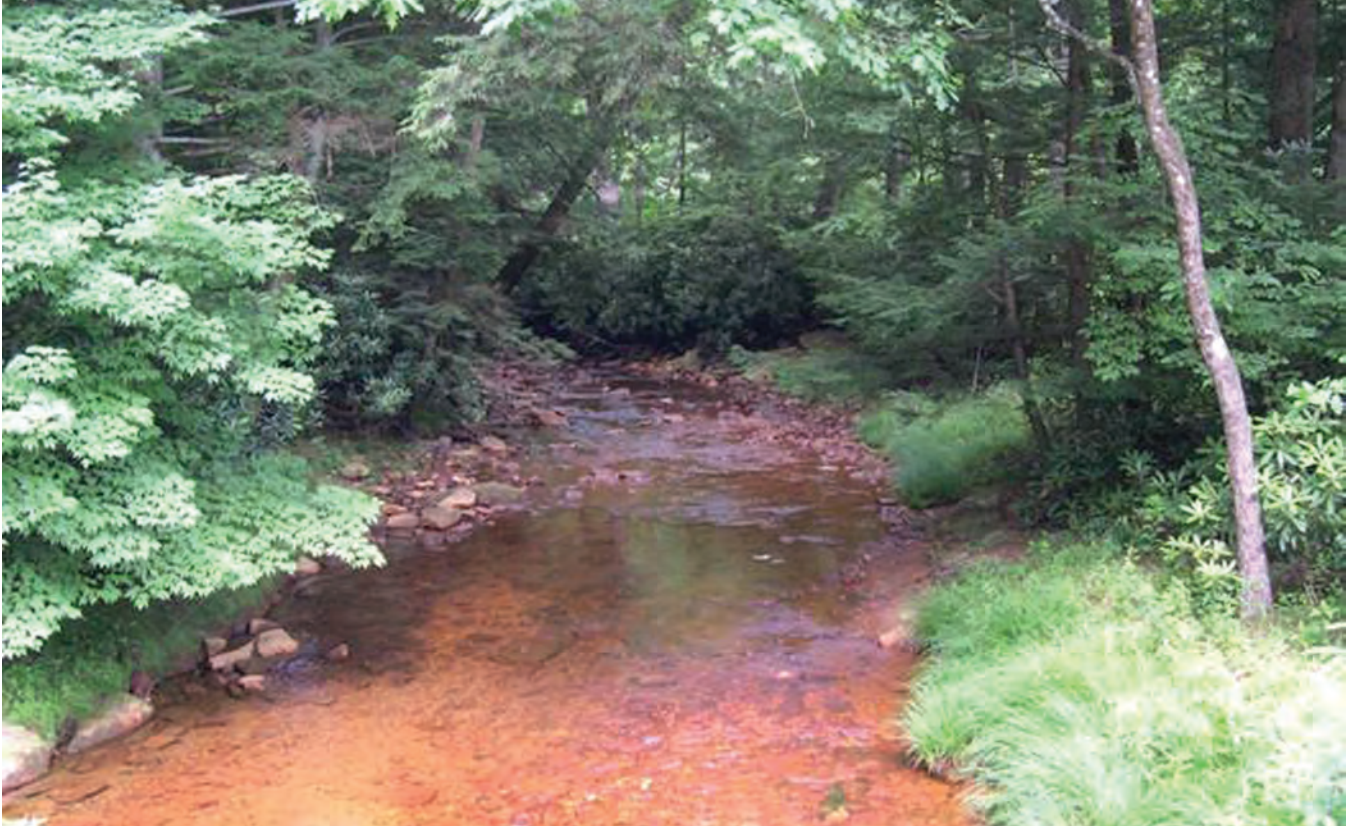
Birds Creek prior to dosing

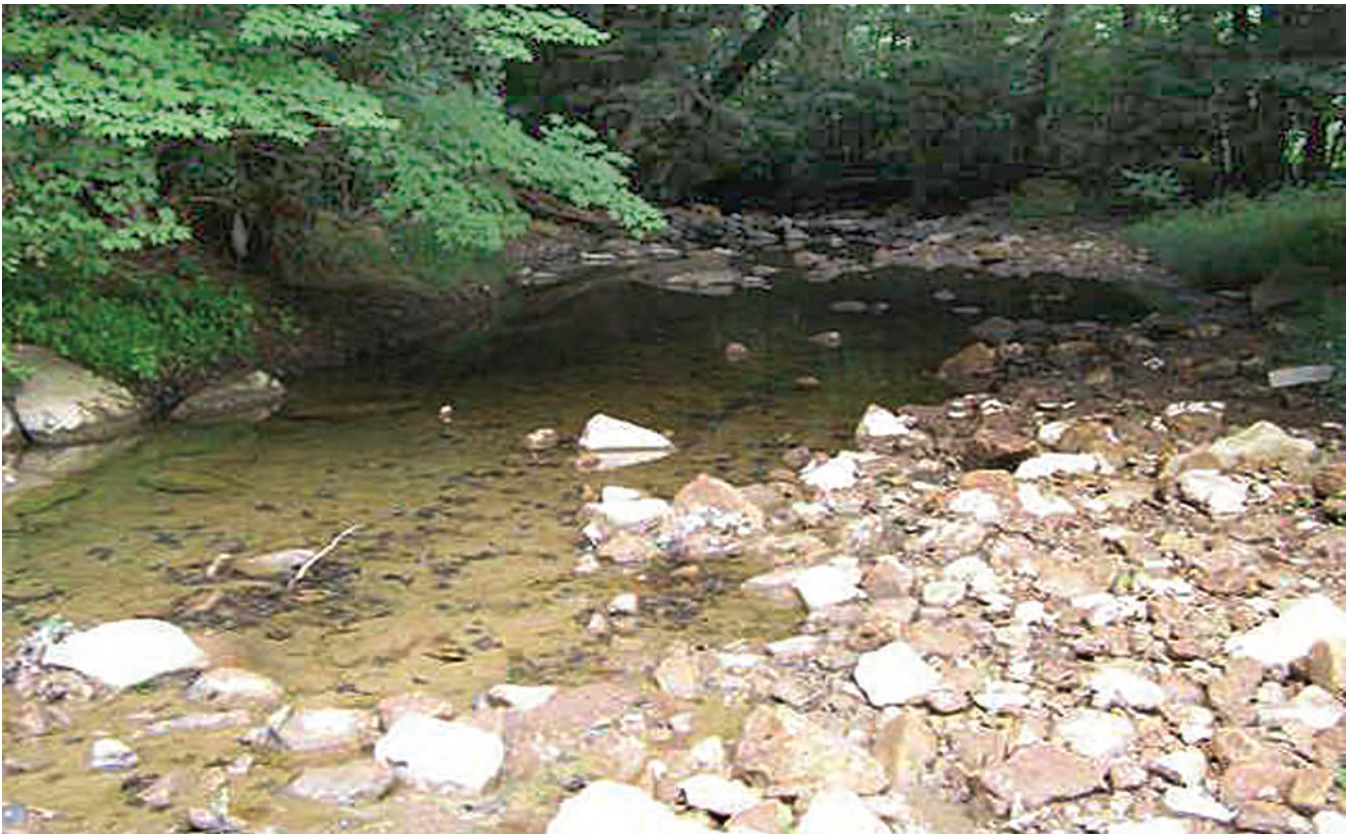
During weekly pH checks through the watershed, AML staff noticed that the iron staining found on most rocks in the stream has slowly been disappearing from both the tributaries and the mainstem of Three Fork Creek, improving the aesthetics of the stream. Embeddedness, which can be defined as the degree to which fine sedi-

Birds Creek after dosing

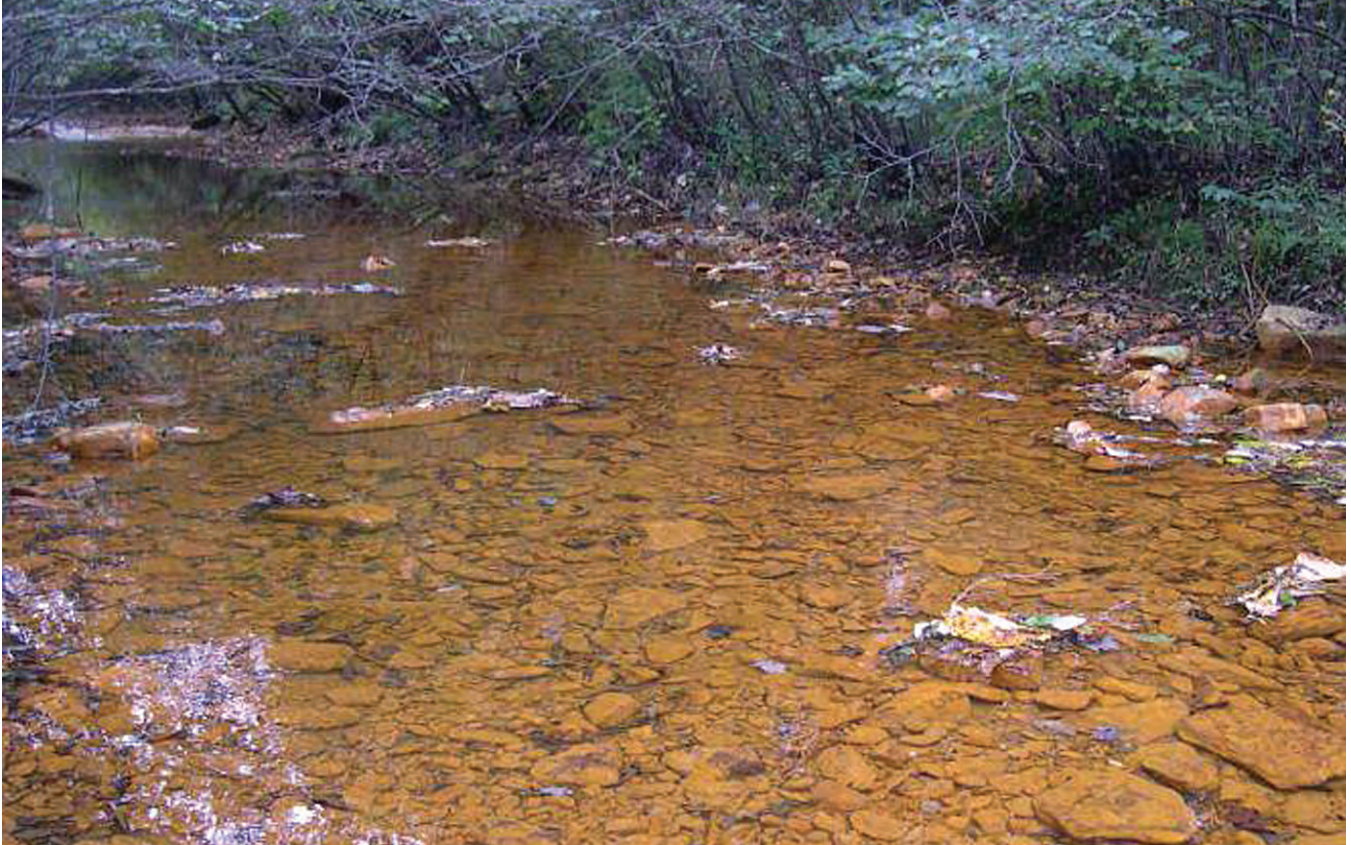
Raccoon Creek prior to dosing

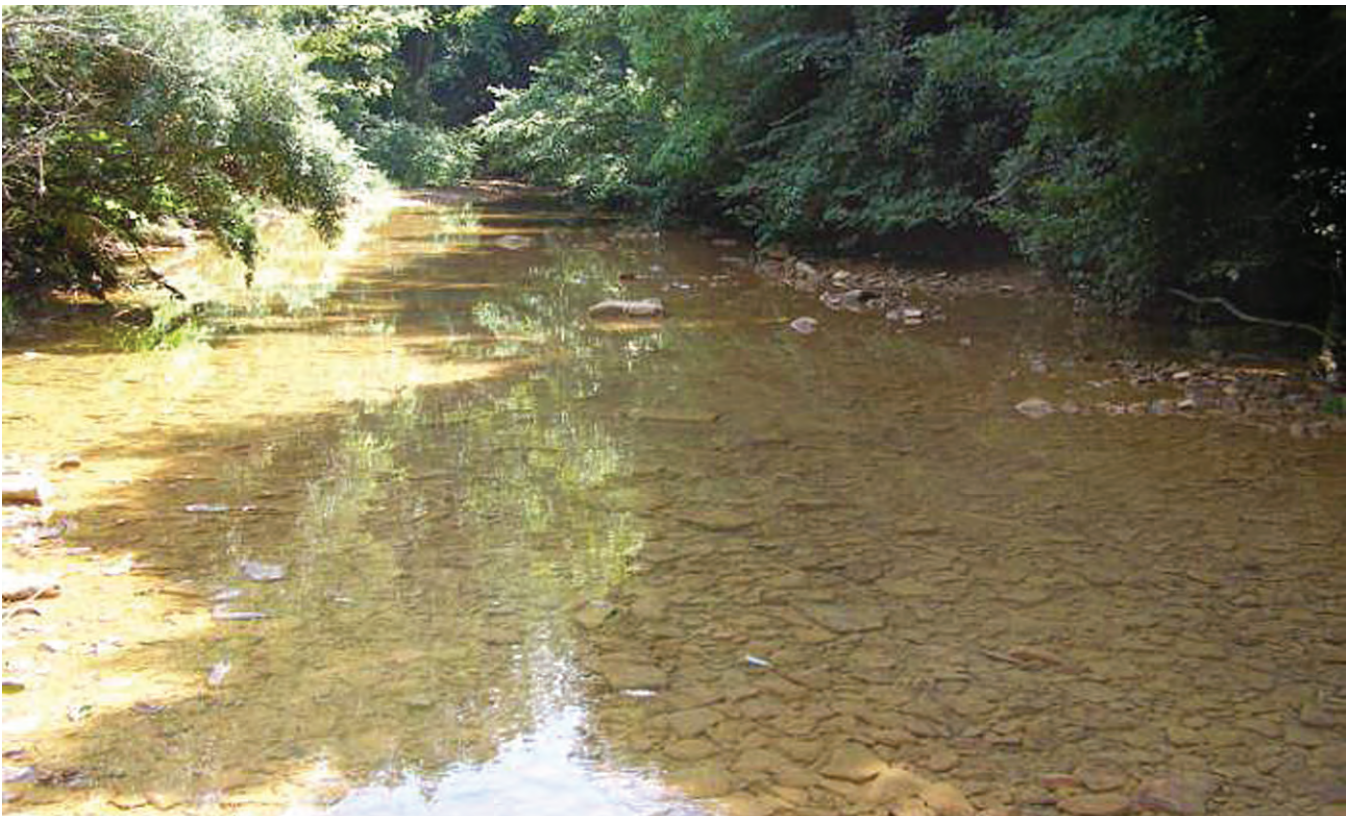
Raccoon Creek after dosing
