**CONSENT ORDER  
ISSUED UNDER THE  
WATER POLLUTION CONTROL ACT  
WEST VIRGINIA CODE CHAPTER 22, ARTICLE 11**

ORDER NO.: 10260

1. Horus West Virginia 1, LLC is conducting land disturbance activity associated with the Blake Solar Project in Jefferson County, West Virginia. Horus West Virginia 1, LLC was issued WV/NPDES Water Pollution Control Permit No. WV0115924, Registration No. WVR111837, on August 12, 2022.
2. On May 15, 2023, West Virginia Department of Environmental Protection (WVDEP) personnel conducted an inspection of the facility. During the inspection, violations of the following sections of the WV/NPDES permit were observed and documented:
  - a. Section II.H.1.d. – Horus West Virginia 1, LLC failed to provide an adequate stone access entrance/exit to reduce the tracking of sediment onto public or private roads.

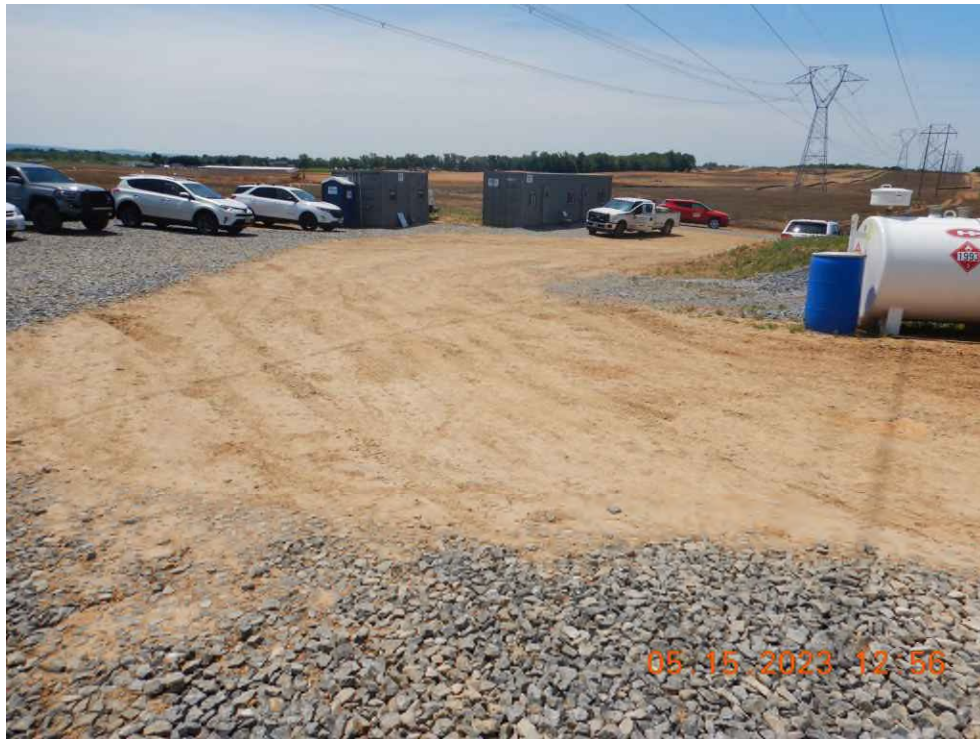
Unstabilized construction entrance.

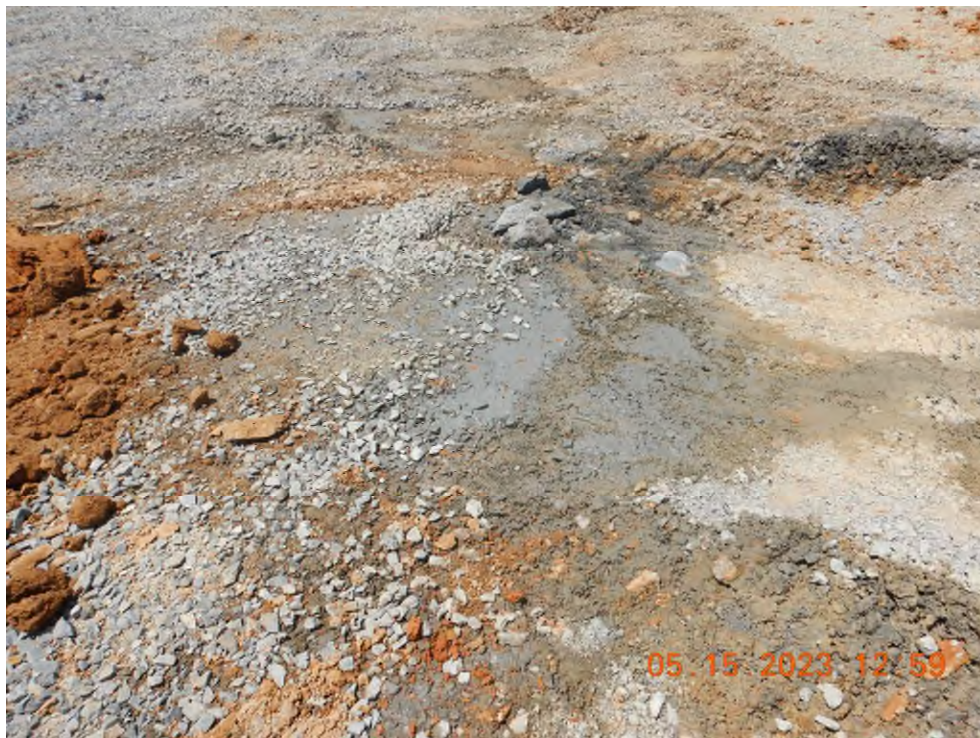
Concrete washout is not being used properly.

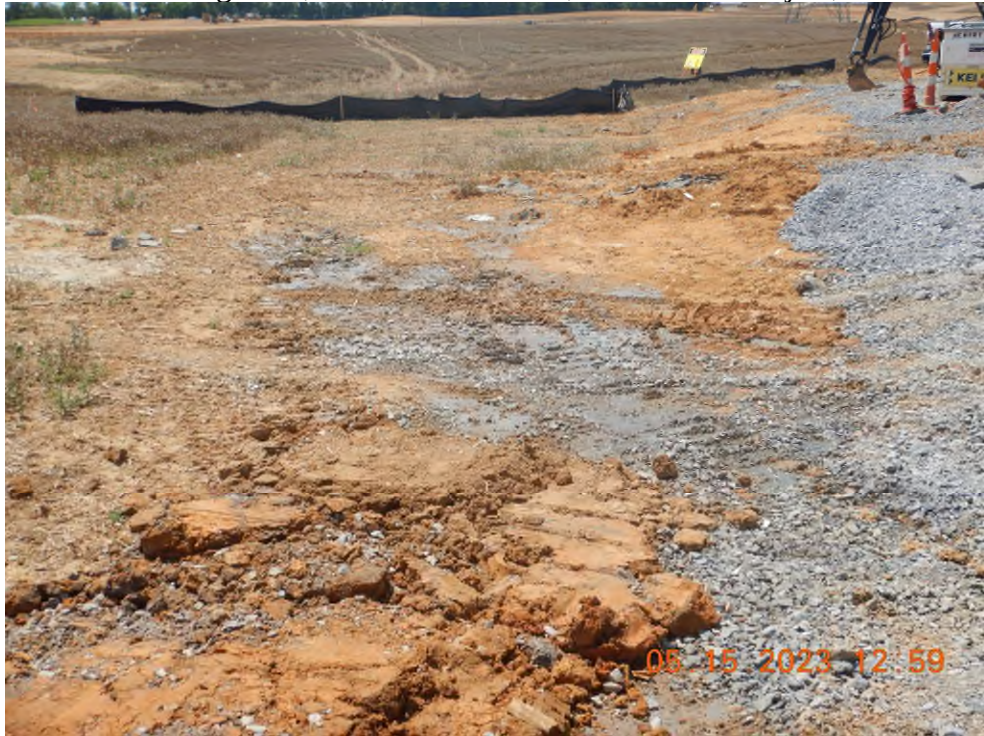
Concrete washout not being used.

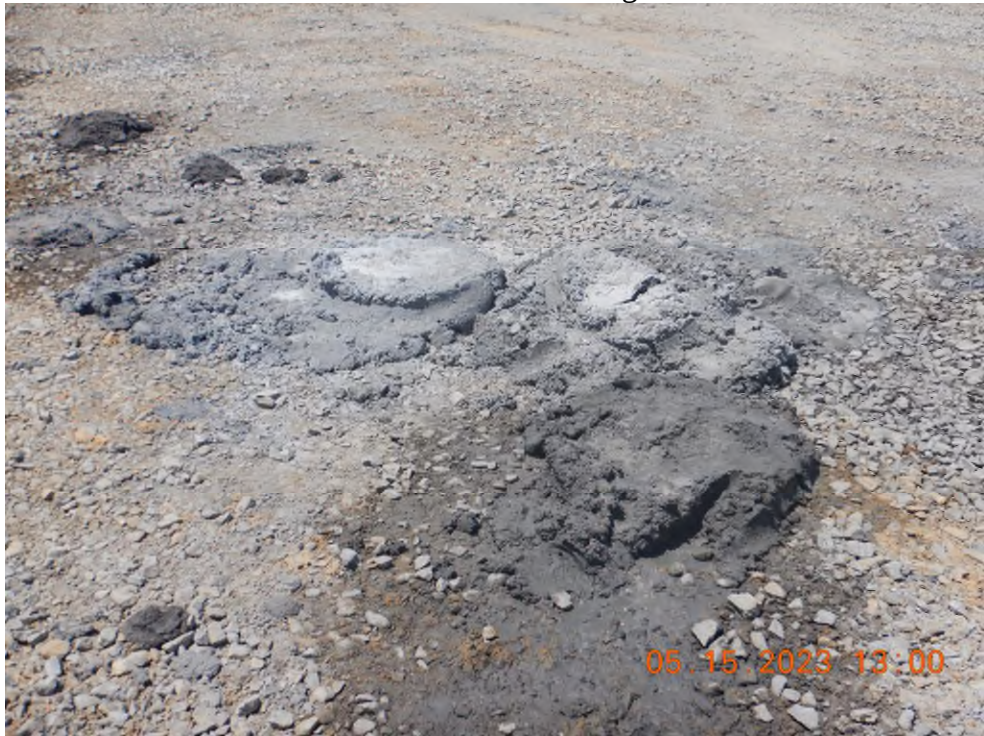
Concrete washout not being used.

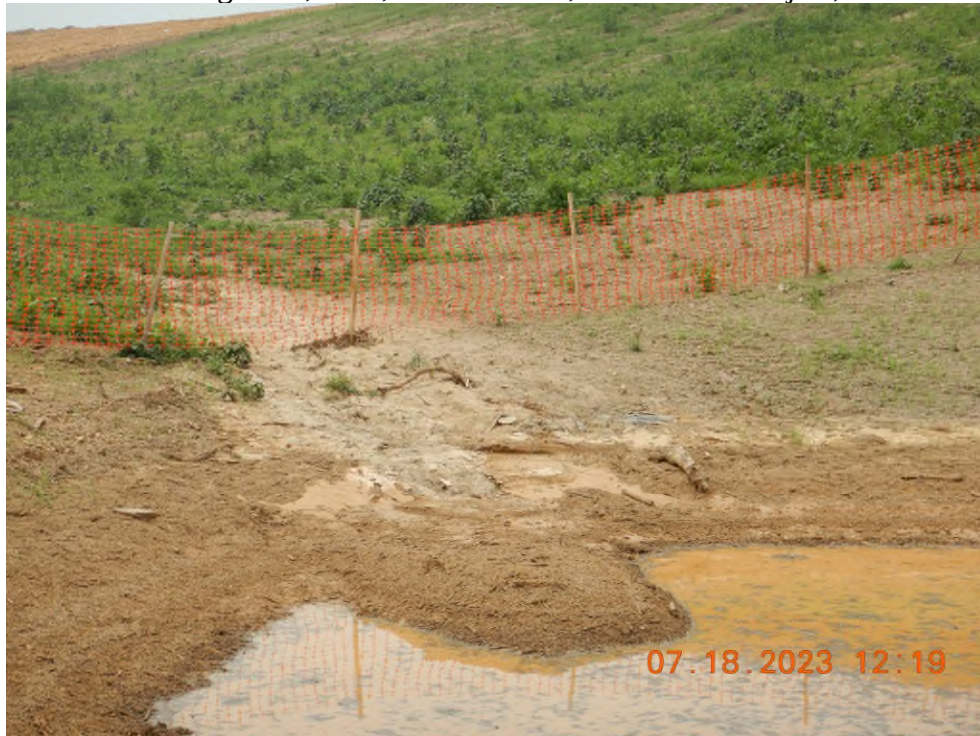
Unstable inlet to Sediment Basin 6.

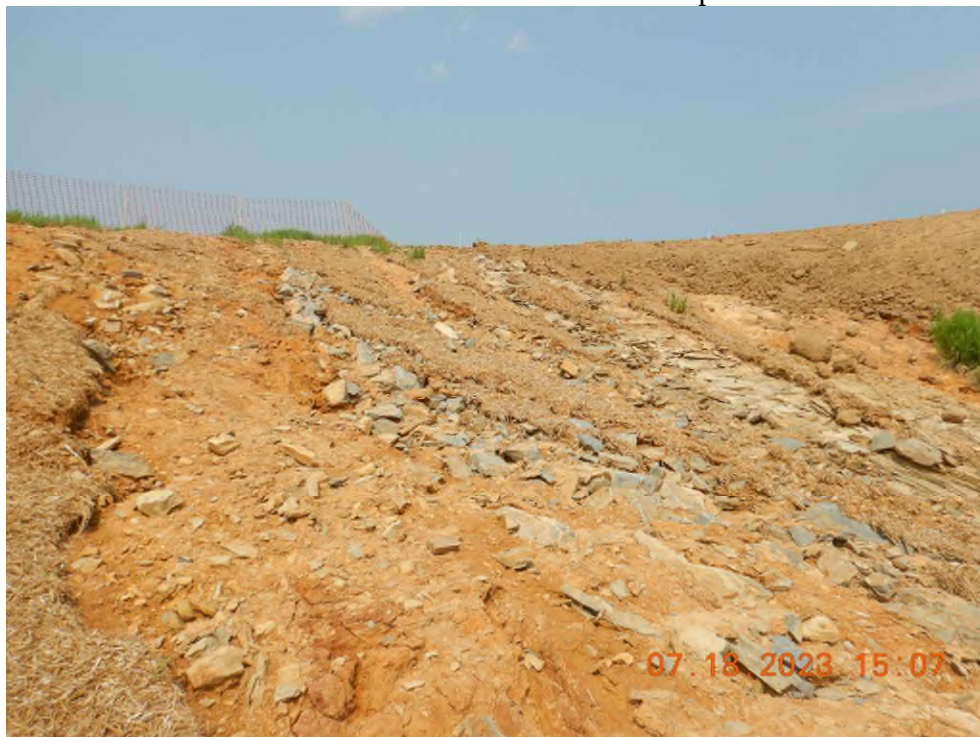
Erosion rills need stabilization.

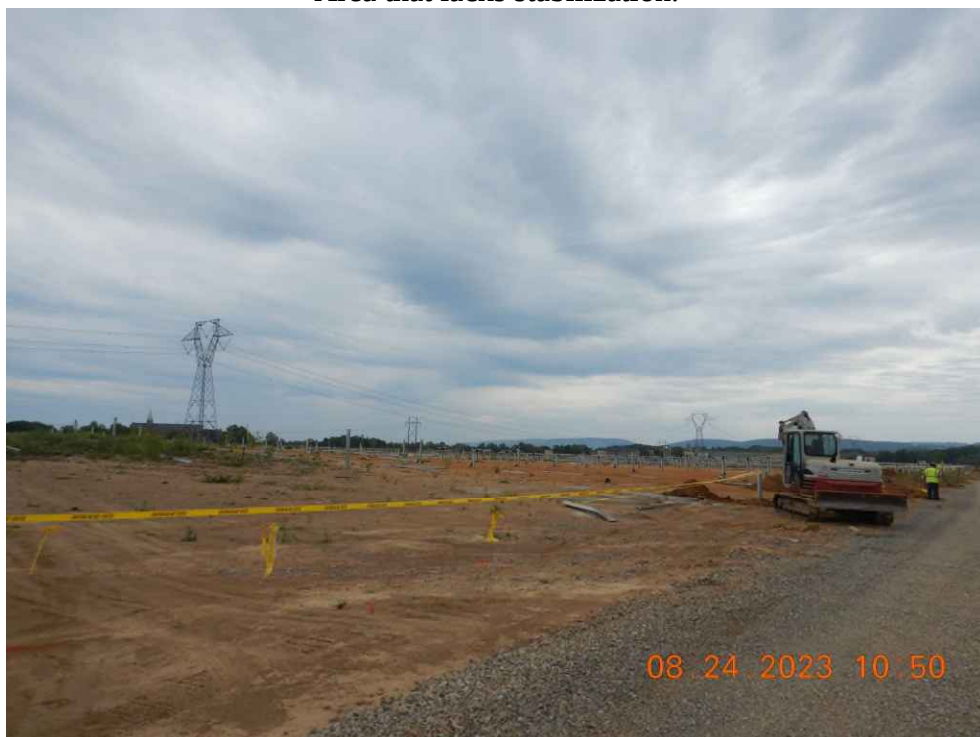
Area that lacks stabilization.

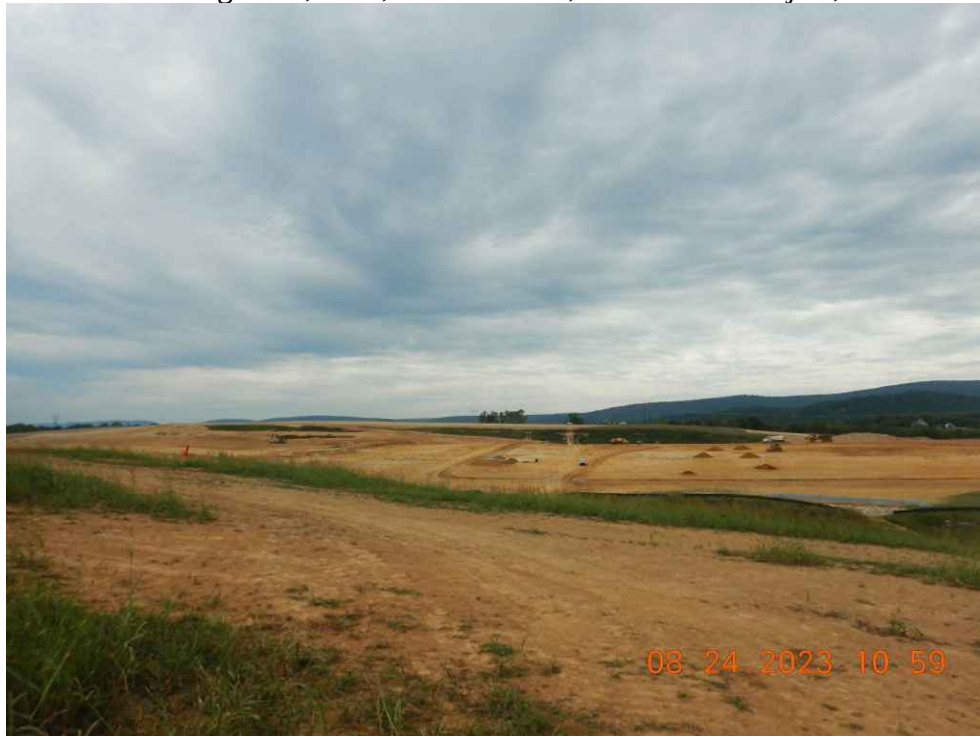
Area that lacks stabilization.

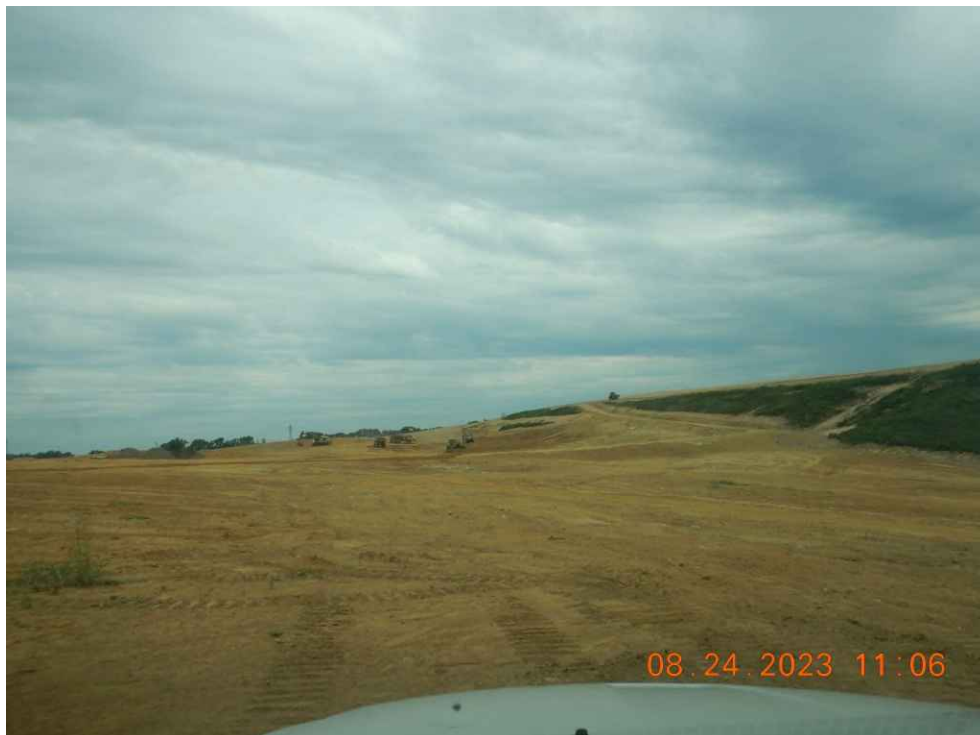
Area that lacks stabilization.

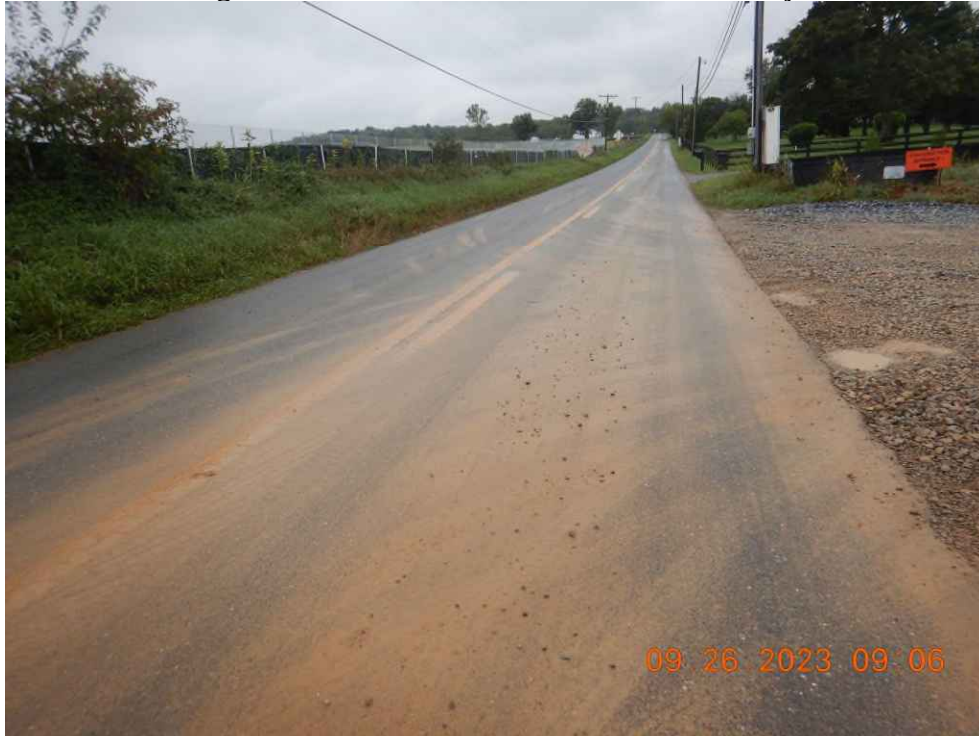
Track-out from the site on Kabletown Road.

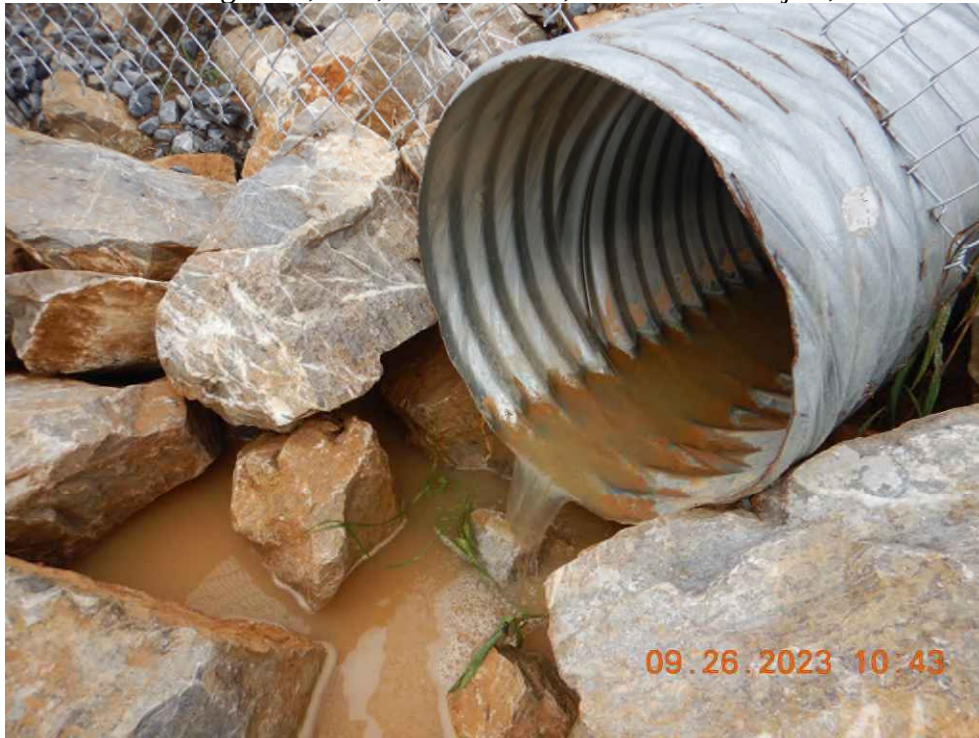
Sediment laden water discharging from Sediment Basin 6.

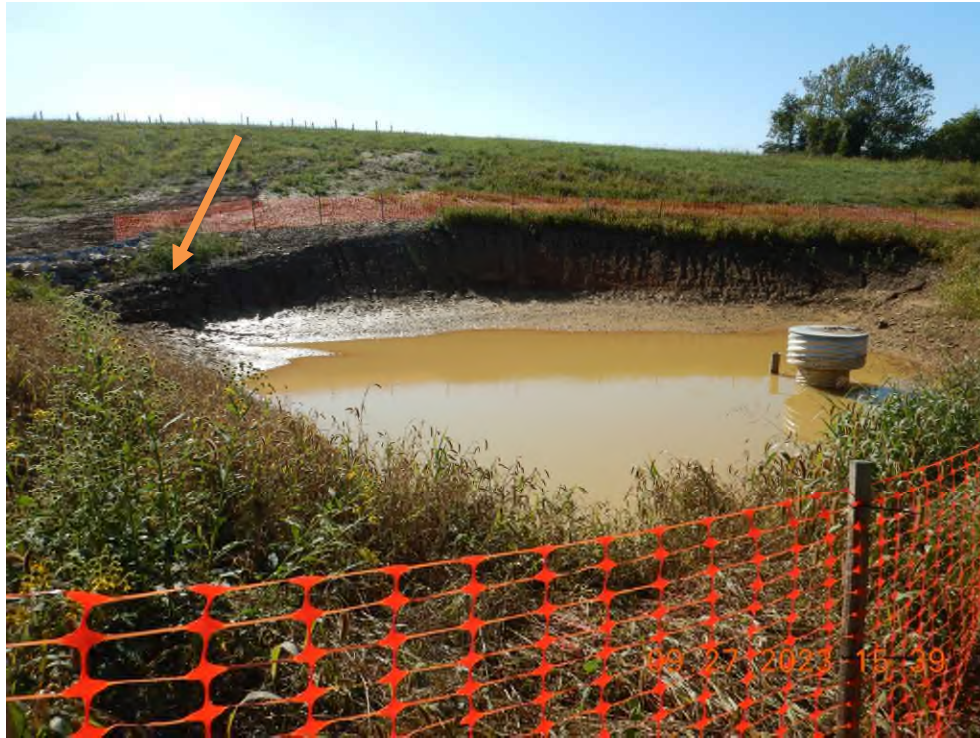
Sediment Pond 6 has unstable inlet.

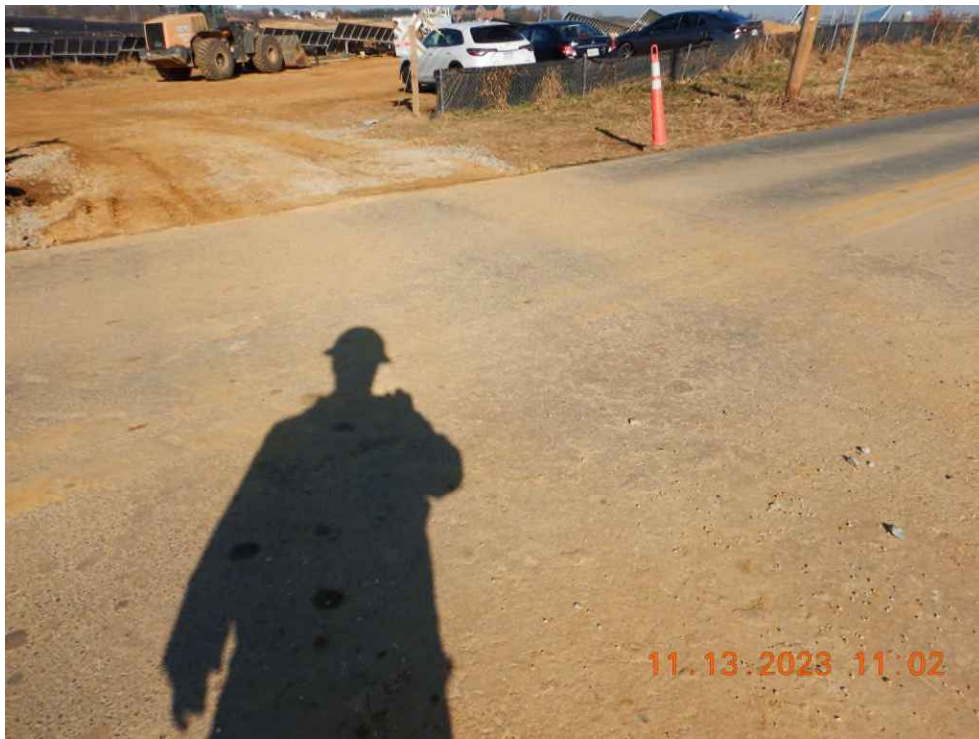
Unstabilized construction entrance.

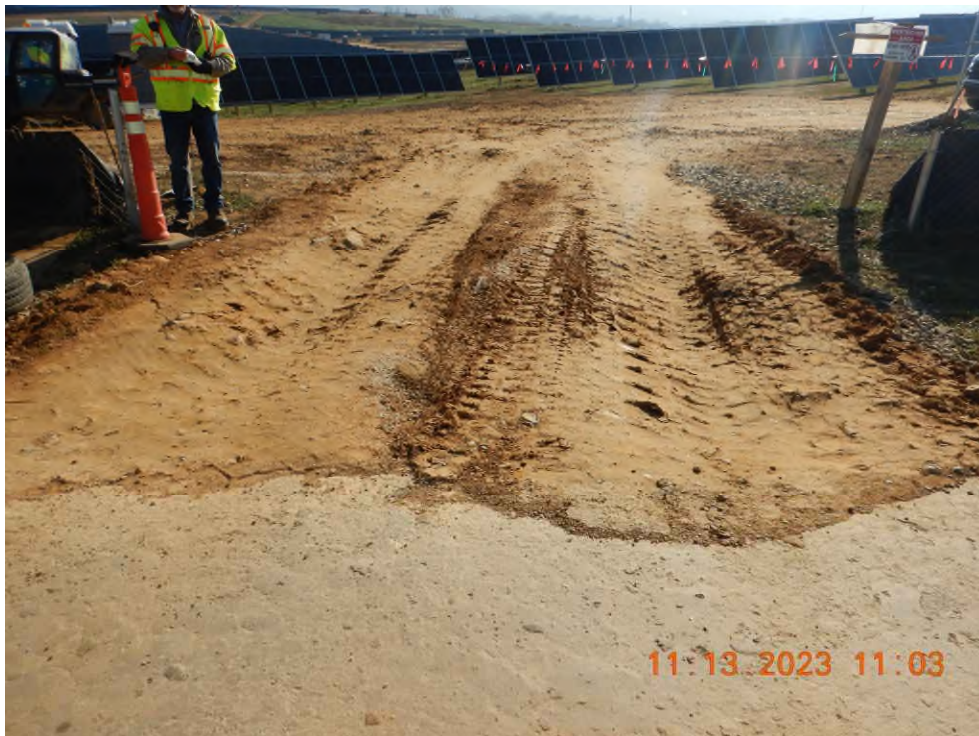
Unstabilized construction entrance.

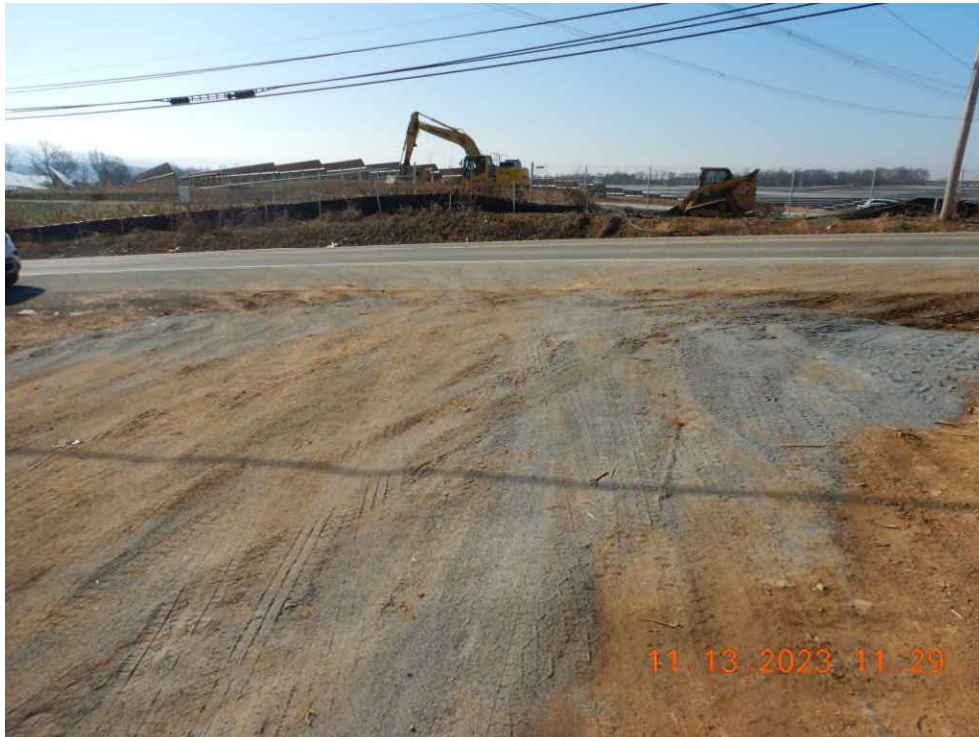
Unstabilized Construction Entrance.

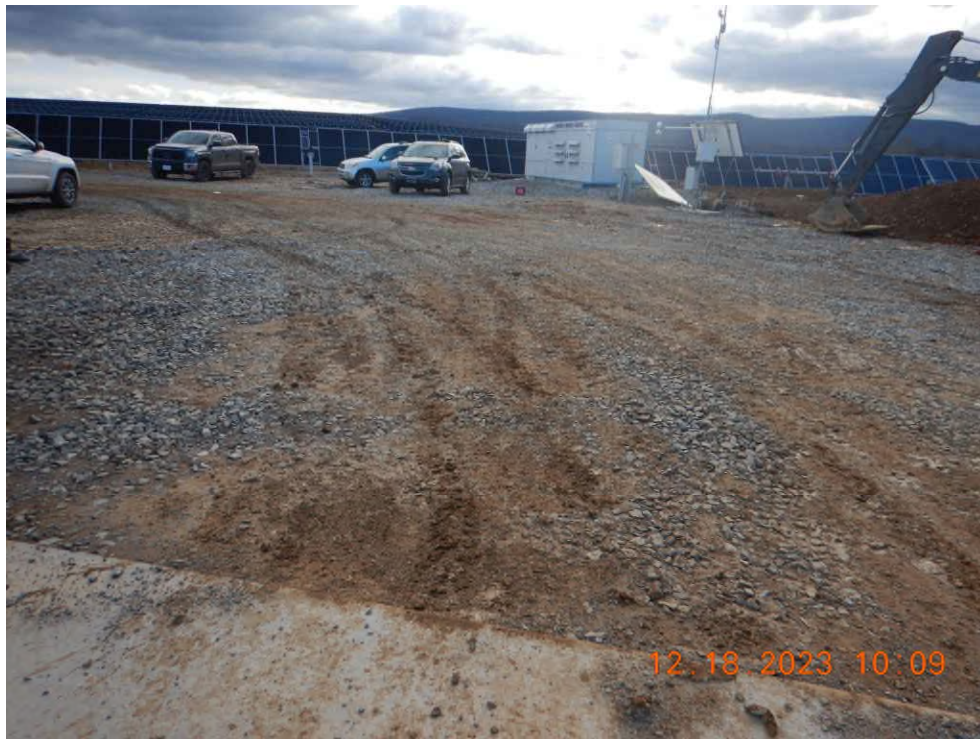
Construction entrance needs stabilized

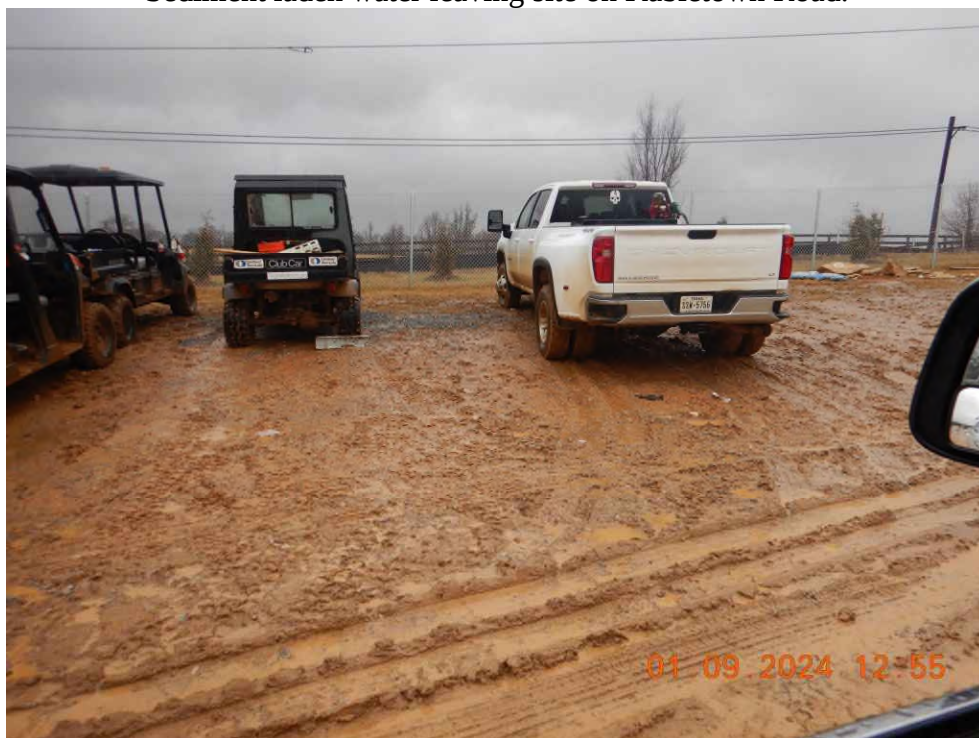
Unstabilized construction entrance by Entrance 2 Kabletown Road

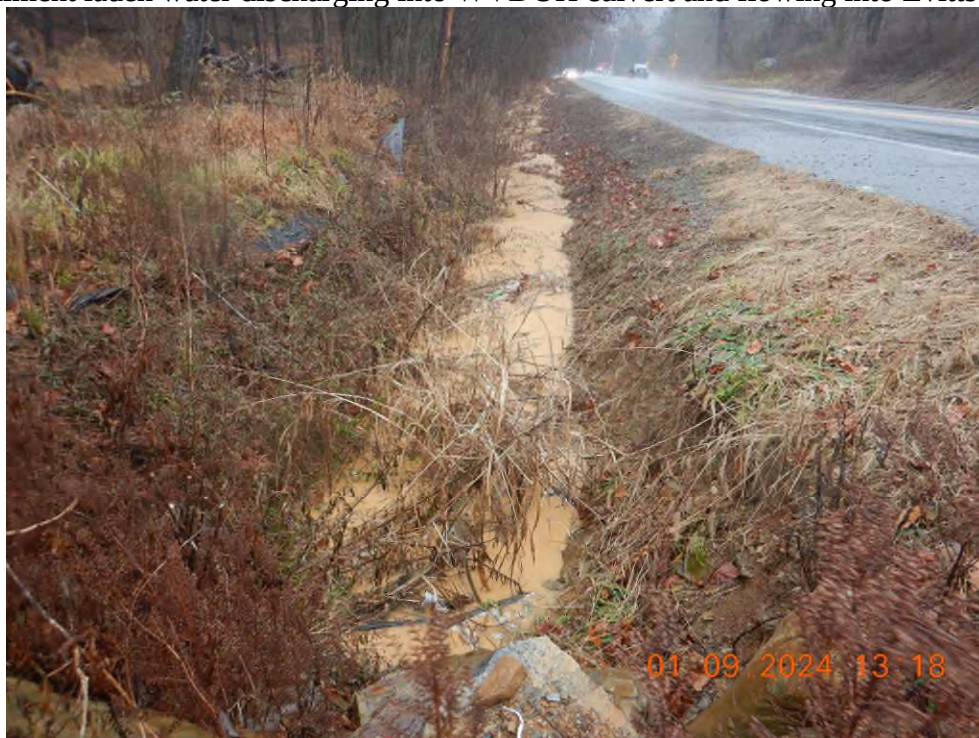
Sediment laden water following WVDOH ditchline into Evitts Run

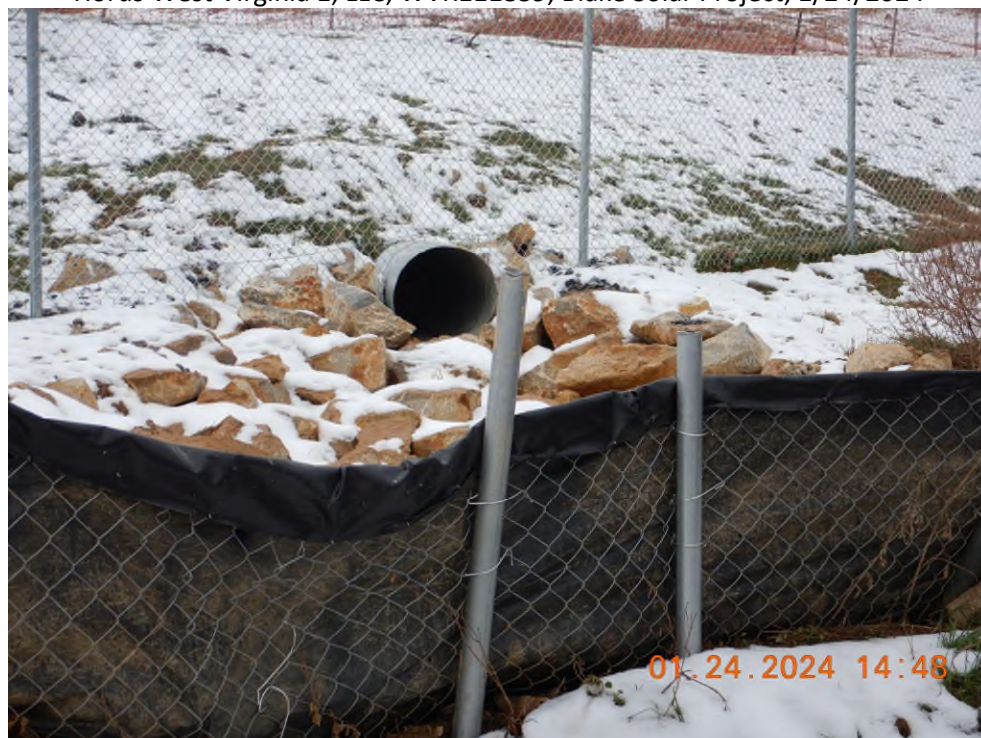
No outlet marker at Pond 6

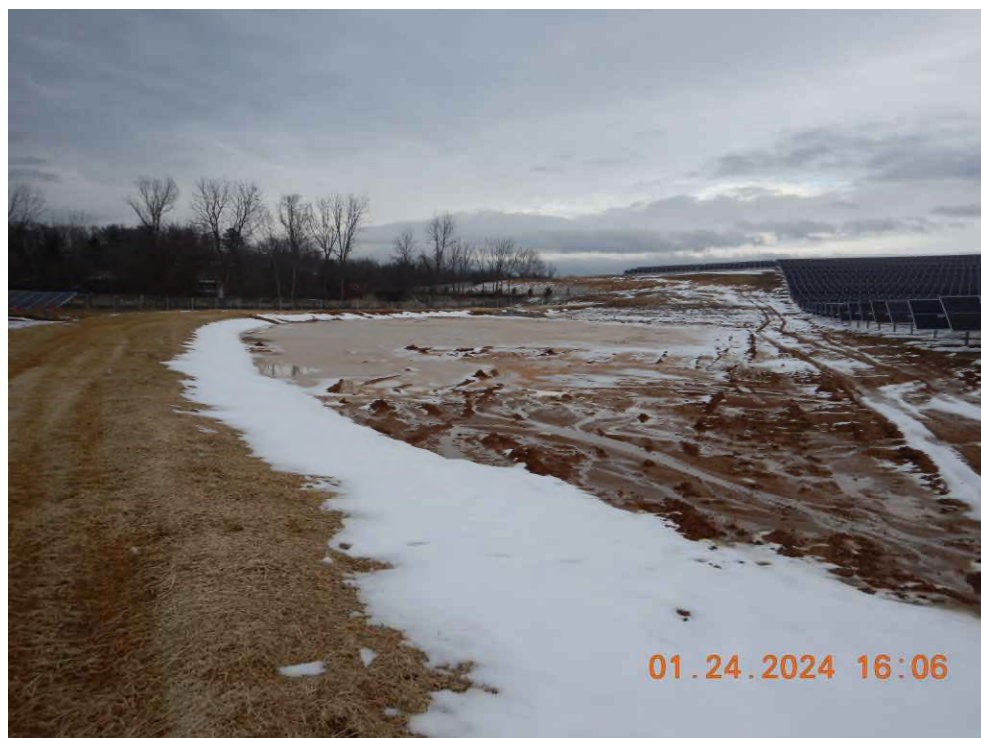
New pond that has been installed to prevent sediment laden water from leaving the site. SWPPP needs to be modified to include pond.

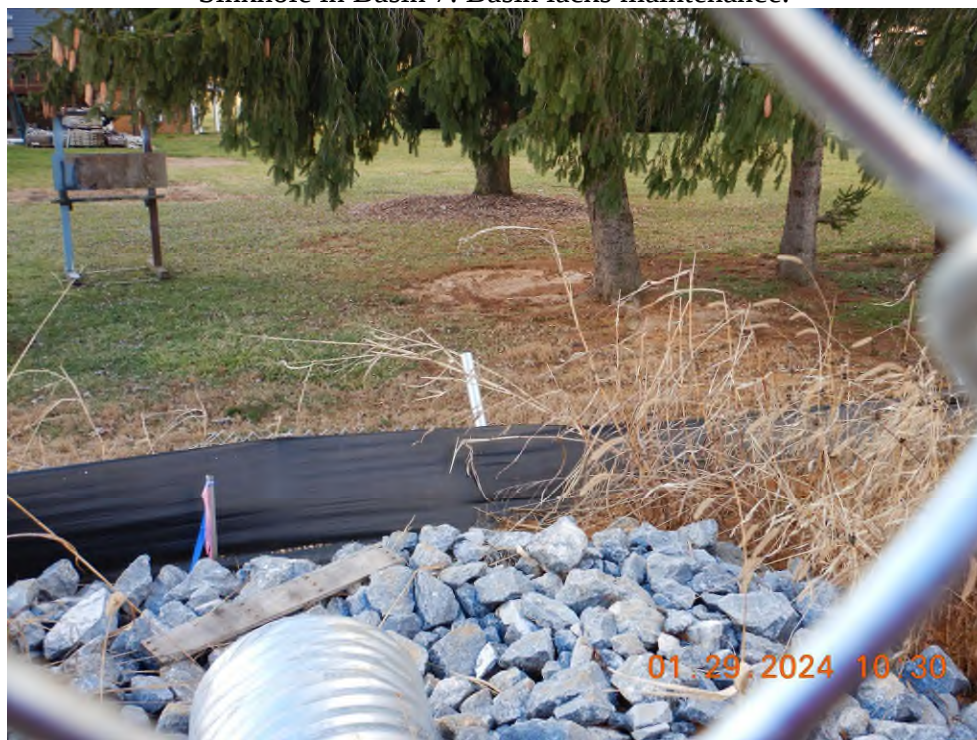
Sinkhole in Basin 7. Basin lacks maintenance.

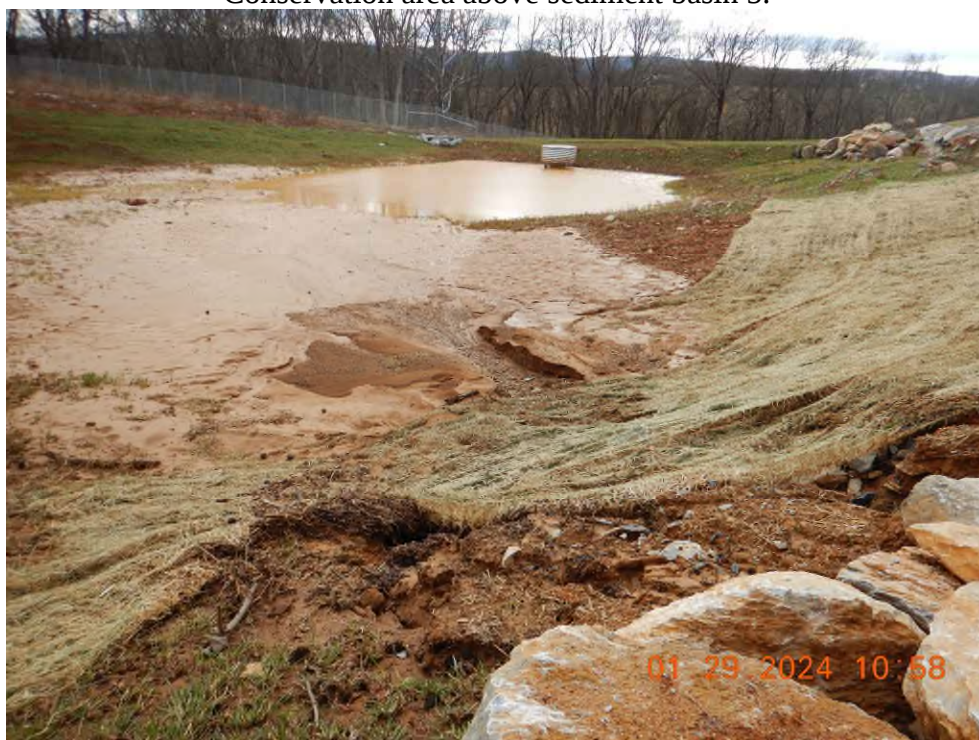
Conservation area above sediment basin 5.

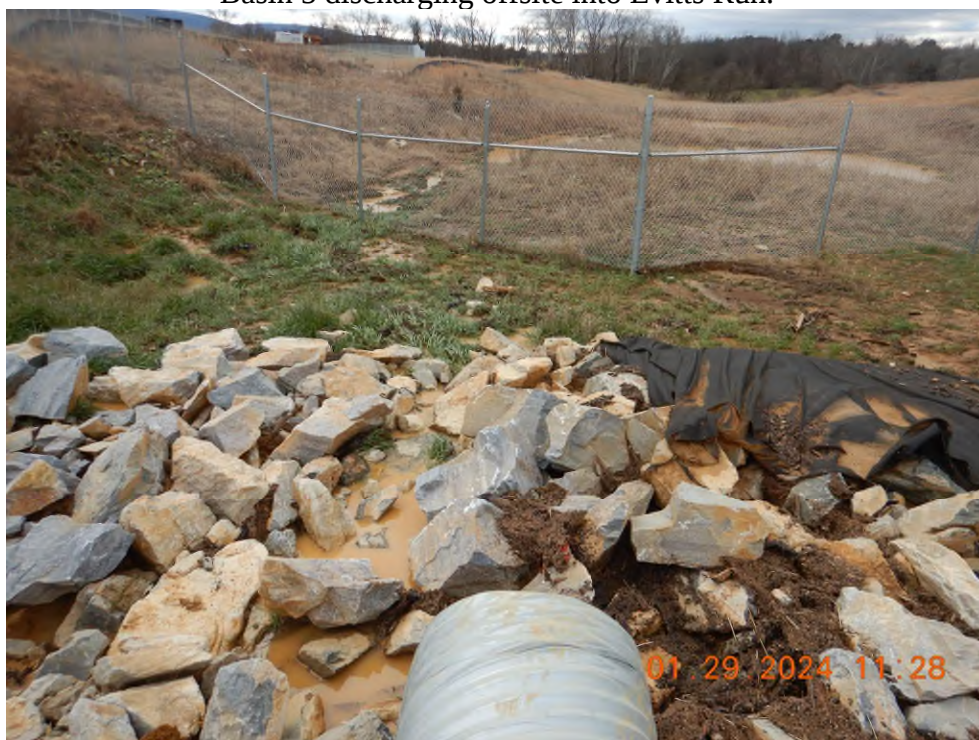
Basin 5 discharging offsite into Evitts Run.

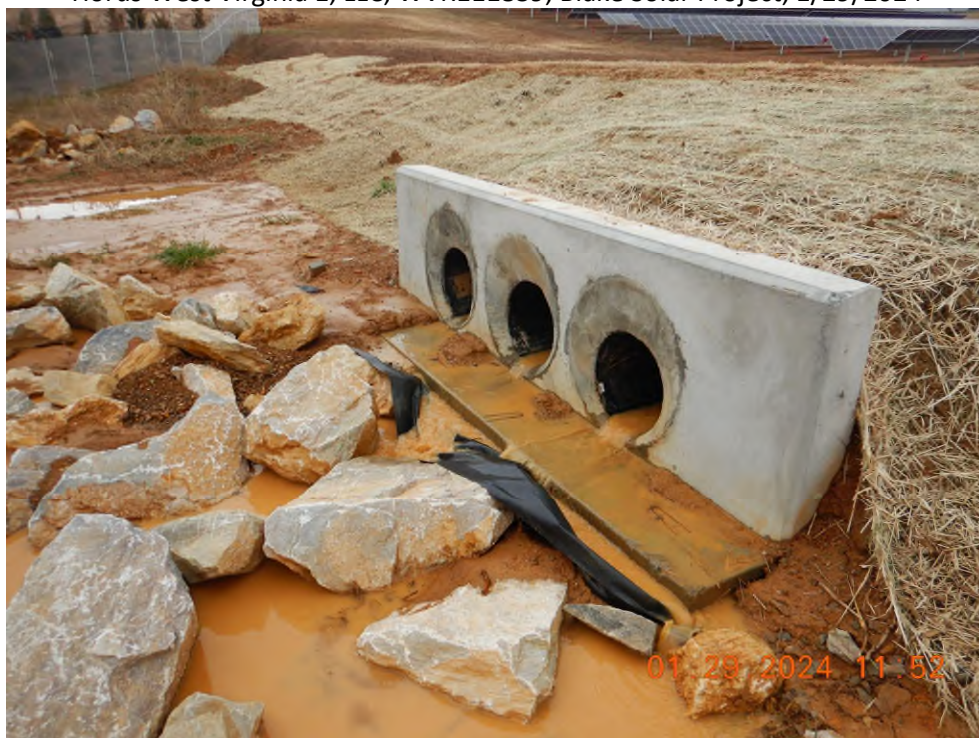
Basin 13 discharging into Evitts Run.

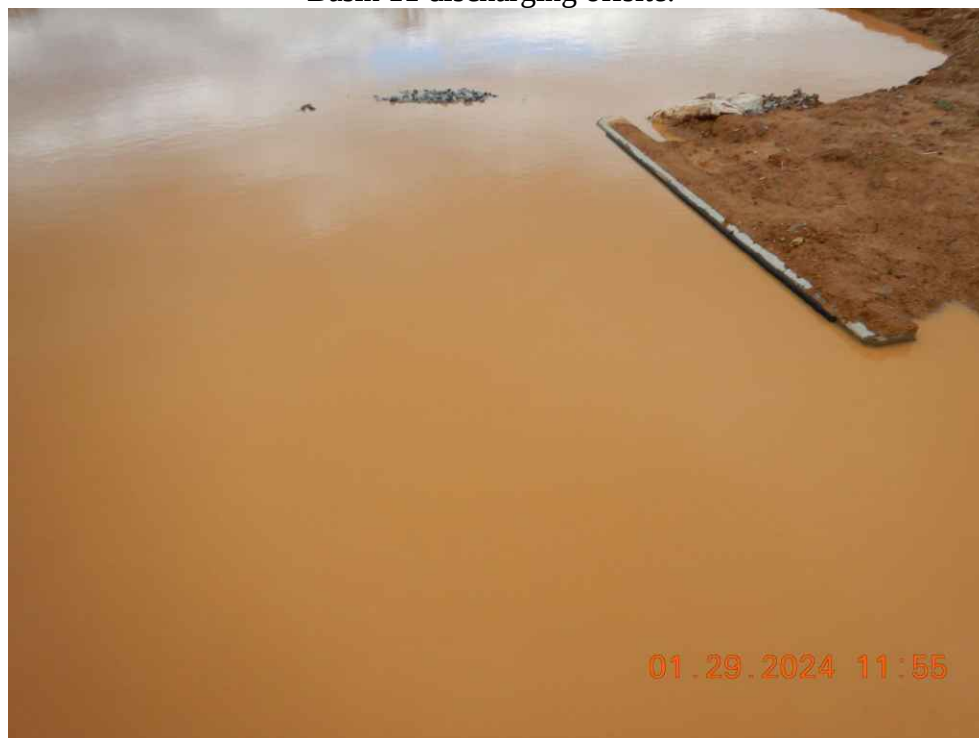
Basin 11 discharging offsite.

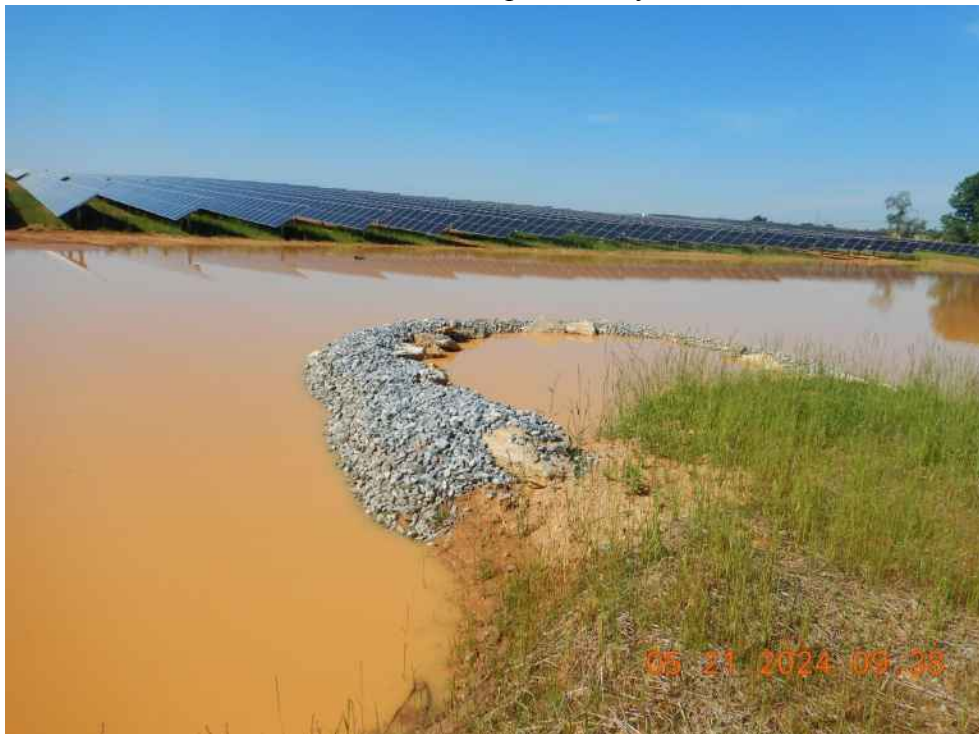
Sediment Basin 11 discharging offsite.

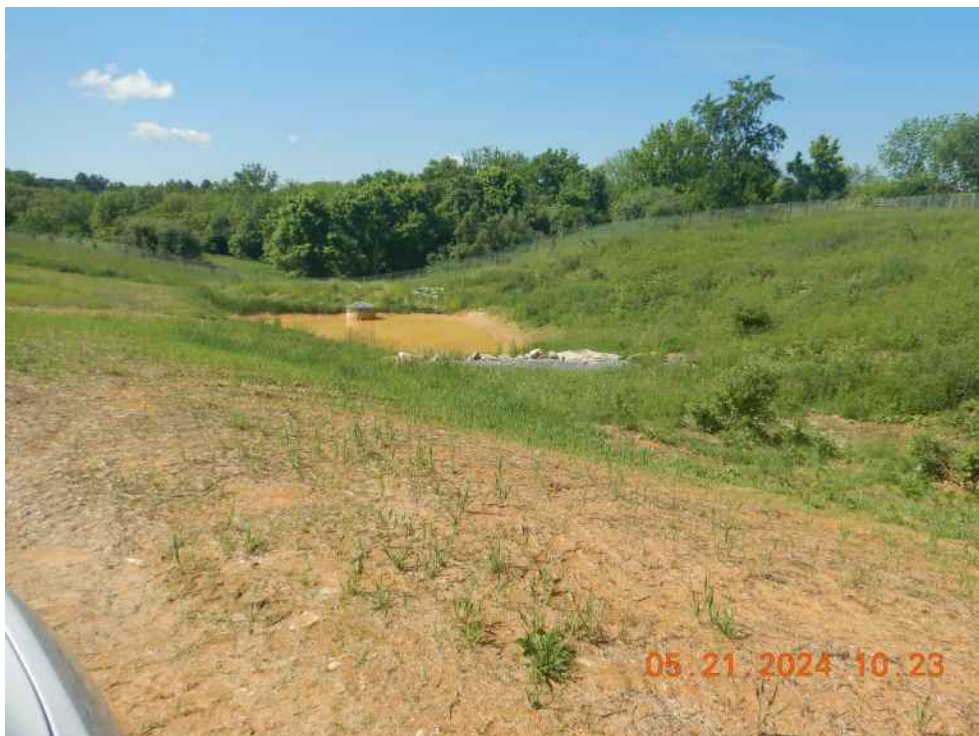
Unstabilized area above Sediment Basin 14.

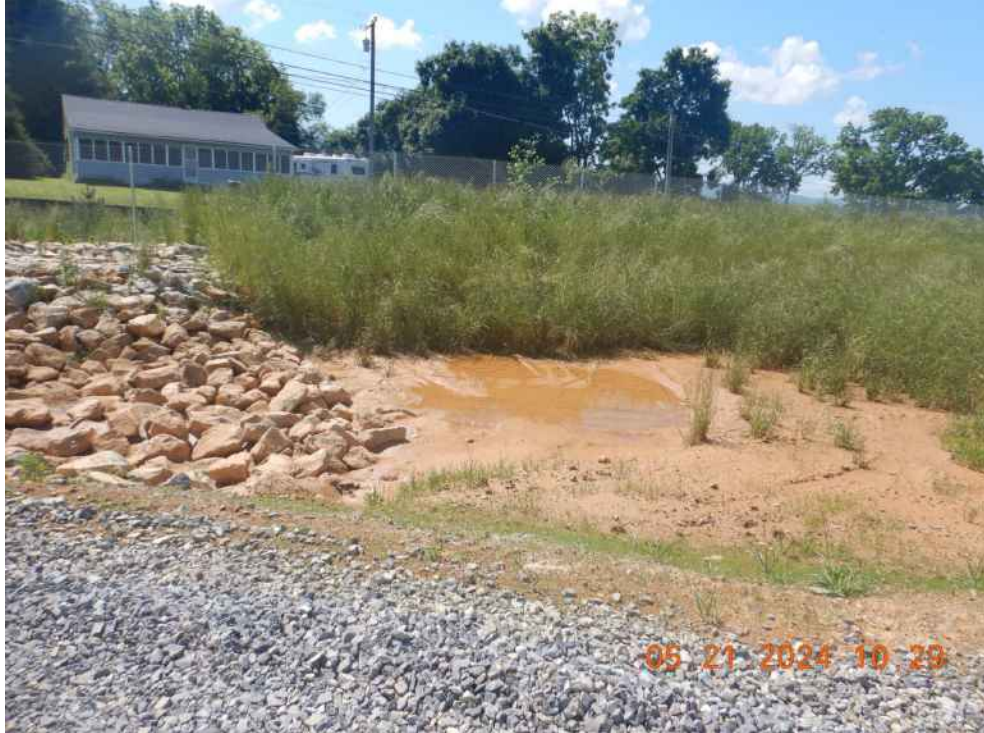
Unstabilized area above Pond 14A.

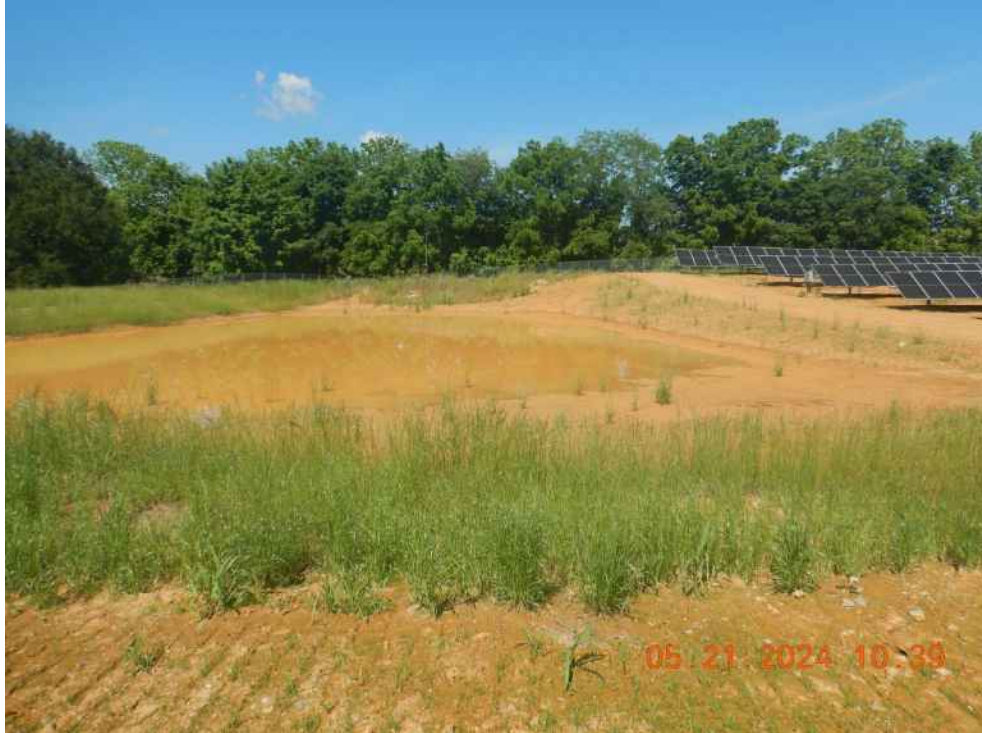
Unstabilized area above Sediment Basin 8.

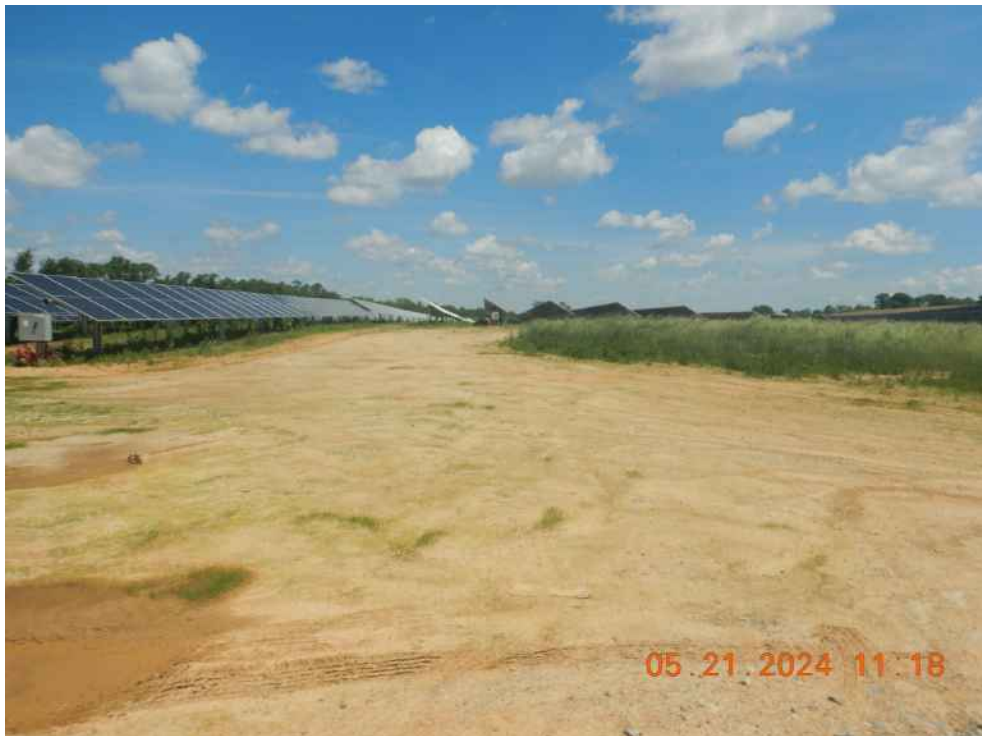
Unstabilized area above Sediment Basin 10.

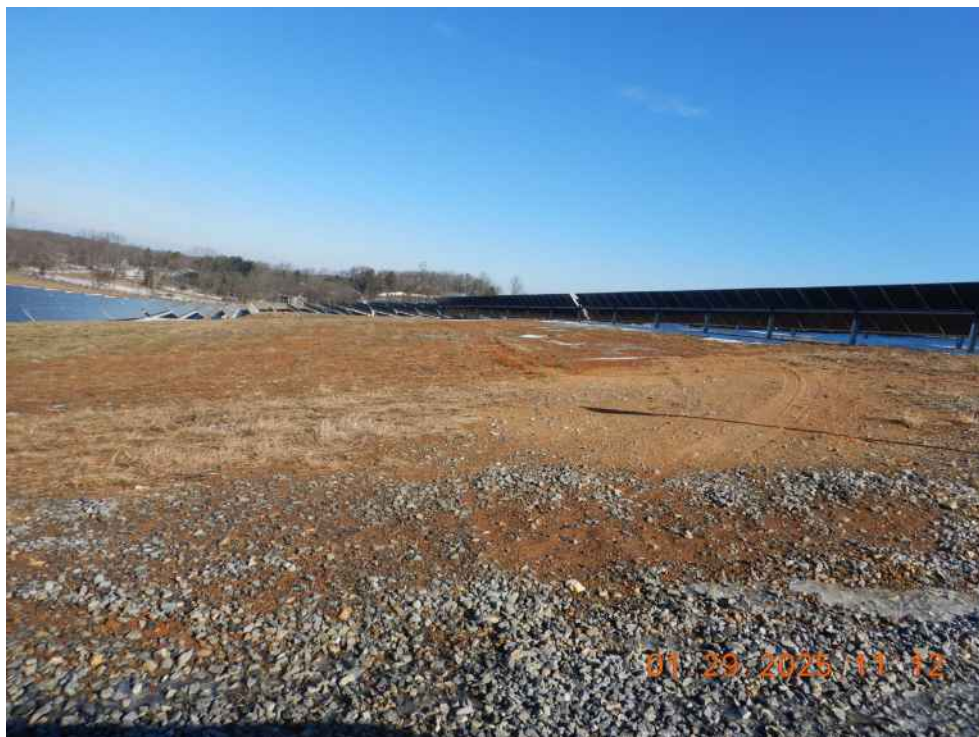
An unstabilized area of the project.
