**CONSENT ORDER  
ISSUED UNDER THE  
WATER POLLUTION CONTROL ACT  
WEST VIRGINIA CODE CHAPTER 22, ARTICLE 11**

ORDER NO.: 10260

1. Horus West Virginia 1, LLC is conducting land disturbance activity associated with the Blake Solar Project in Jefferson County, West Virginia. Horus West Virginia 1, LLC was issued WV/NPDES Water Pollution Control Permit No. WV0115924, Registration No. WVR111837, on August 12, 2022.
2. On May 15, 2023, West Virginia Department of Environmental Protection (WVDEP) personnel conducted an inspection of the facility. During the inspection, violations of the following sections of the WV/NPDES permit were observed and documented:
  - a. Section II.H.1.d. – Horus West Virginia 1, LLC failed to provide an adequate stone access entrance/exit to reduce the tracking of sediment onto public or private roads.

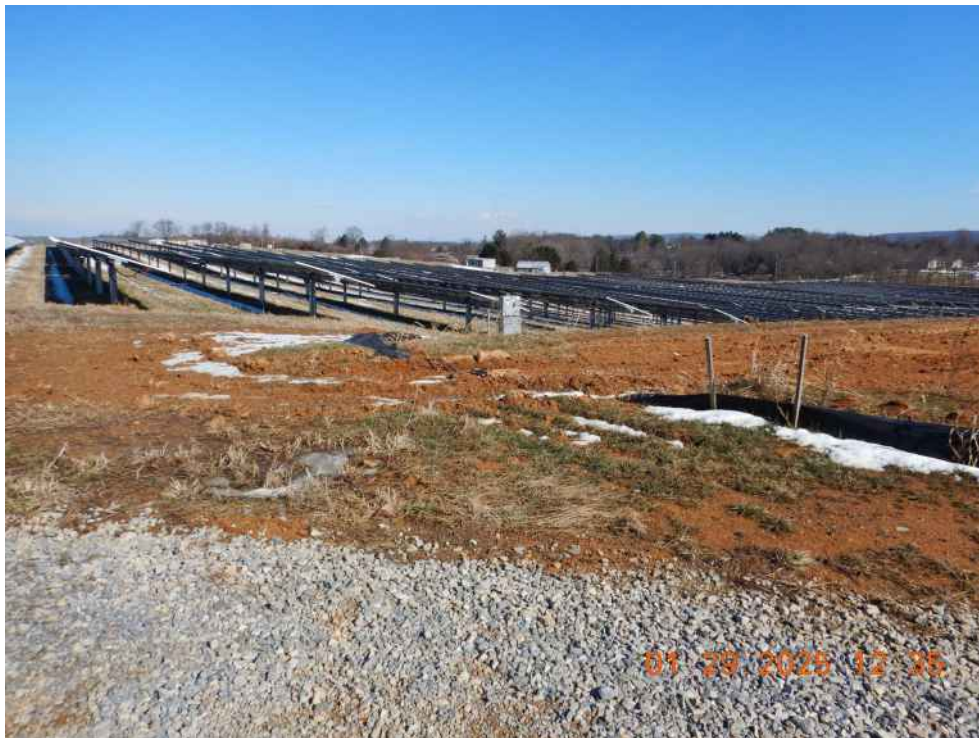
An unstabilized area of the project.
