**CONSENT ORDER  
ISSUED UNDER THE  
WATER POLLUTION CONTROL ACT  
WEST VIRGINIA CODE CHAPTER 22, ARTICLE 11**

ORDER NO.: 10260

1. Horus West Virginia 1, LLC is conducting land disturbance activity associated with the Blake Solar Project in Jefferson County, West Virginia. Horus West Virginia 1, LLC was issued WV/NPDES Water Pollution Control Permit No. WV0115924, Registration No. WVR111837, on August 12, 2022.
2. On May 15, 2023, West Virginia Department of Environmental Protection (WVDEP) personnel conducted an inspection of the facility. During the inspection, violations of the following sections of the WV/NPDES permit were observed and documented:
  - a. Section II.H.1.d. – Horus West Virginia 1, LLC failed to provide an adequate stone access entrance/exit to reduce the tracking of sediment onto public or private roads.

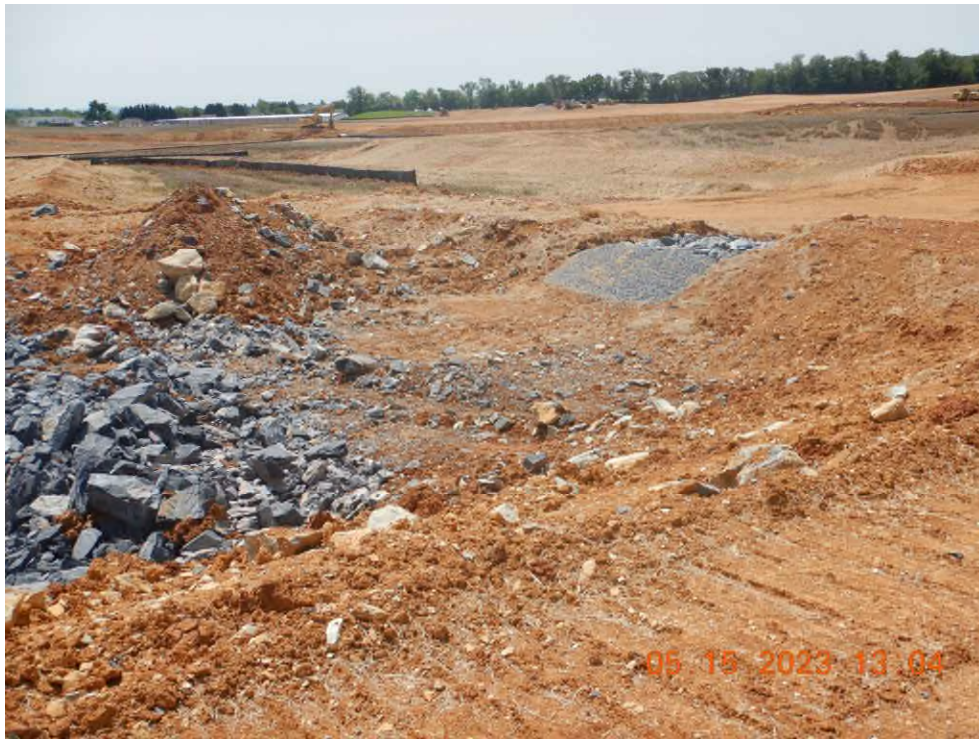
Sediment Trap 11 has no inlet, outlet marker, or Super Silt fence.

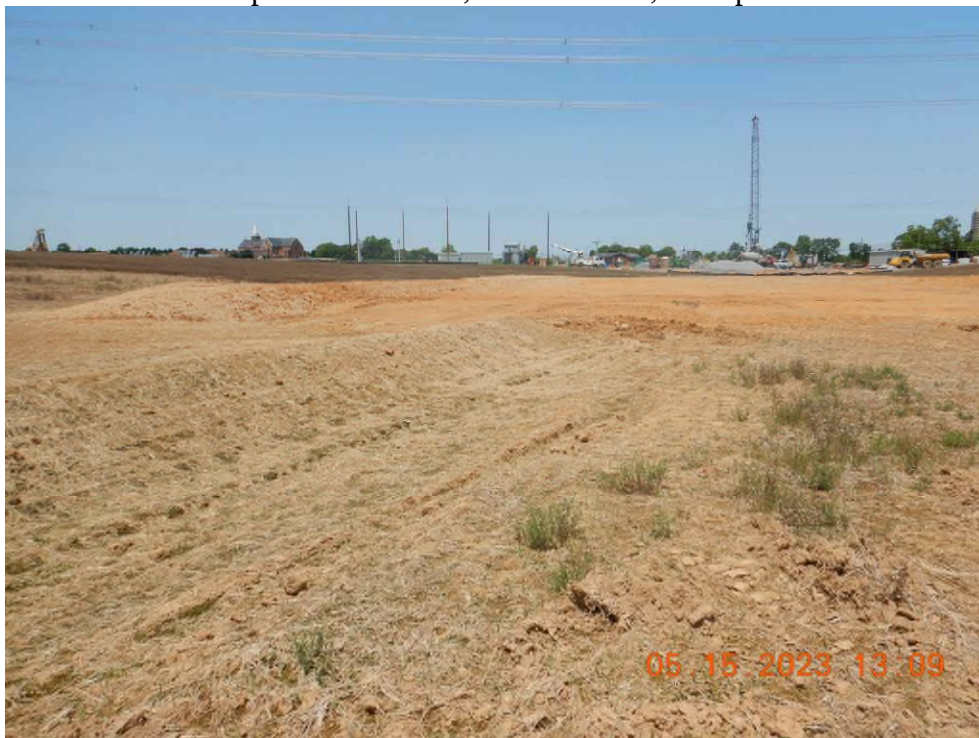
Clean water diversion is not vegetated prior to being put into use.

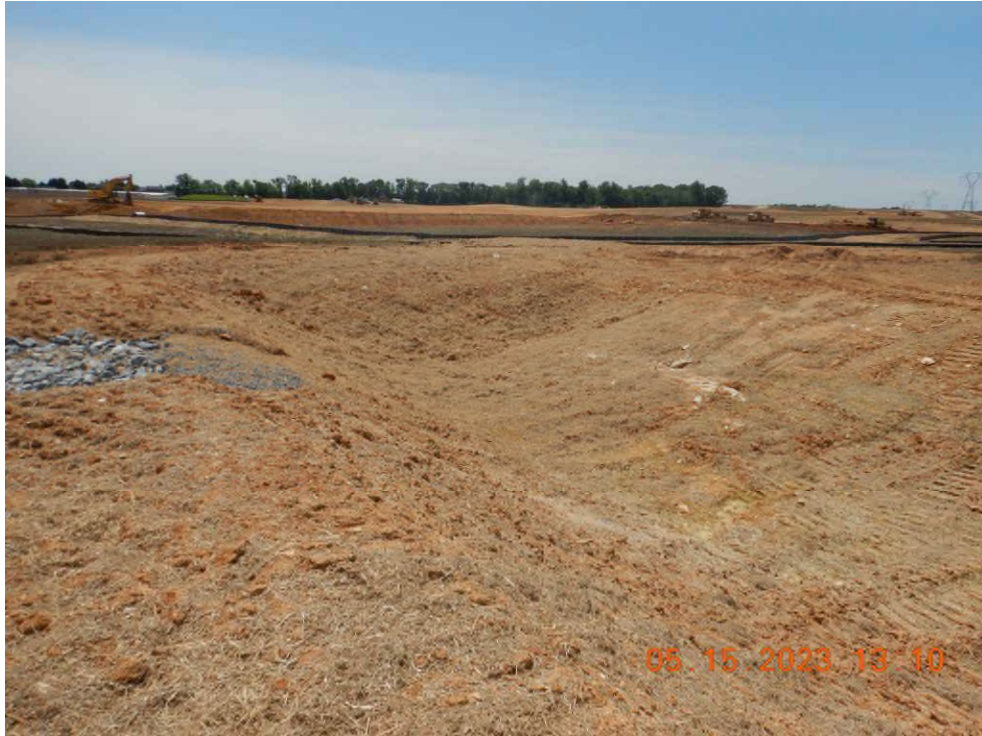
Sediment Trap 14 does not have a stabilized inlet.

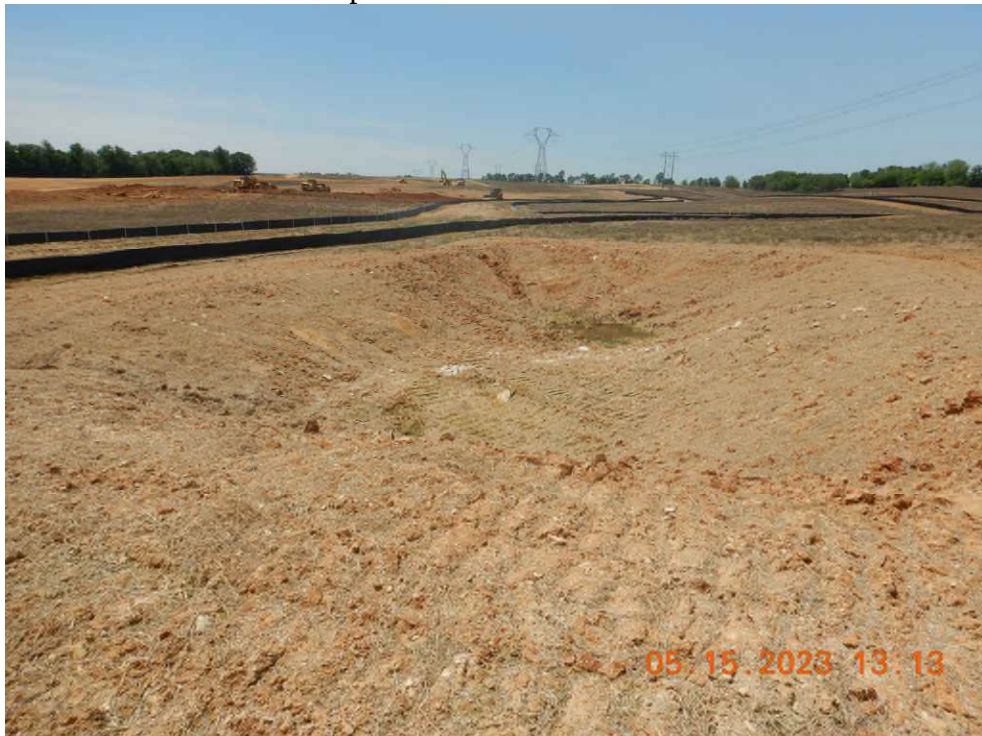
Sediment Trap 16 has no stabilized inlet or outlet.

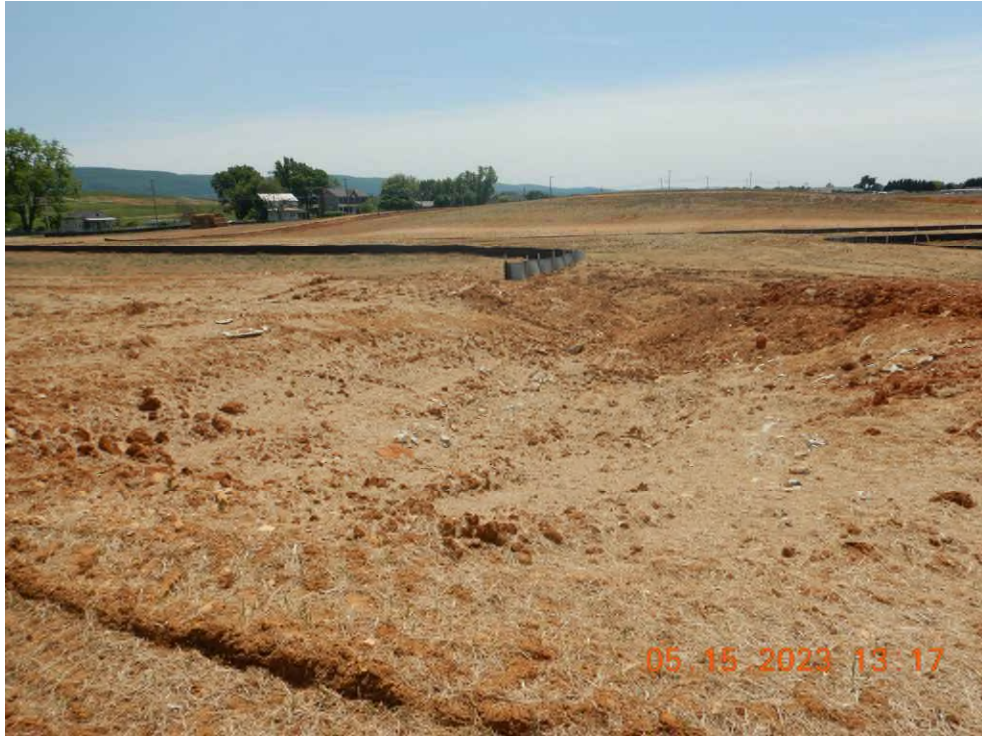
Sediment Trap 10 has no stabilized Inlet or Outlet.

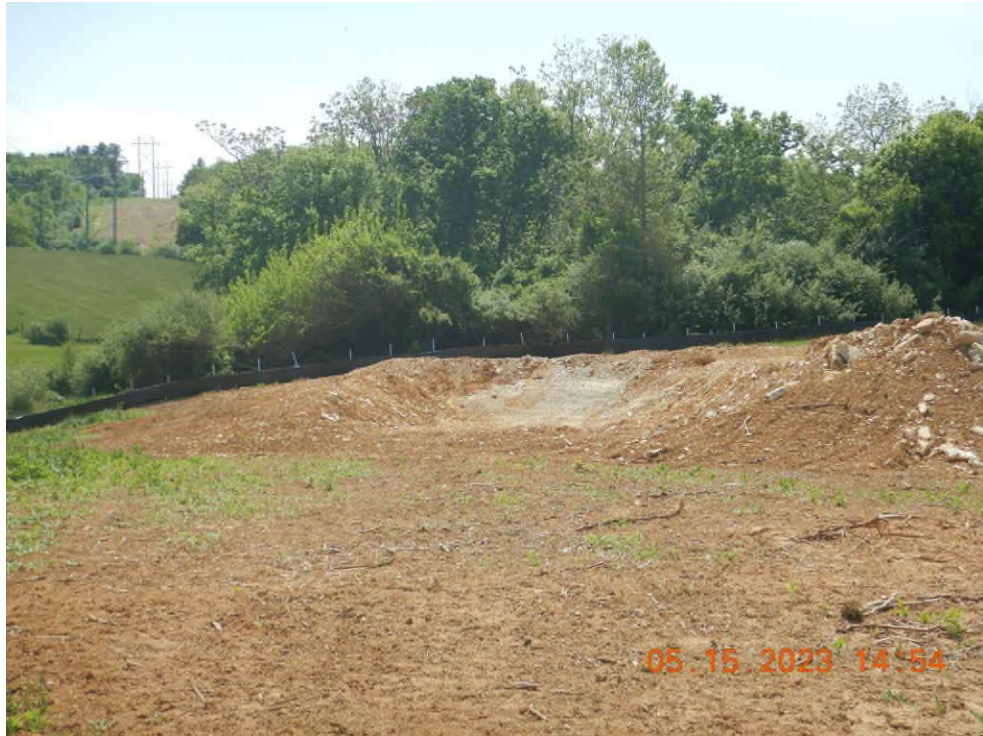
Sediment Trap 6 not finished. No stabilized Inlet or Outlet.

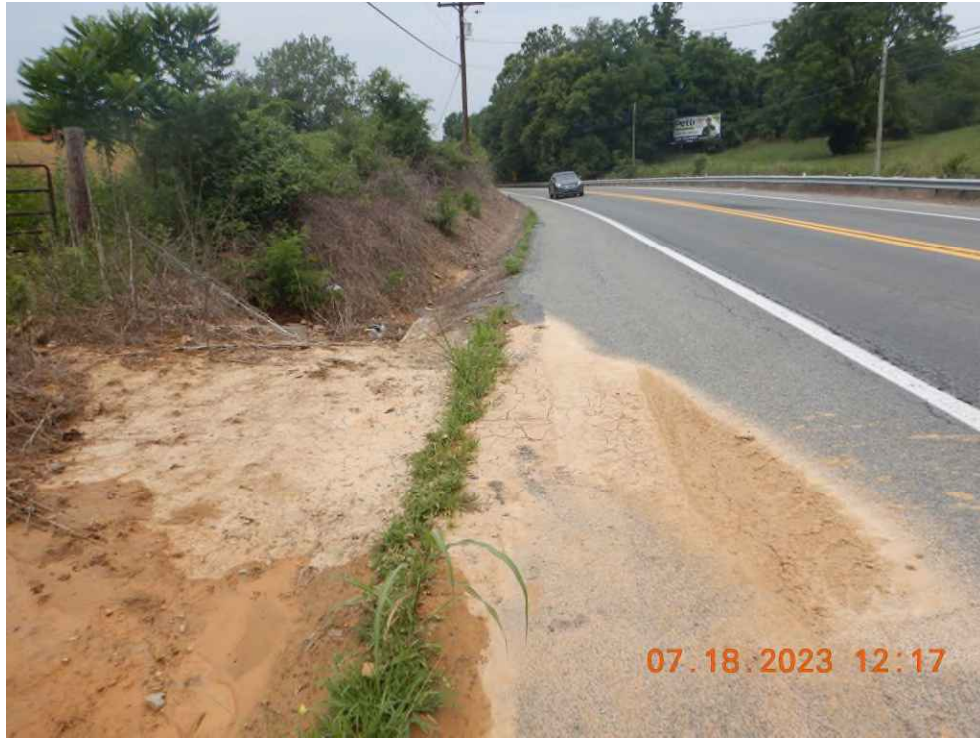
Outlet drainage area of Sediment Basin 6, discharging into WVDOH right of way

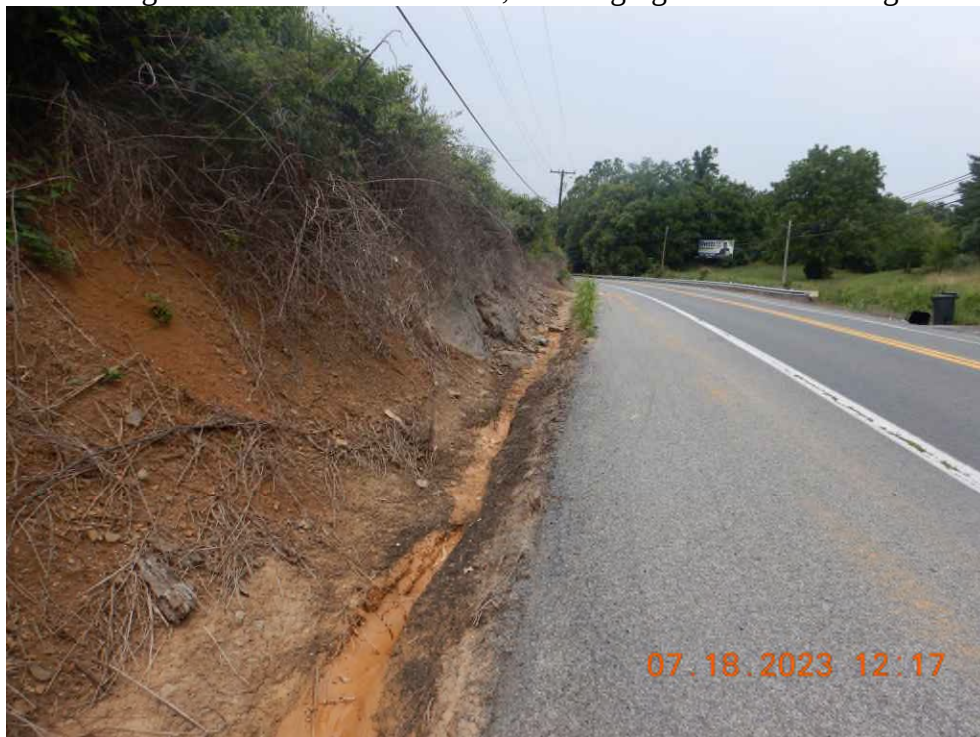
Sediment laden water leaving the project area through WVDOH right of way.

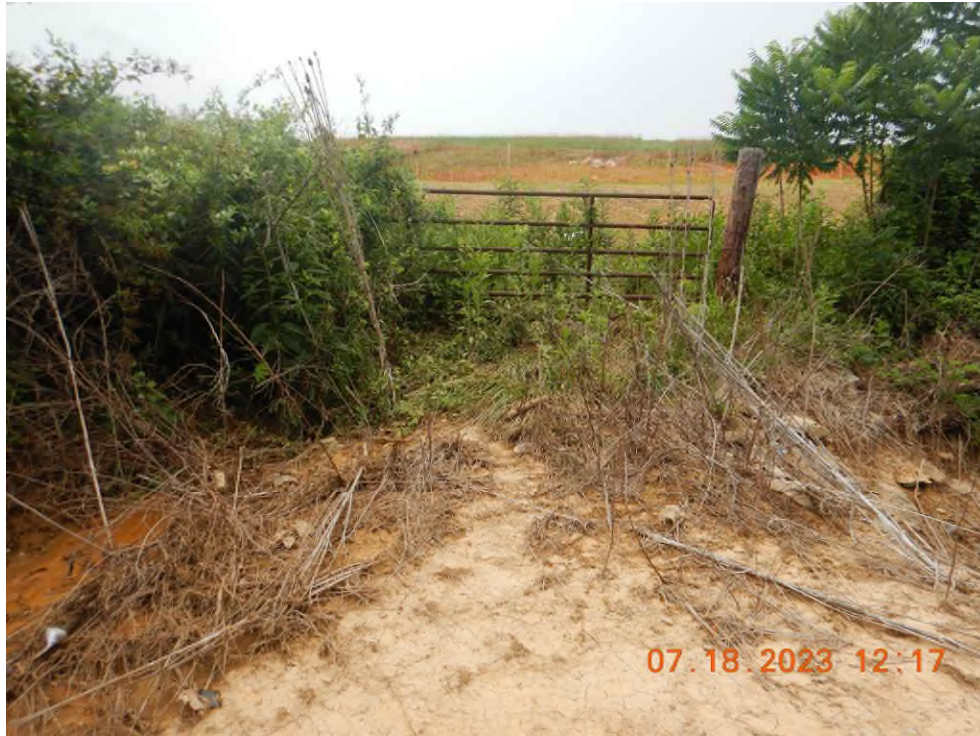
Sediment laden water leaving area through outlet of Sediment Basin 6.

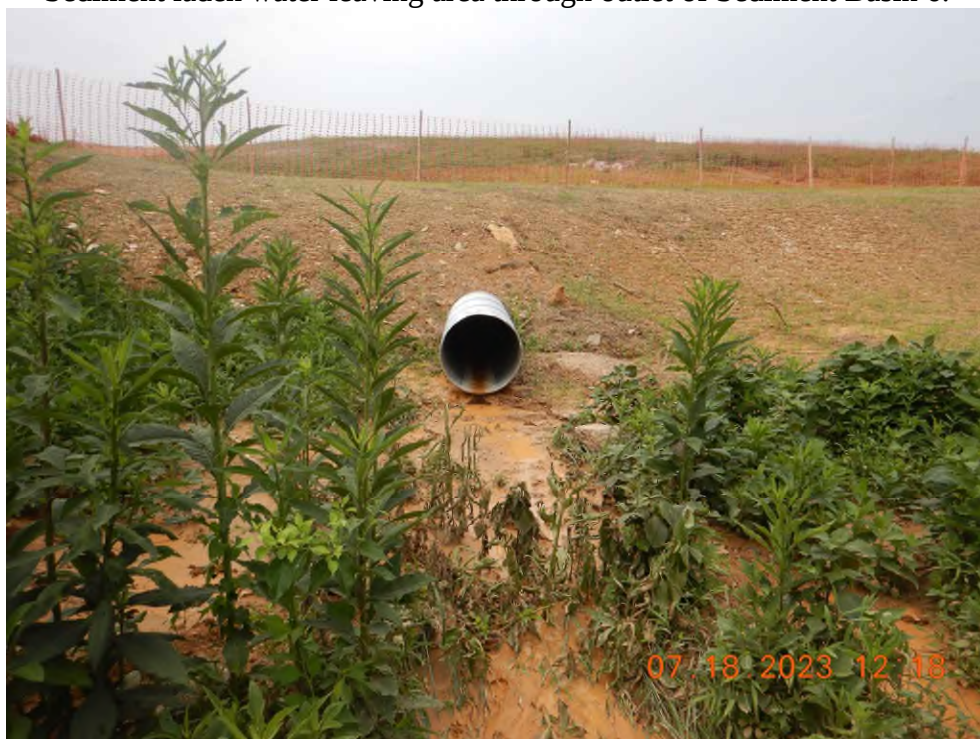
Outlet of Sediment Basin 6. No marker/sign for outlet.

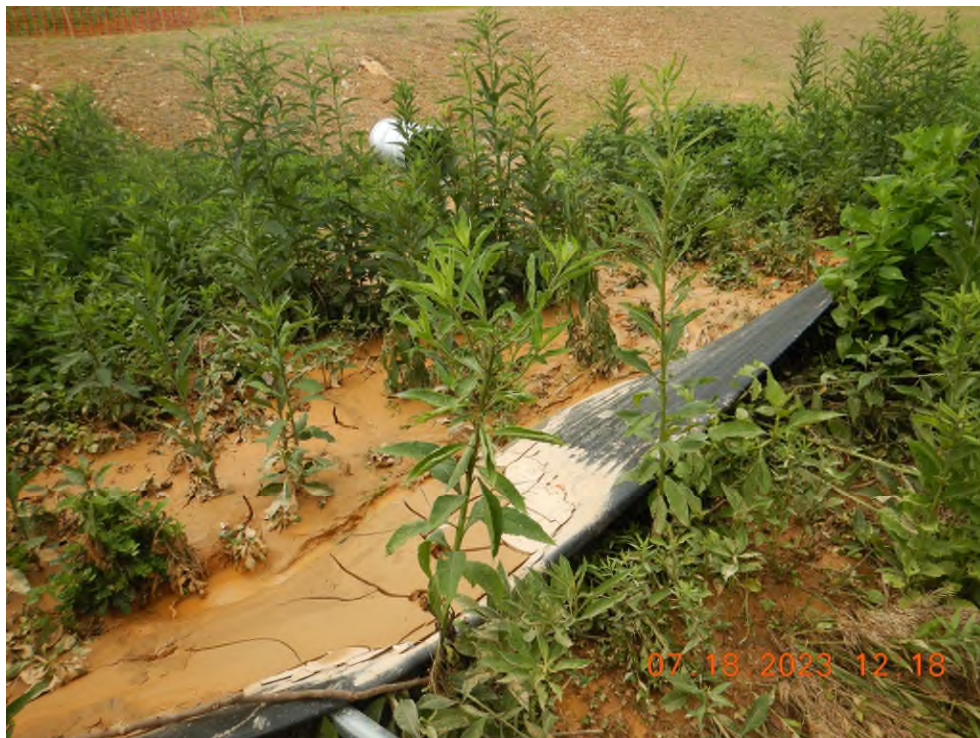
Super Silt fencing at lower end of outlet of Sediment Basin 6 needs maintenance

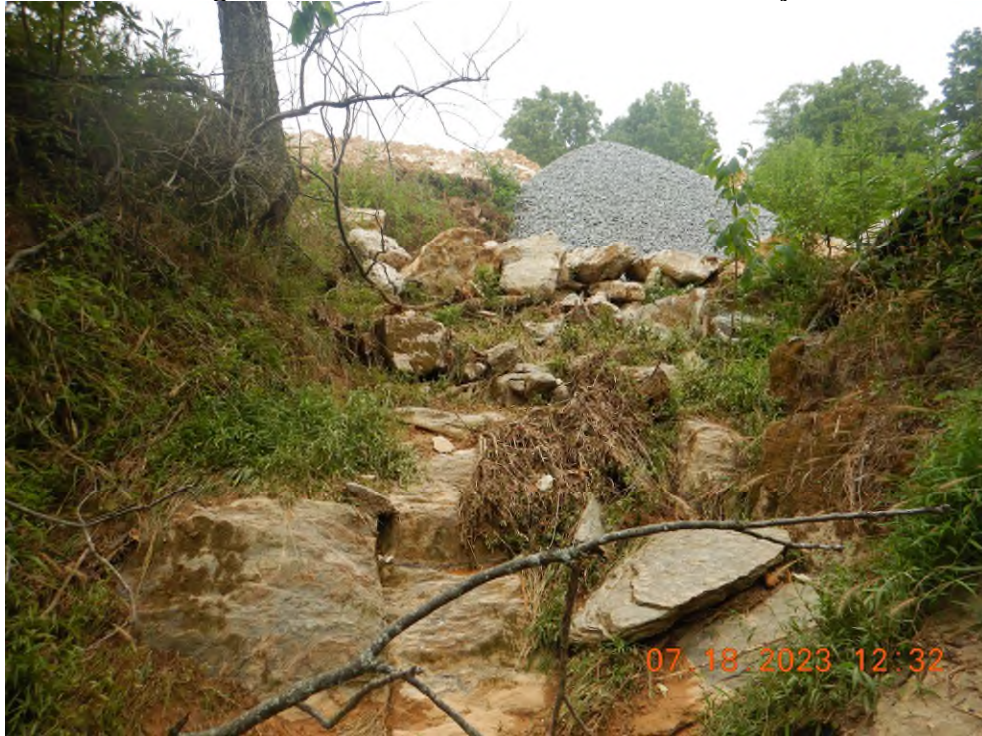
Sediment Basin 5 has not been installed per the approved SWPPP. Sediment laden water is leaving the area and discharging into Evitts Run.

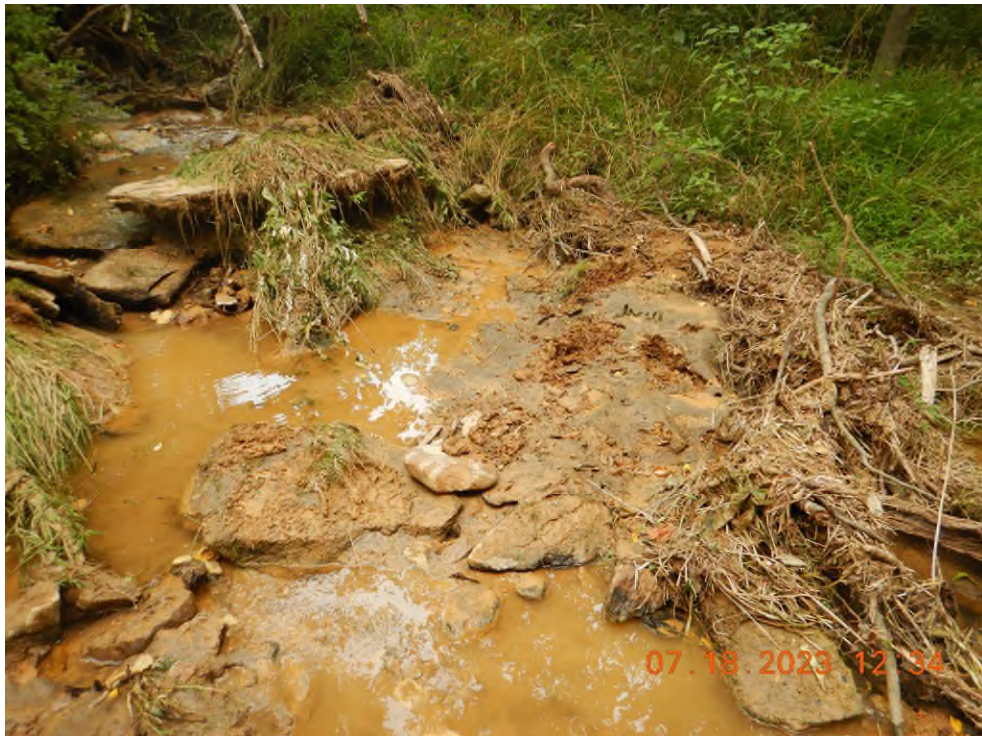
Sediment laden water in drainage area for Evitts Run.

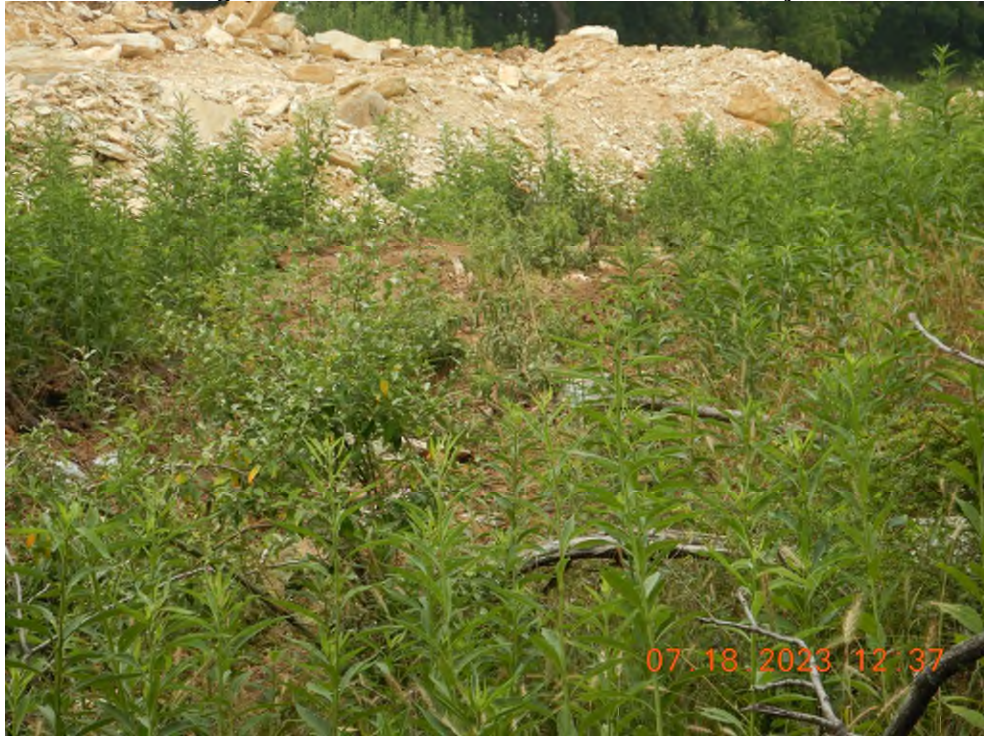
Area where Sediment Basin 5 should be installed and is not.

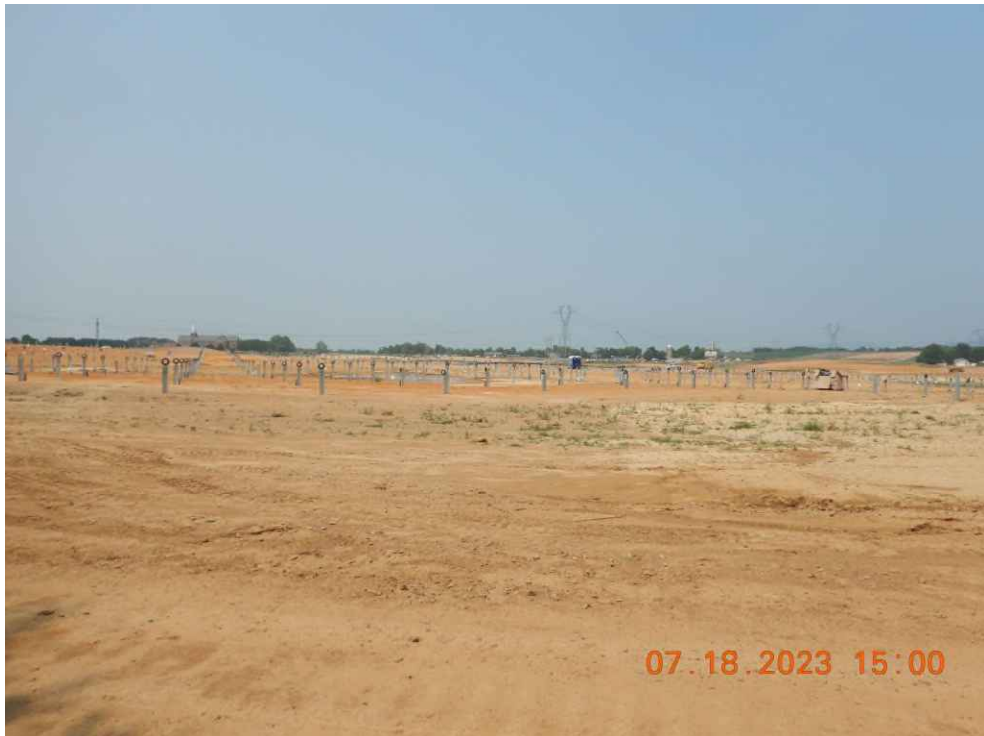
Unvegetated area that has not been excavated within the past 30 days.

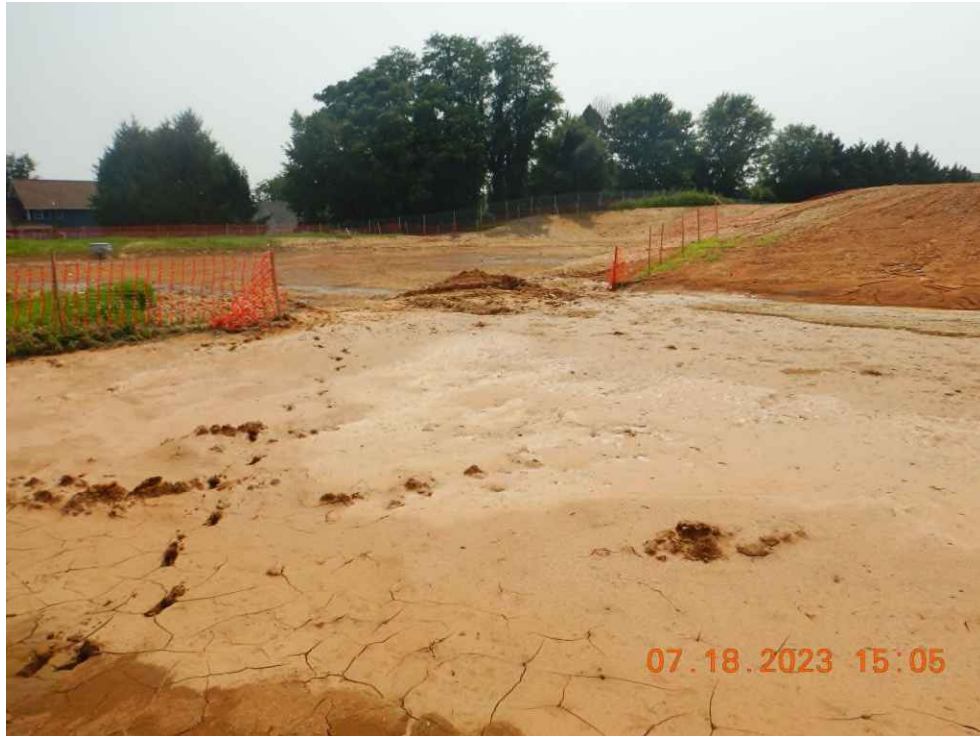
Unstabilized inlet of sediment trap.

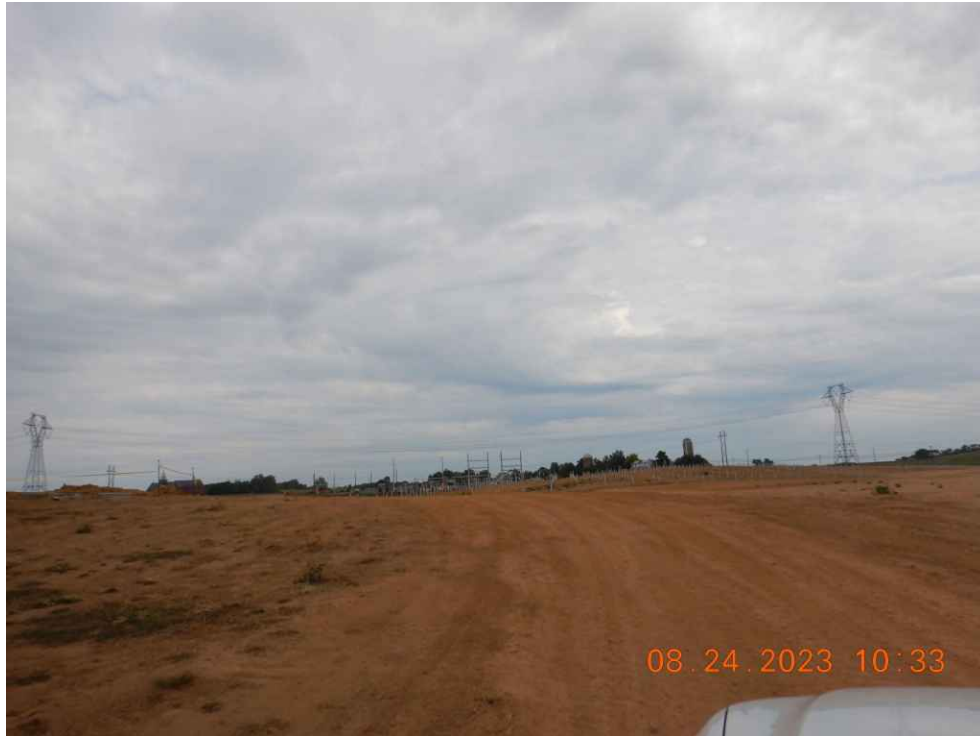
Area that has not been worked within the past 14 days and lacks temporary stabilization.

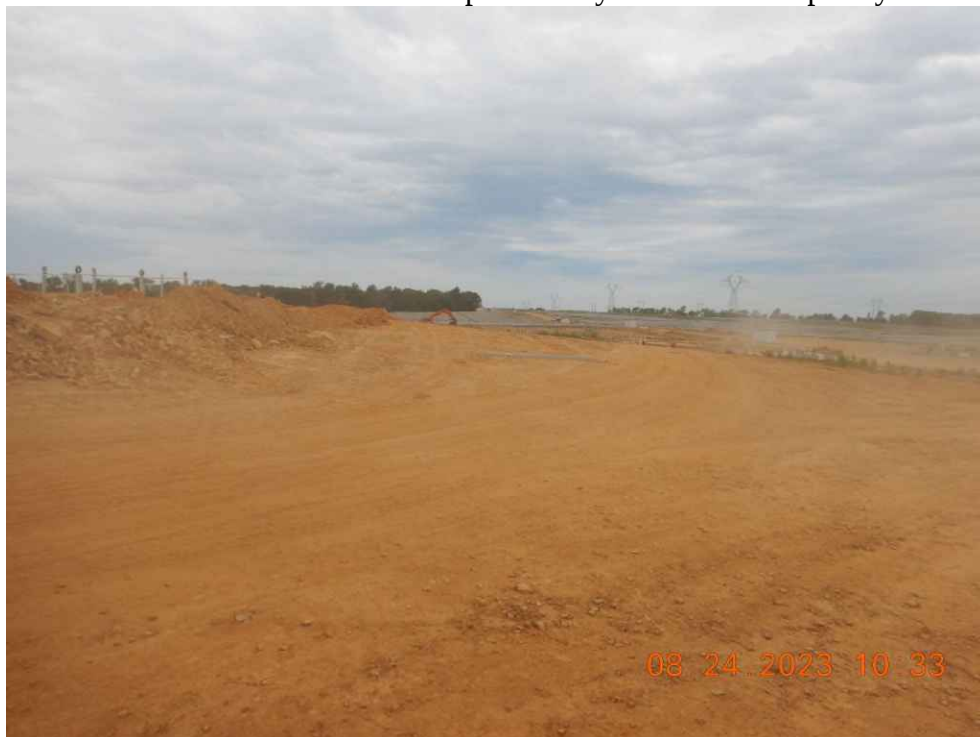
Area lacks temporary stabilization.

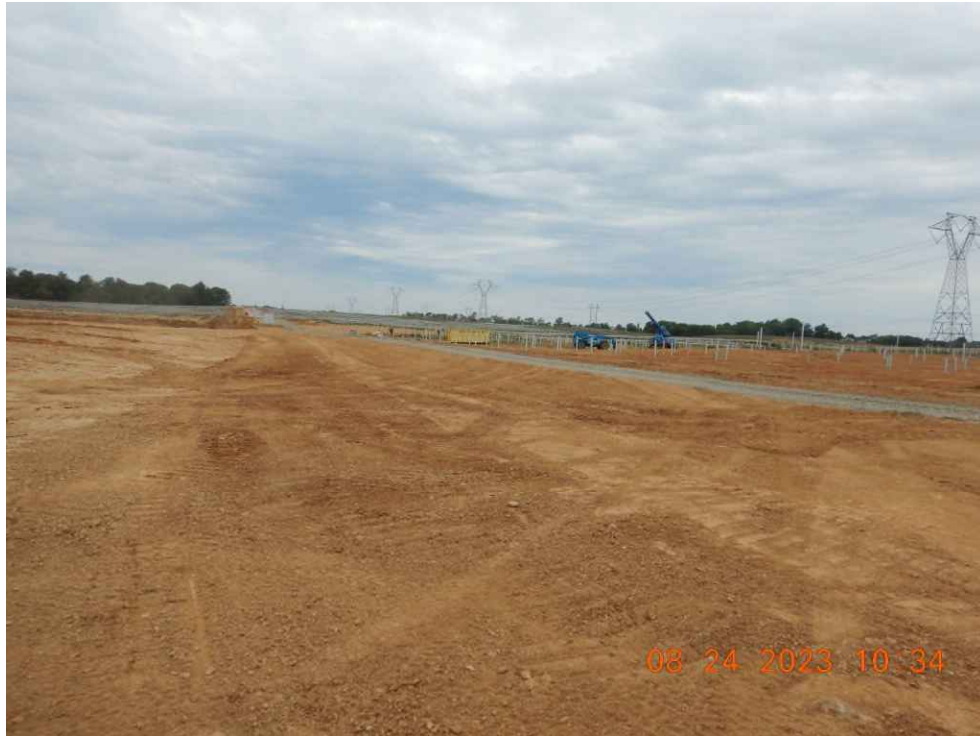
Area that lacks stabilization.

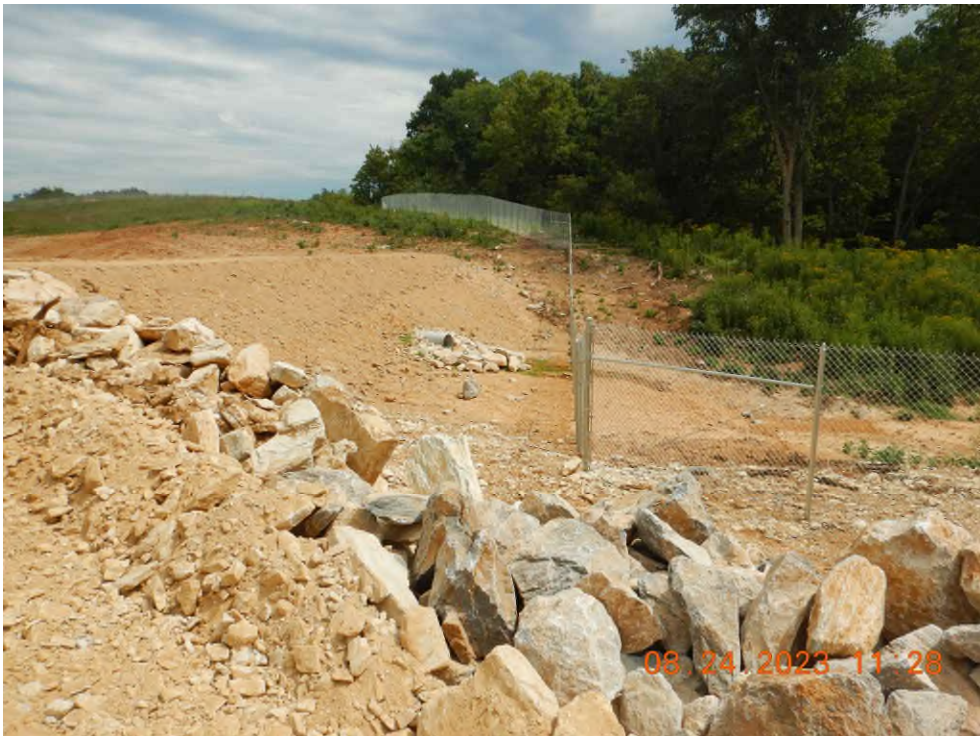
Area of Sediment Basin 5. Lacks stabilization and outlet marker.

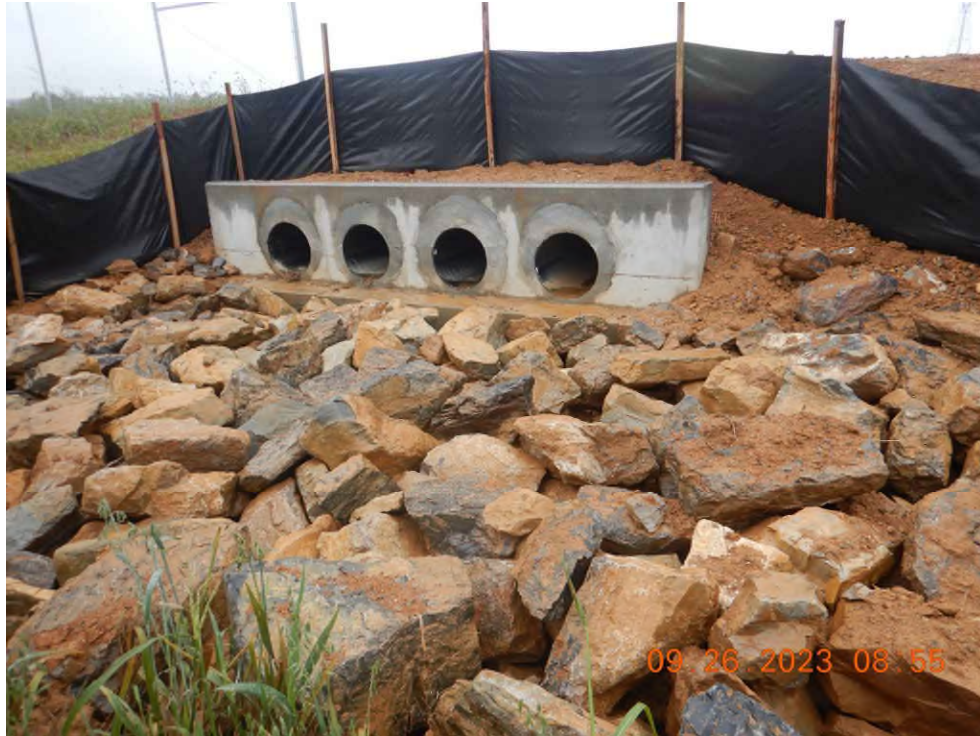
Outlet drainage area of Sediment Basin 14, discharging onto Kabletown Road

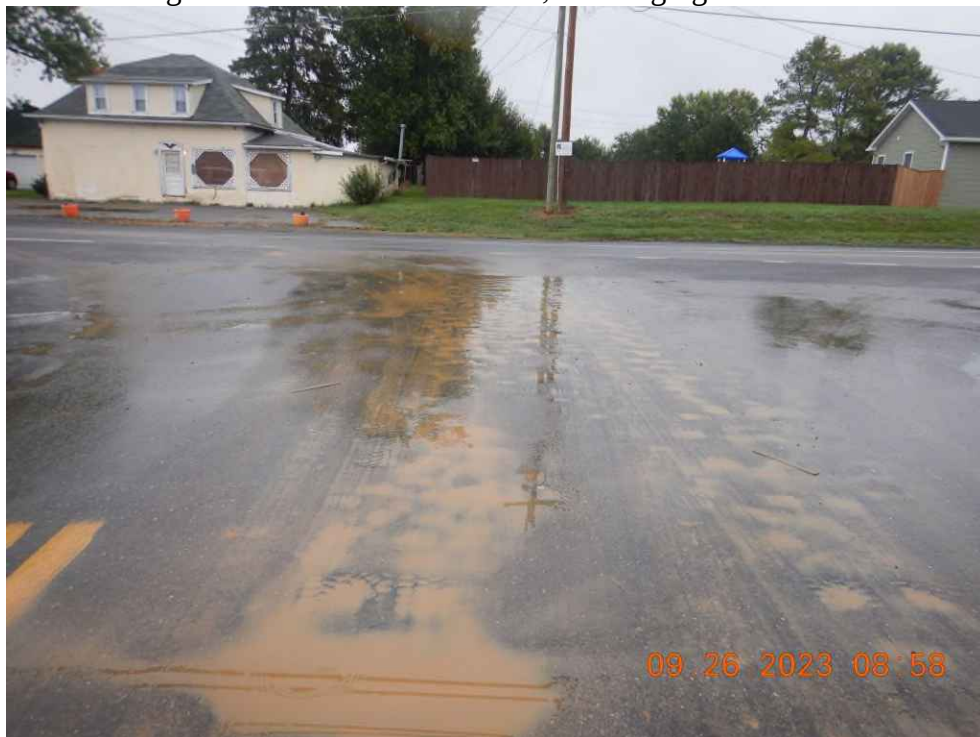
Sediment laden water in the road at the intersection of 115 and Kabletown Road.

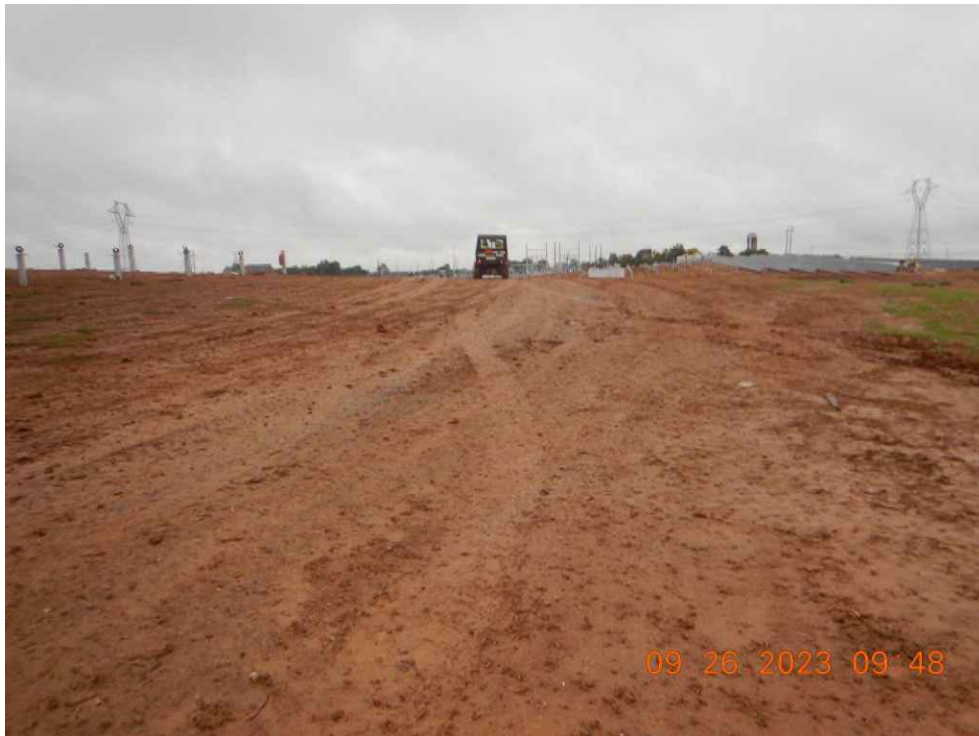
Unstabilized area of project. Temporary or permanent stabilization has not been started.

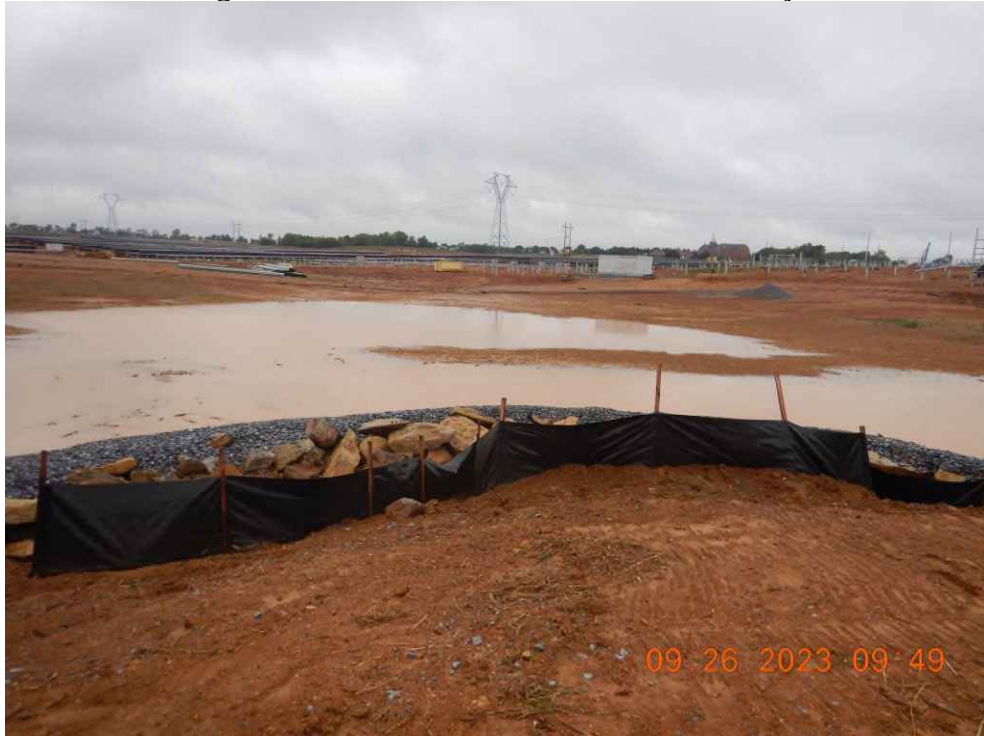
Sediment Pond 14 has been converted to a final stormwater management pond prior to all uphill disturbance being vegetated.

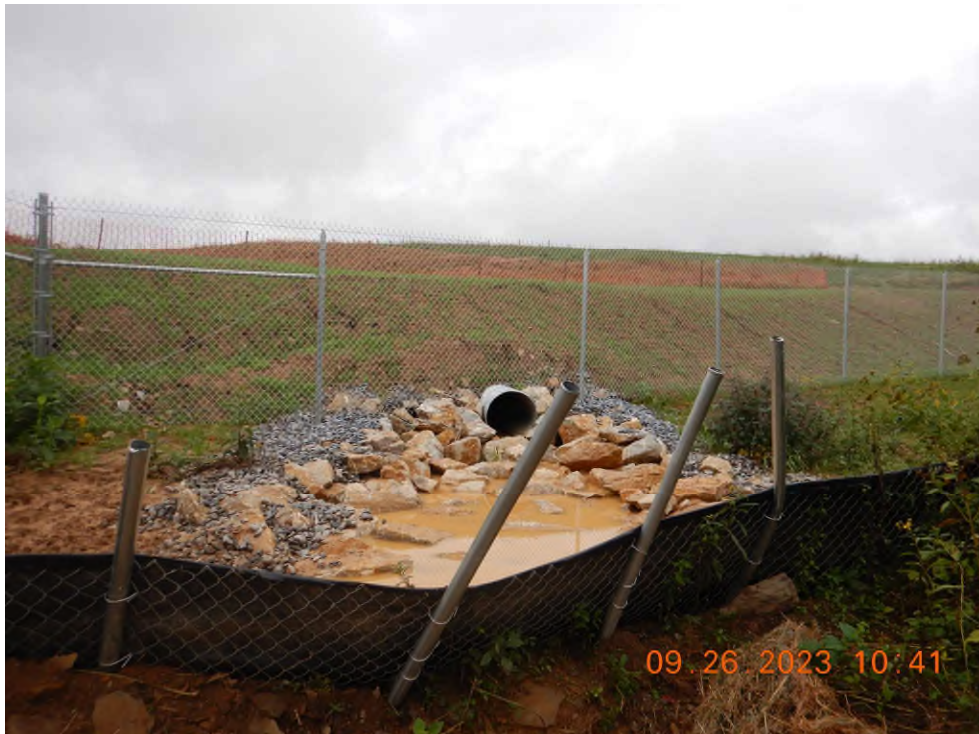
Sediment laden water leaving Sediment Basin 6. No outlet sign is visible.

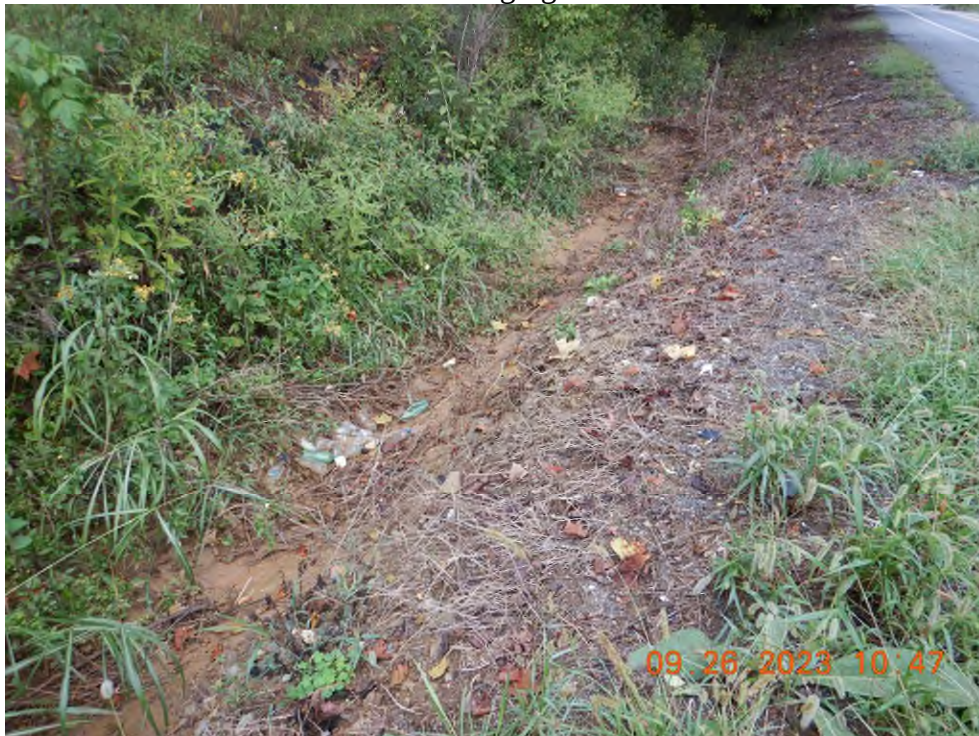
Sediment laden water from Sediment Basin 6 entering into an ephemeral UNT of Evitts Run (39° 15' 33.3189" X -77° 49' 30.6042").

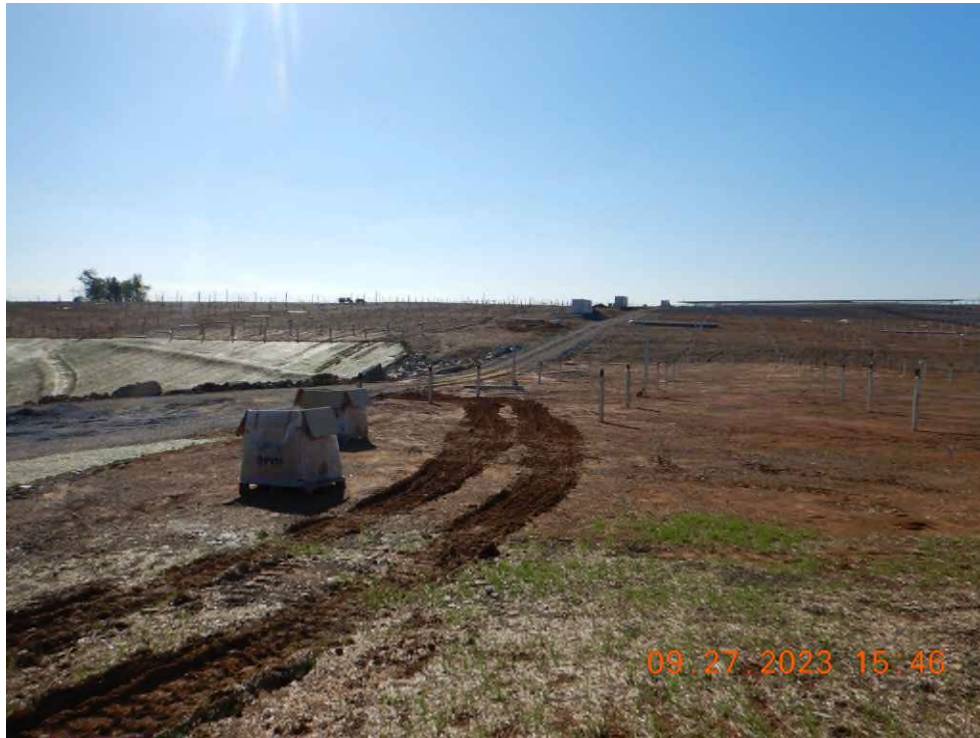
Unstabilized area of project. Temporary or permanent stabilization has not been started.

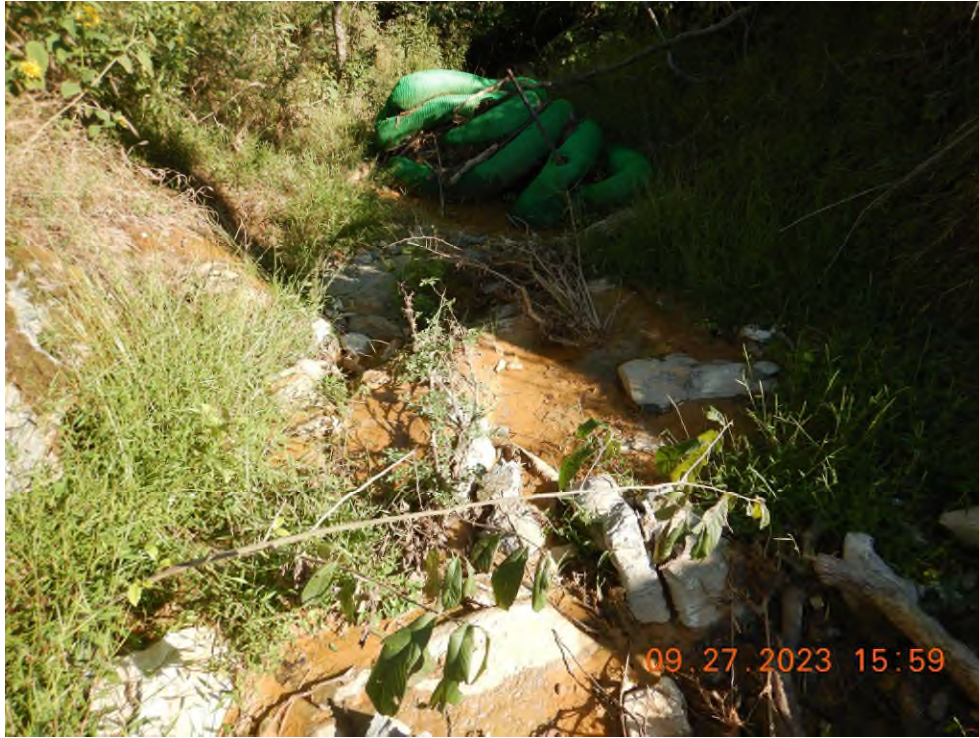
Sediment laden water discharged from Sediment Basin 5 into the UNT of Evitts Run.

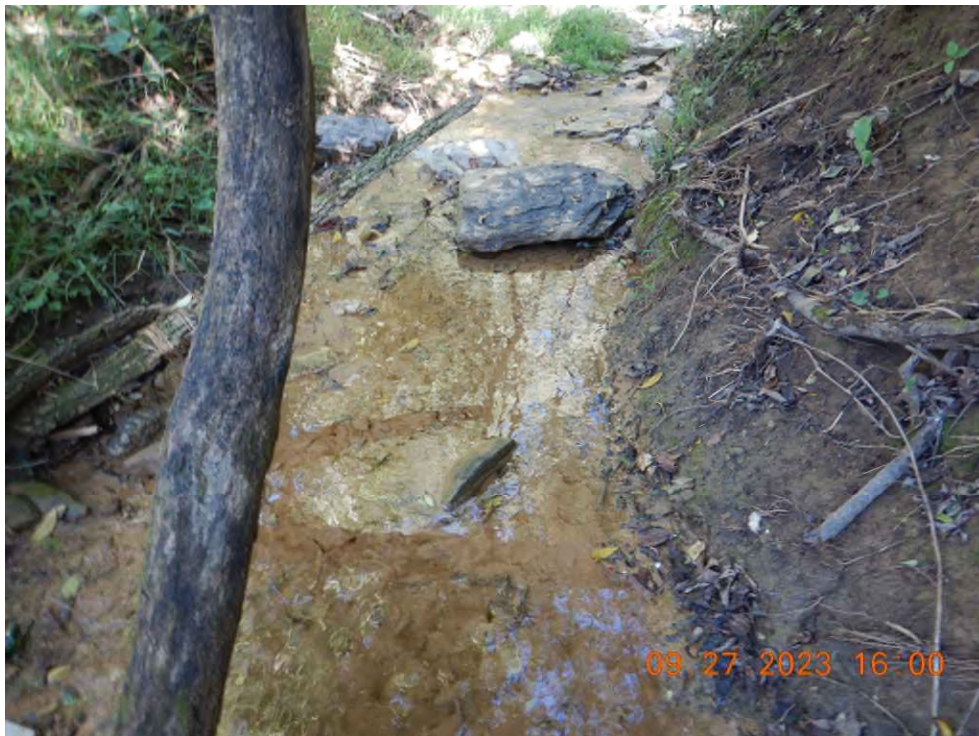
Sediment deposits from Sediment Basin 5 in the UNT of Evitts Run.

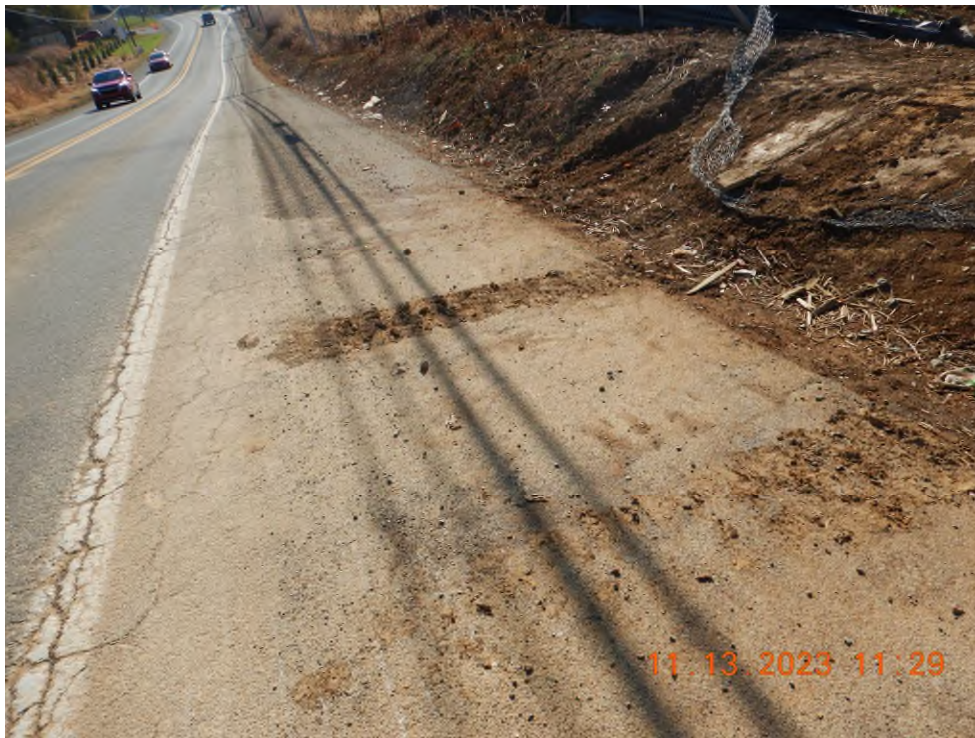
Track-out due to construction entrance not being stabilized.

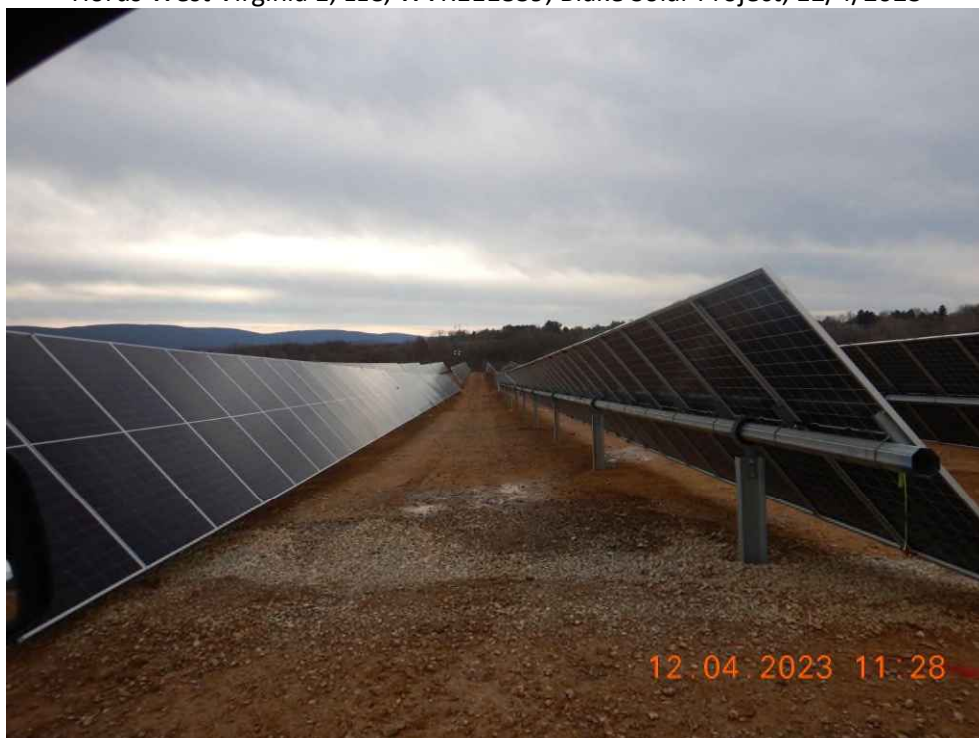
Unstabilized area that has not been worked within the past 14 days.
