**CONSENT ORDER  
ISSUED UNDER THE  
WATER POLLUTION CONTROL ACT  
WEST VIRGINIA CODE CHAPTER 22, ARTICLE 11**

ORDER NO.: 10260

1. Horus West Virginia 1, LLC is conducting land disturbance activity associated with the Blake Solar Project in Jefferson County, West Virginia. Horus West Virginia 1, LLC was issued WV/NPDES Water Pollution Control Permit No. WV0115924, Registration No. WVR111837, on August 12, 2022.
2. On May 15, 2023, West Virginia Department of Environmental Protection (WVDEP) personnel conducted an inspection of the facility. During the inspection, violations of the following sections of the WV/NPDES permit were observed and documented:
  - a. Section II.H.1.d. – Horus West Virginia 1, LLC failed to provide an adequate stone access entrance/exit to reduce the tracking of sediment onto public or private roads.

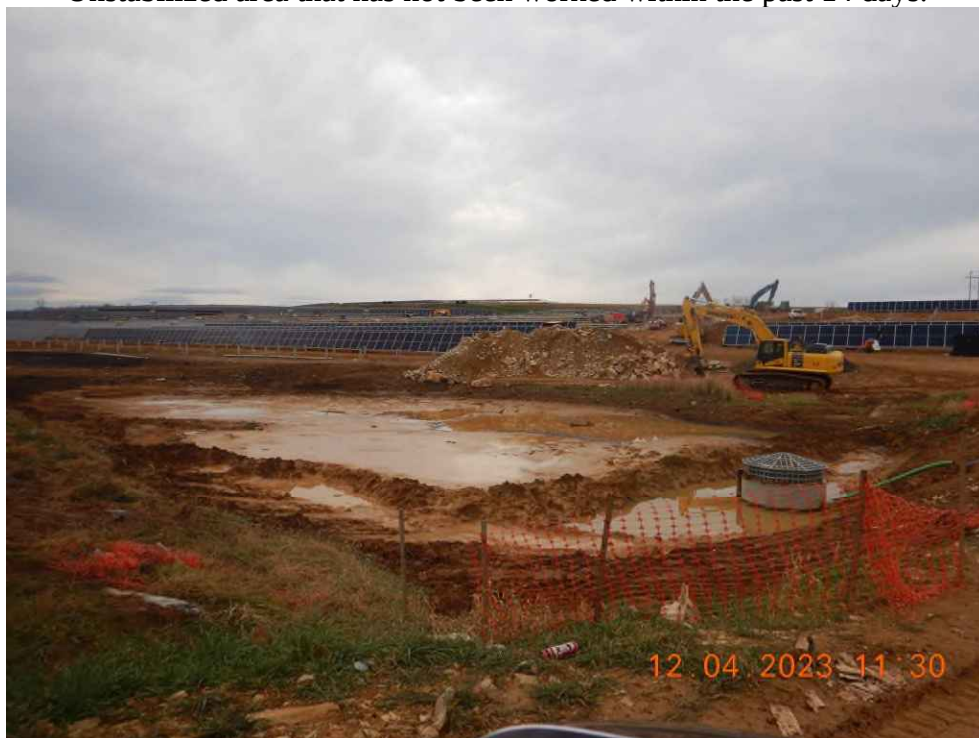
Sediment Basin 13 that has not been stabilized with outlet structure installed. Now known as Pond 2A on redline plan.

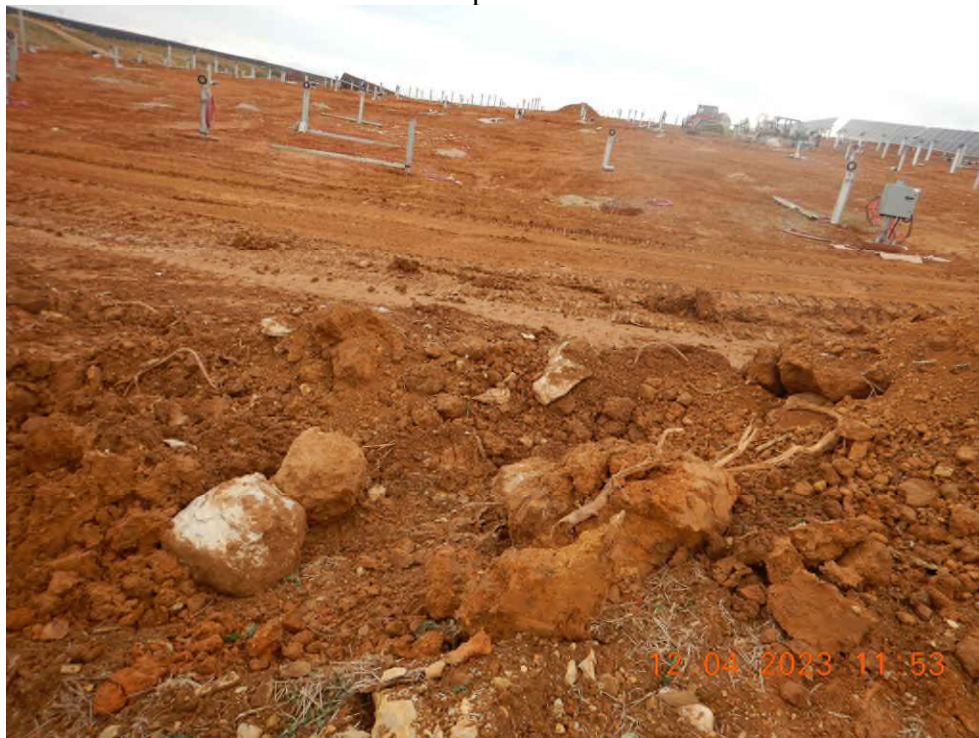
Unvegetated area that has not been excavated within the past 30 days

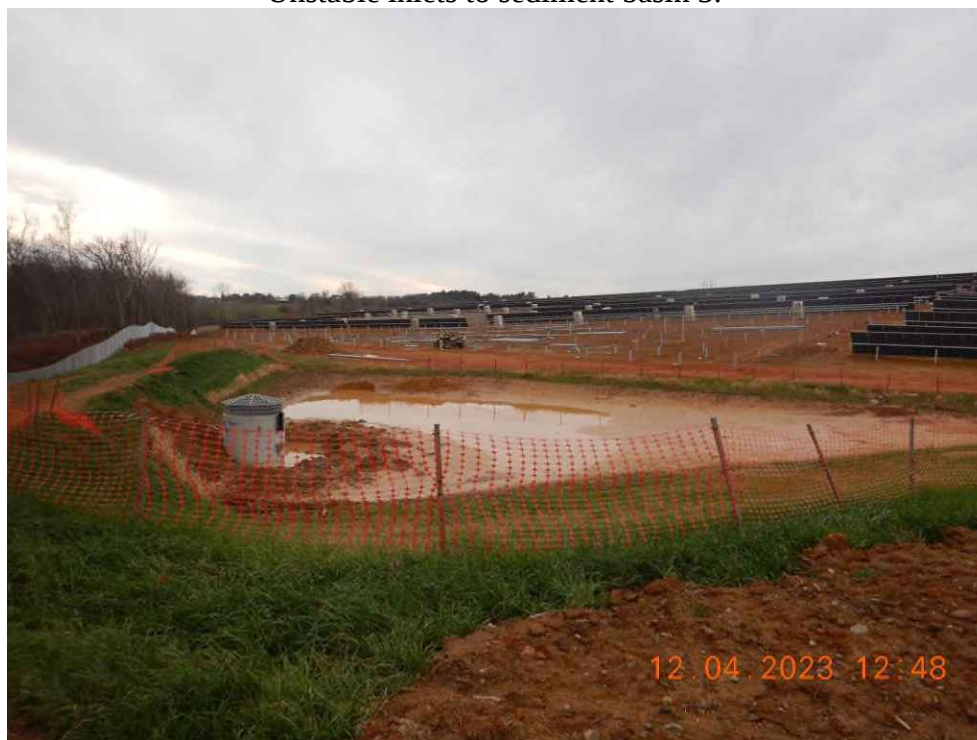
Sediment basin 3 (Pond 3B) converted prior to all uphill disturbance being vegetated.

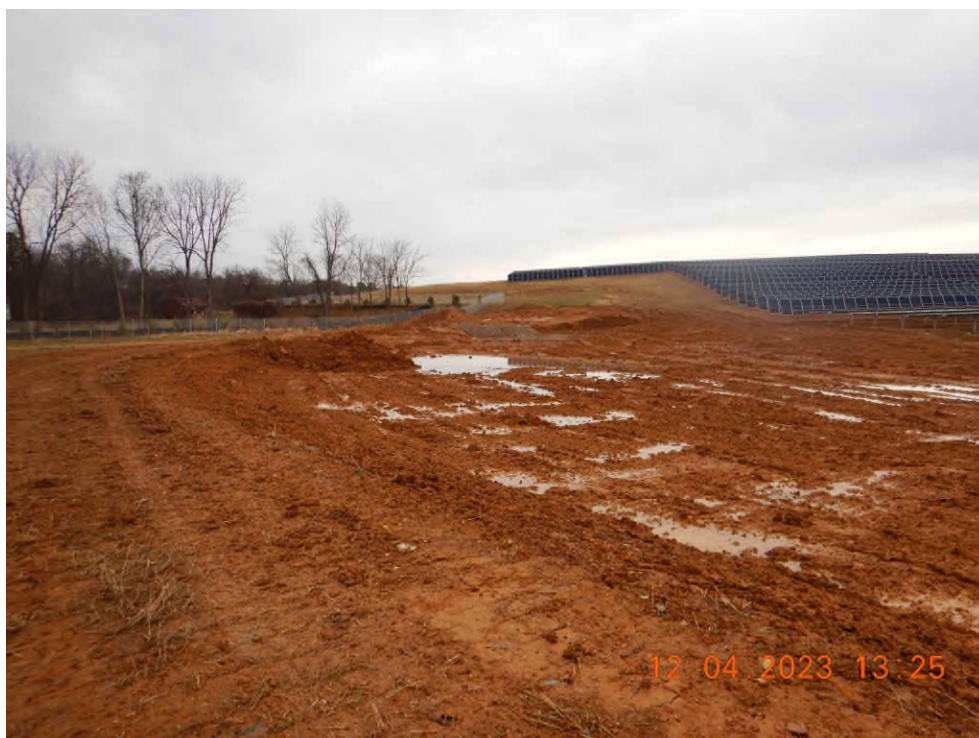
Sediment basin SB-11 (Pond 2B redline) that has been converted to stormwater retention prior to stabilization of the contributing area.

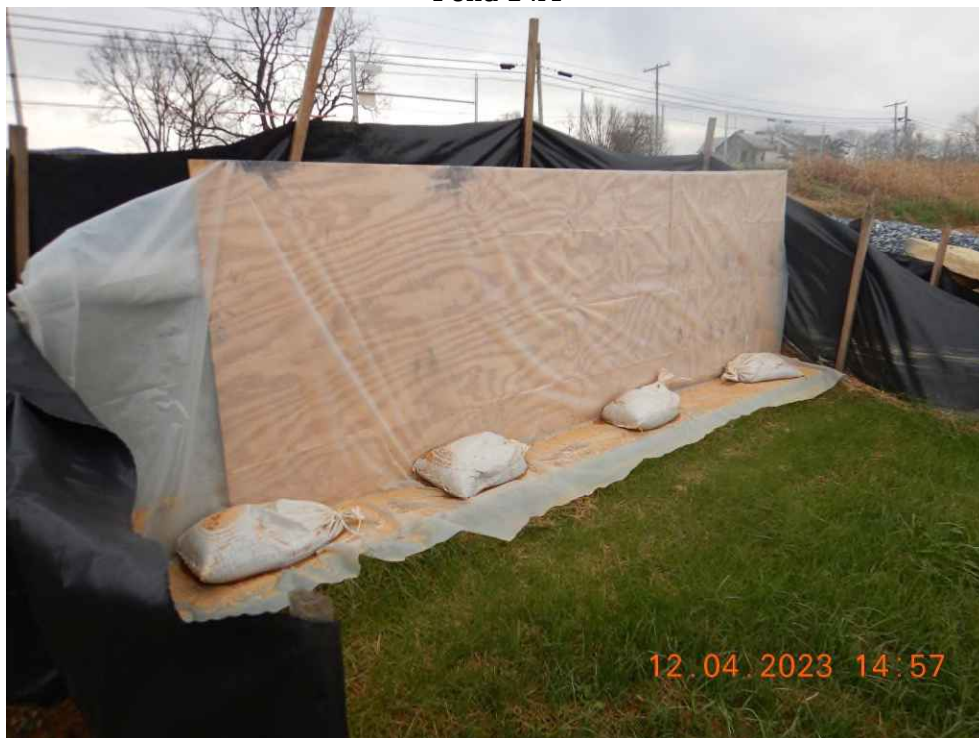
Outlet to Pond 14A. Still discharging on the other side.

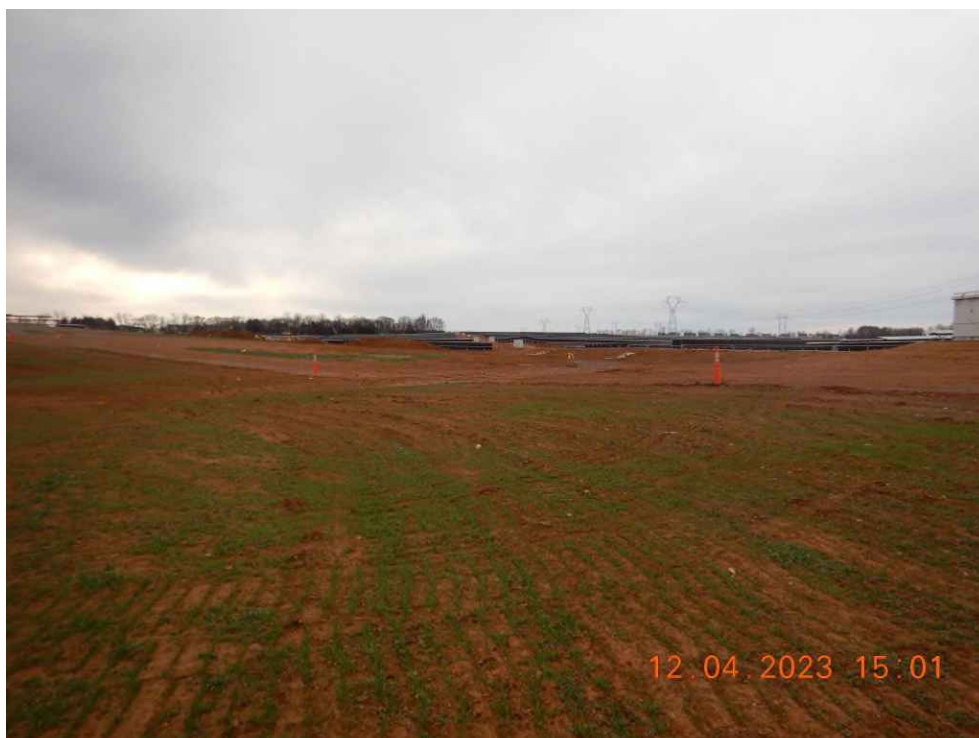
Area where sediment Basin 17 should be installed. Basin has been removed prior to all uphill disturbance being vegetated.

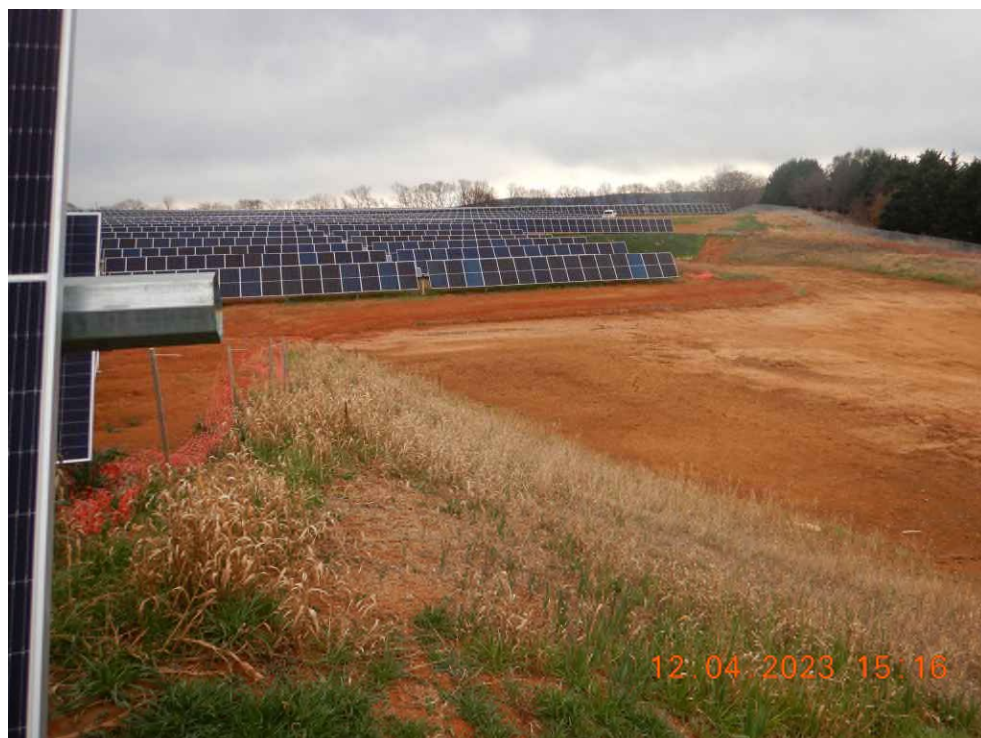
Sediment Basin 7 has been removed without all uphill disturbance being vegetated.

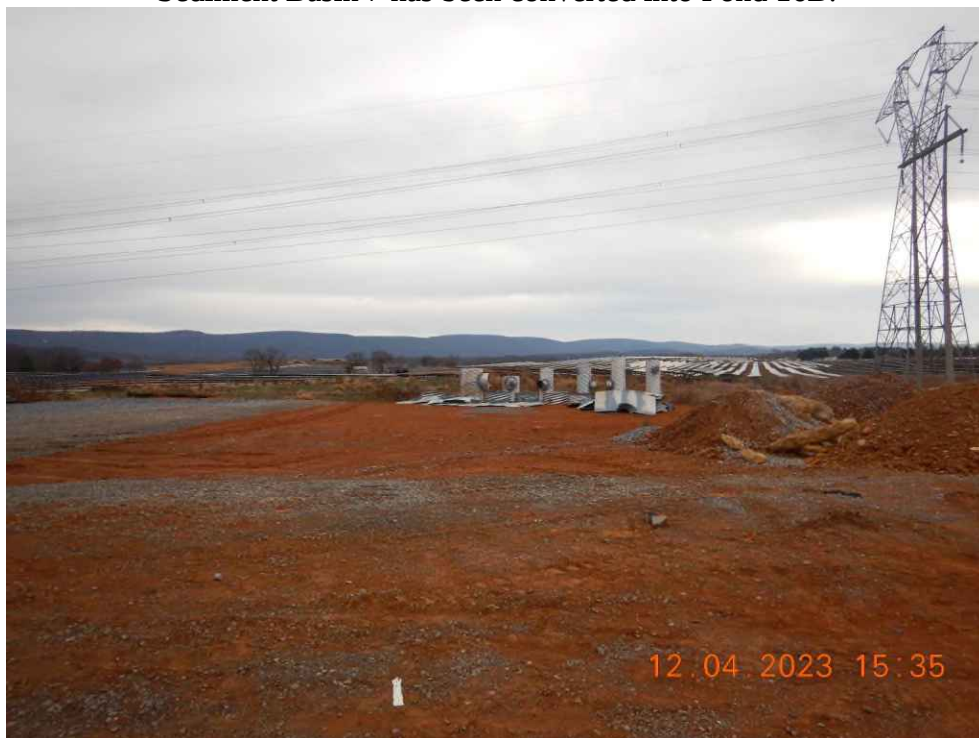
Sediment basin structures that have been removed prior to all uphill disturbance being vegetated.  
Stockpiled riser structures from removed trapping structures pictured.

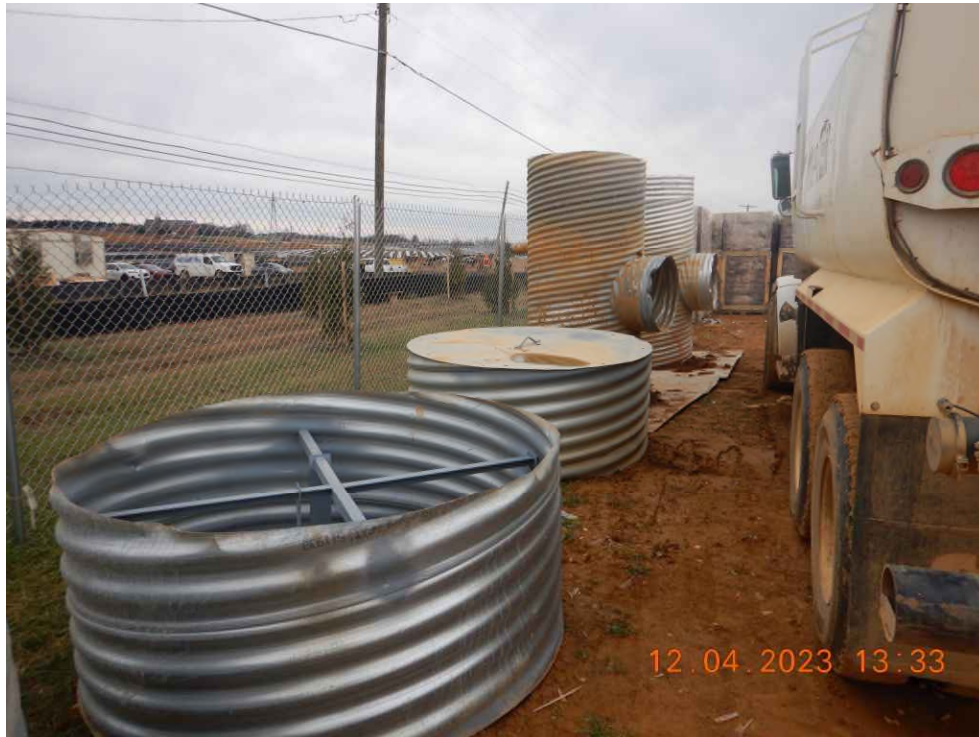
Sediment basin structures that have been removed prior to all uphill disturbance being vegetated.  
Stockpiled riser structures from removed trapping structures pictured.

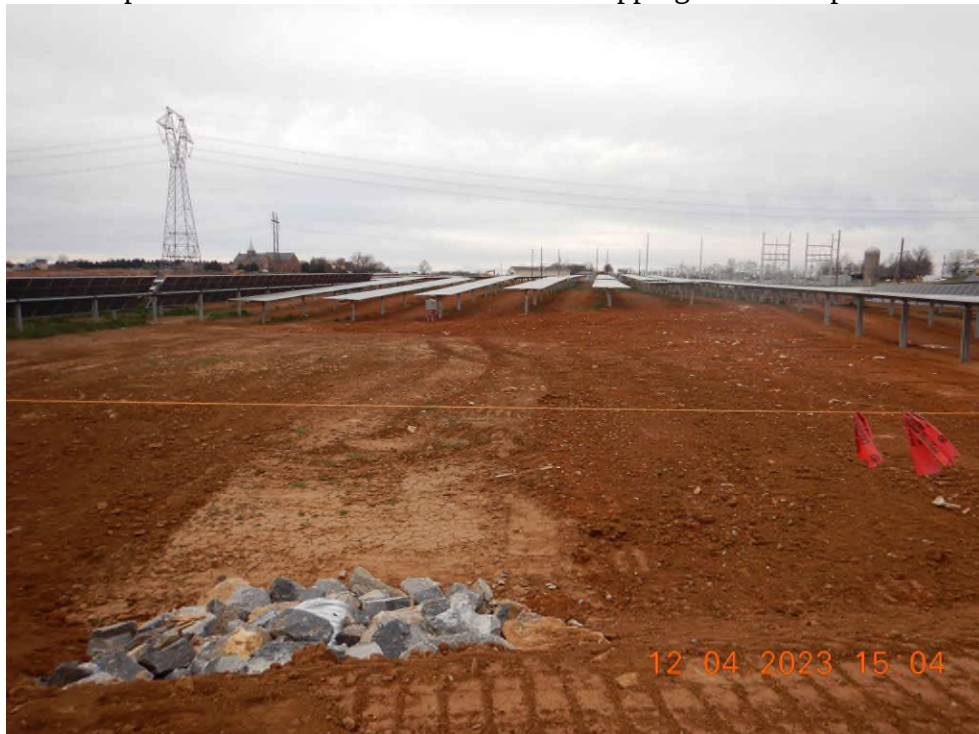
Area that has not been worked within the past 14 days and has not been stabilized. Area of proposed Sediment Trap ST-10 pictured, showing it as not in place with a disturbed contributing area.

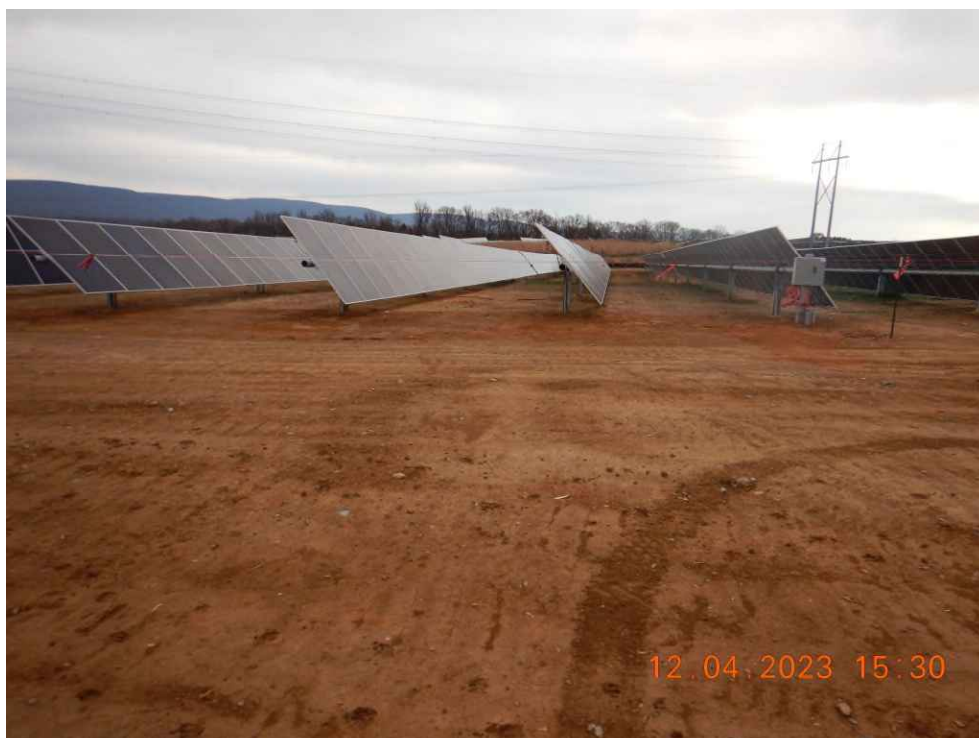
Area that has not been worked within the past 14 days and has not been stabilized.

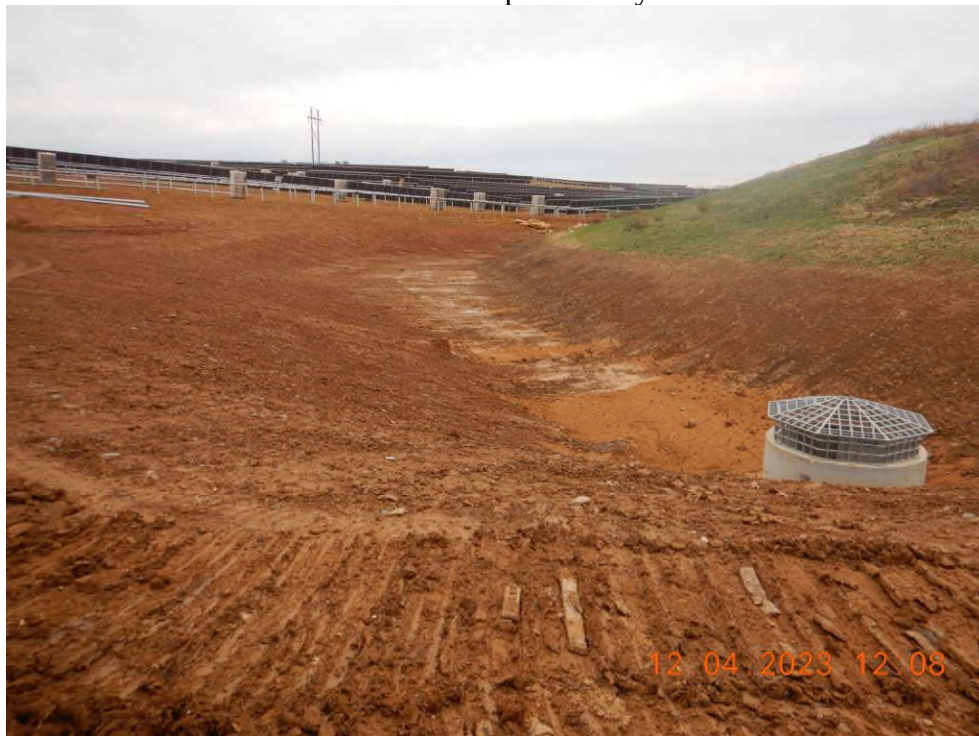
Sediment Basin 1 has been converted to Pond 3A prior to all upstream disturbance being vegetated.

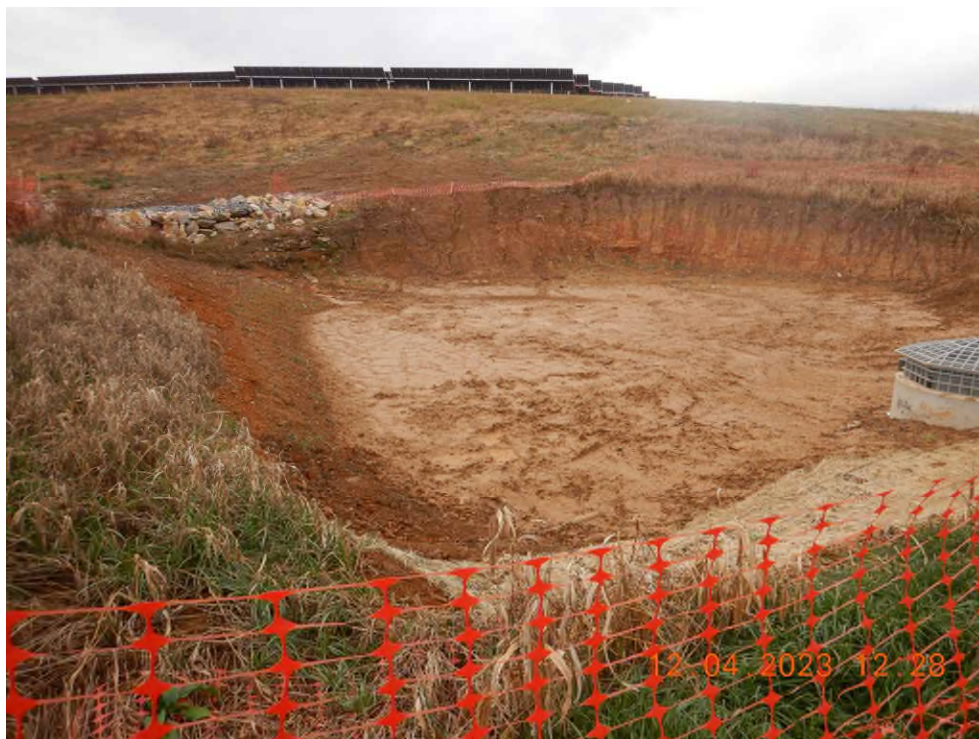
Sediment Basin 6 has been converted to Pond 6 prior to all upstream disturbance being vegetated.

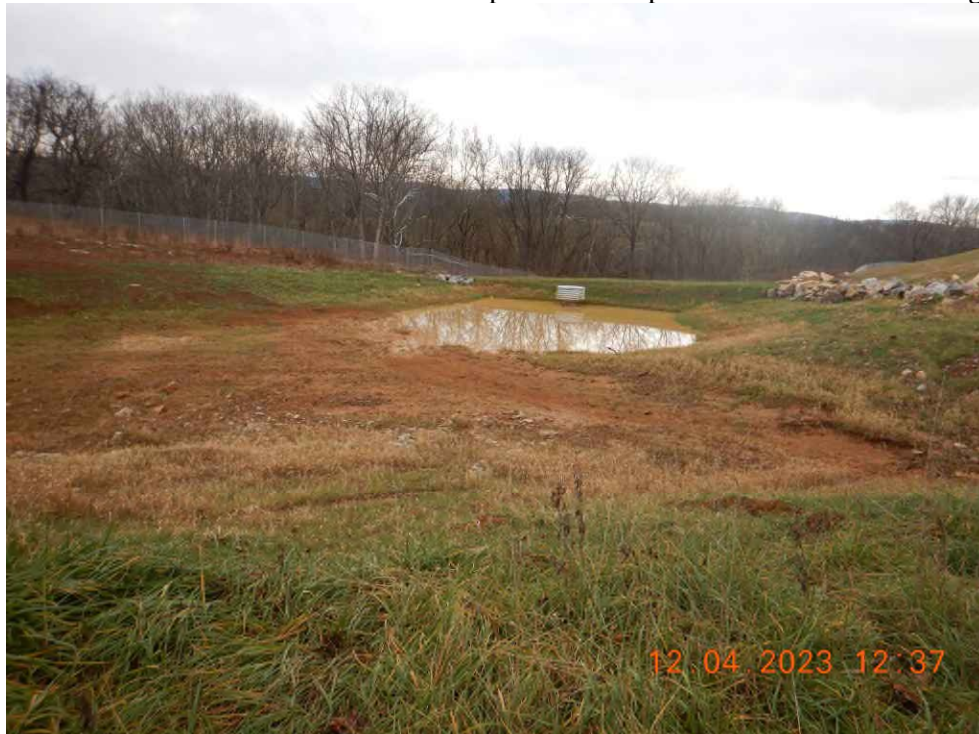
Sediment Basin 6 has been converted to Pond 4B prior to all upstream disturbance being vegetated.

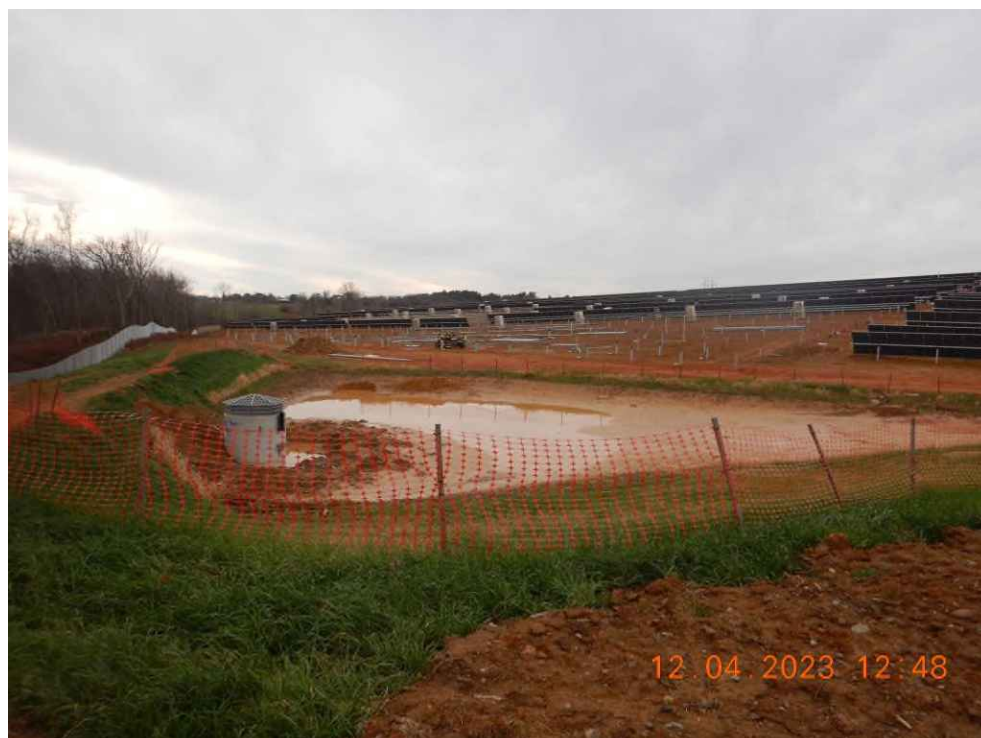
Sediment Basin 3 has been converted to Pond 3B prior to all upstream disturbance being vegetated.

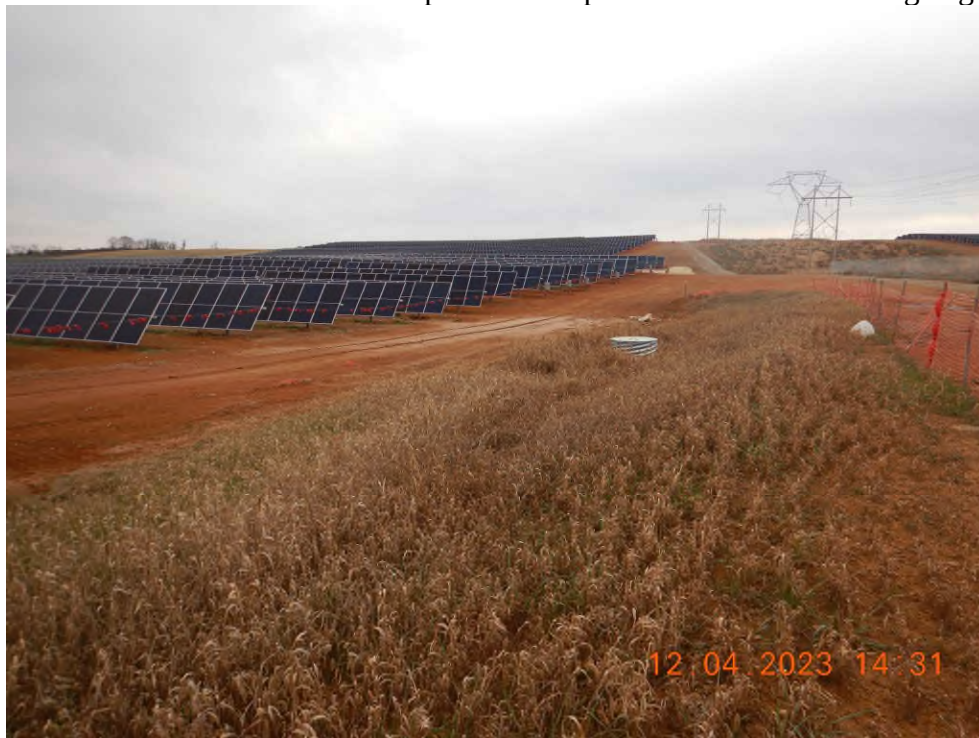
Sediment Basin 10 converted to Pond 8 prior to all upstream disturbance being vegetated.

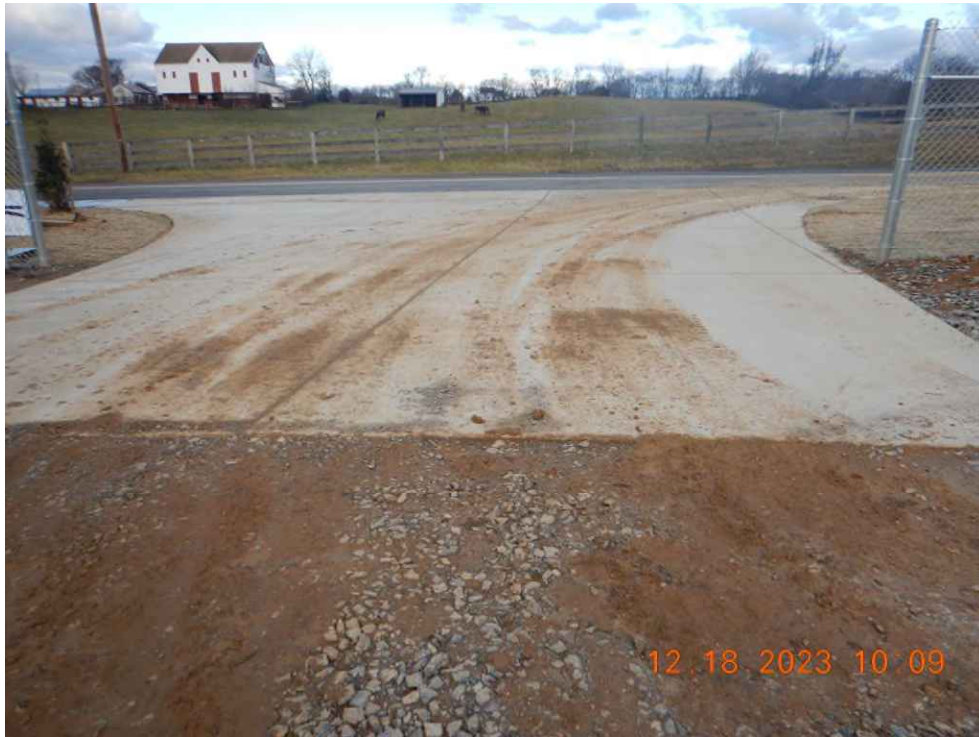
Track-out onto main road due to lack of stabilized construction entrance.

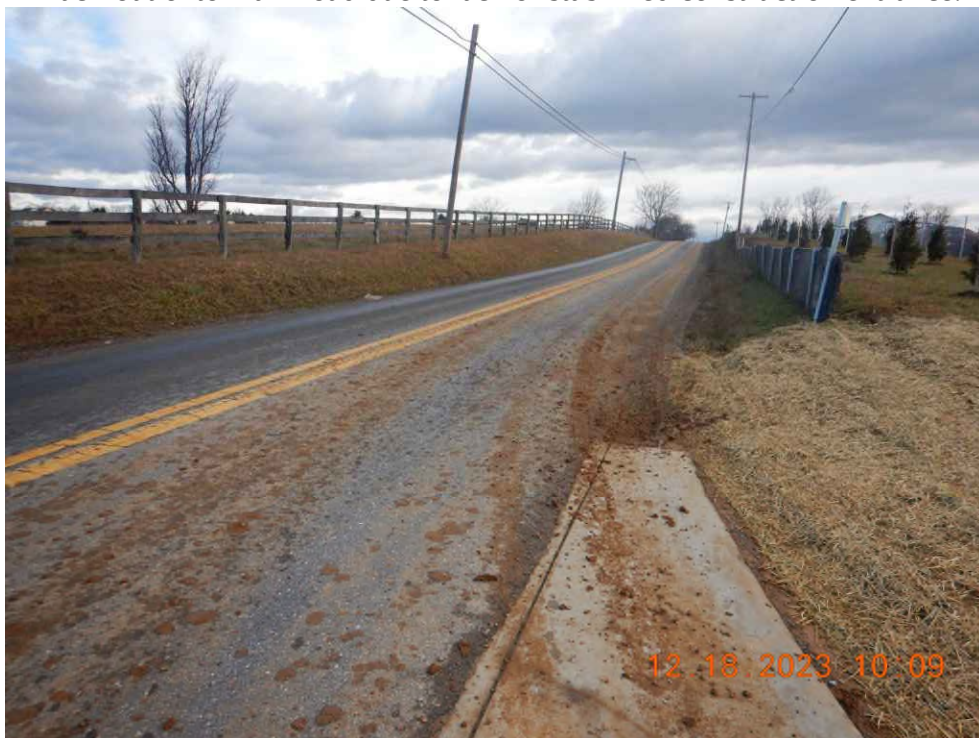
Track-out onto main road due to lack of stabilized construction entrance.

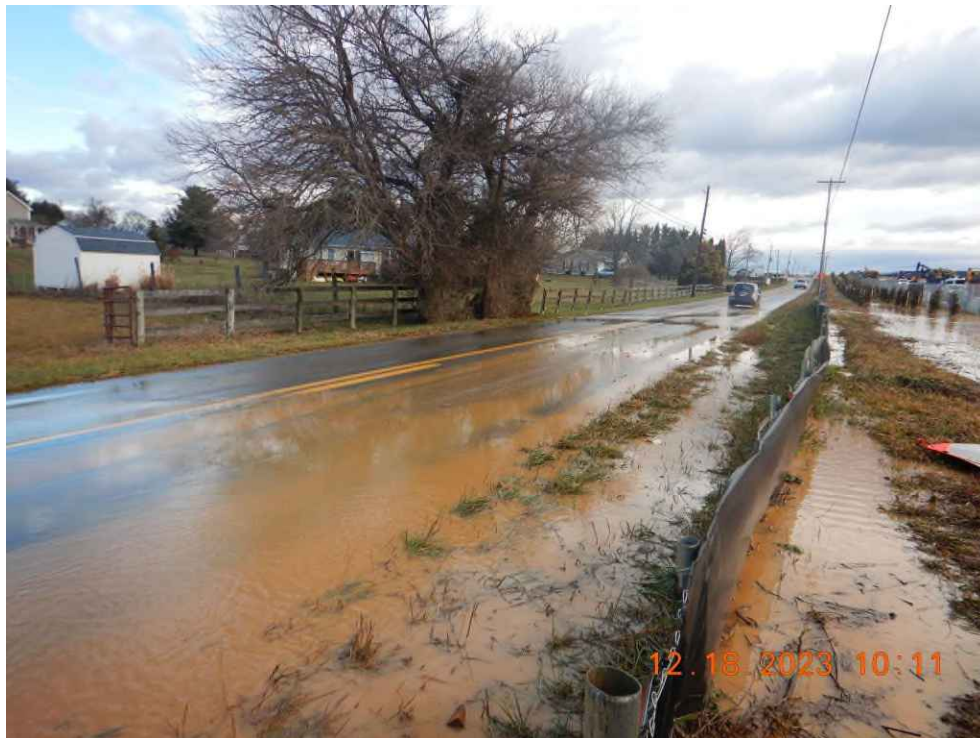
Sediment laden water leaving the site onto Kabletown Road.

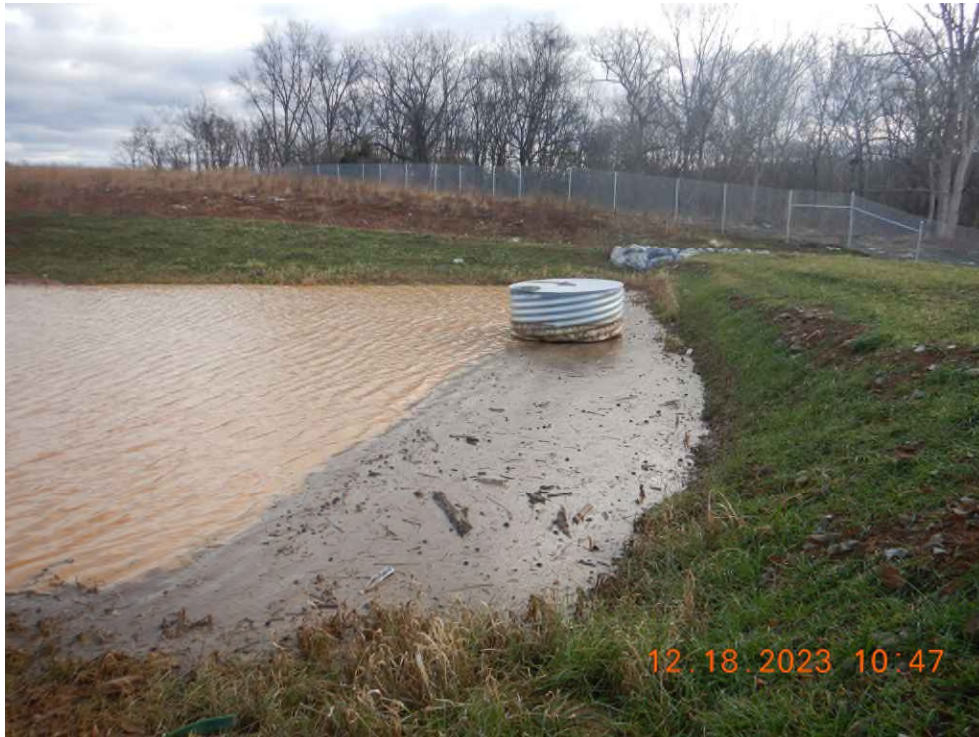
Sediment Basin 5 has been converted to final stormwater management Pond 4B. Discharging sediment laden water into Evitts Run.

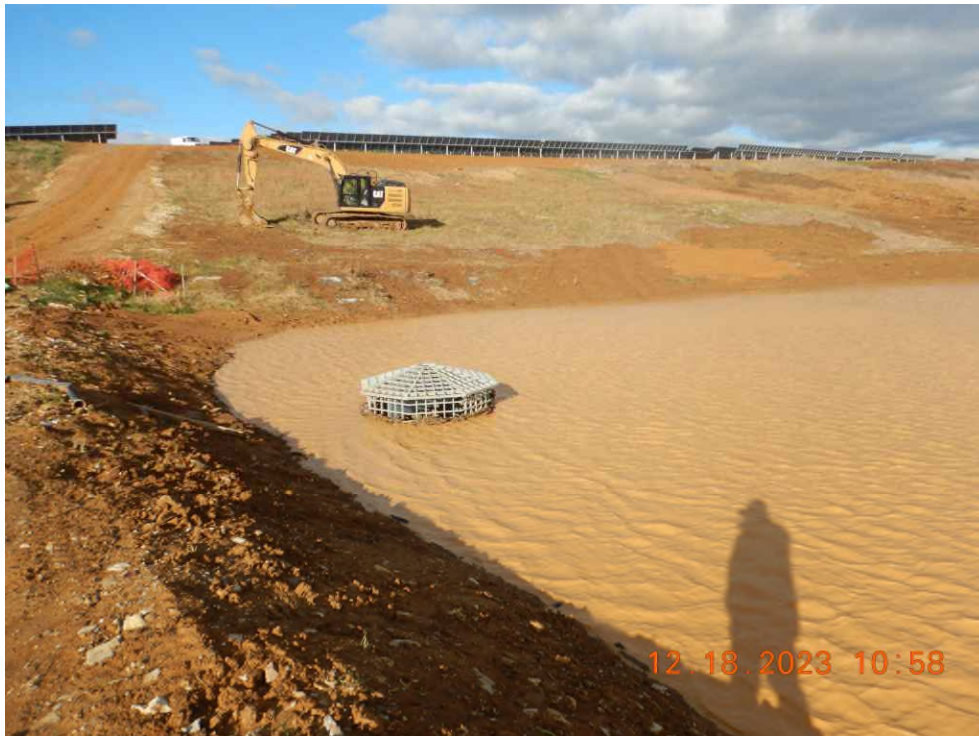
Sediment Basin 13 has been converted to final stormwater management Pond 2A. Discharging sediment laden water into Evitts Run.

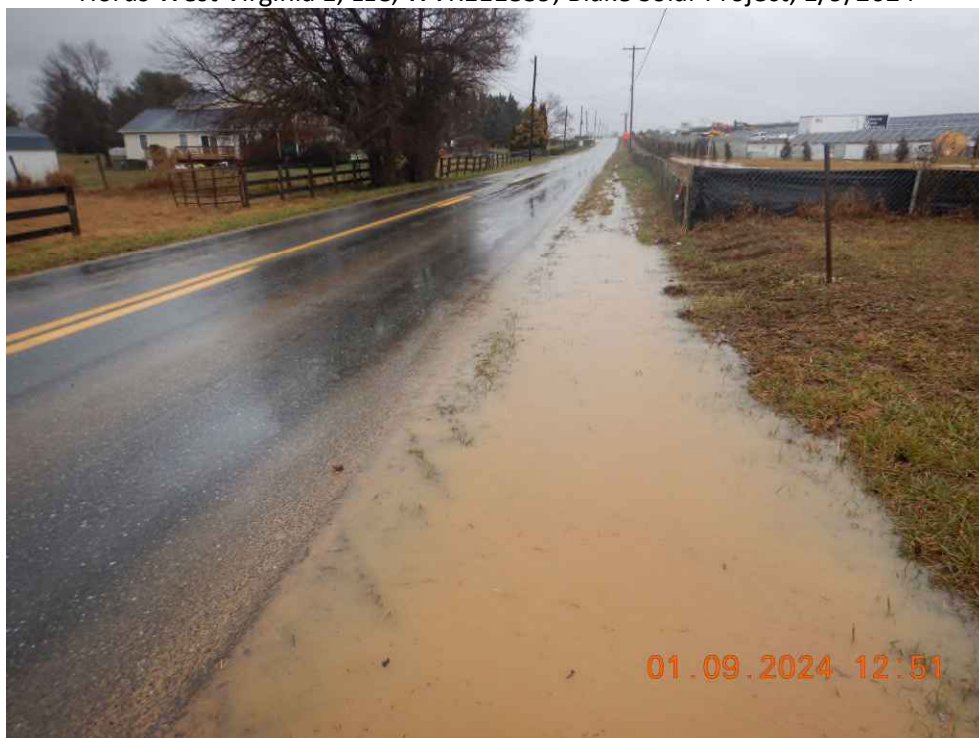
Sediment laden water leaving site on Kabletown Road.

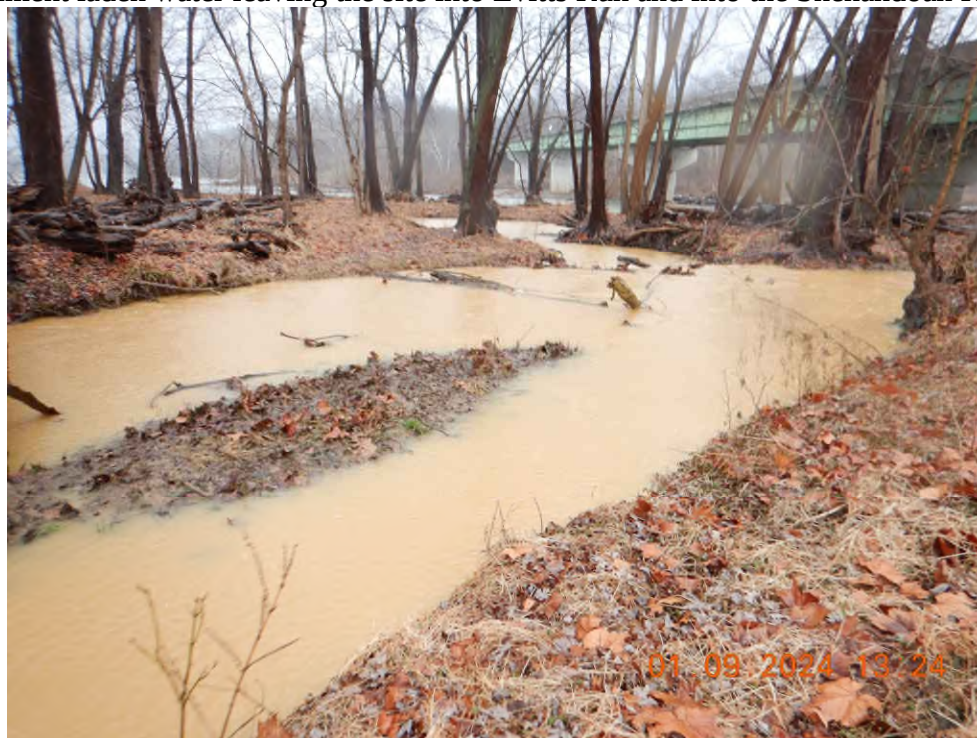
Evitts Run into the Shenandoah River.

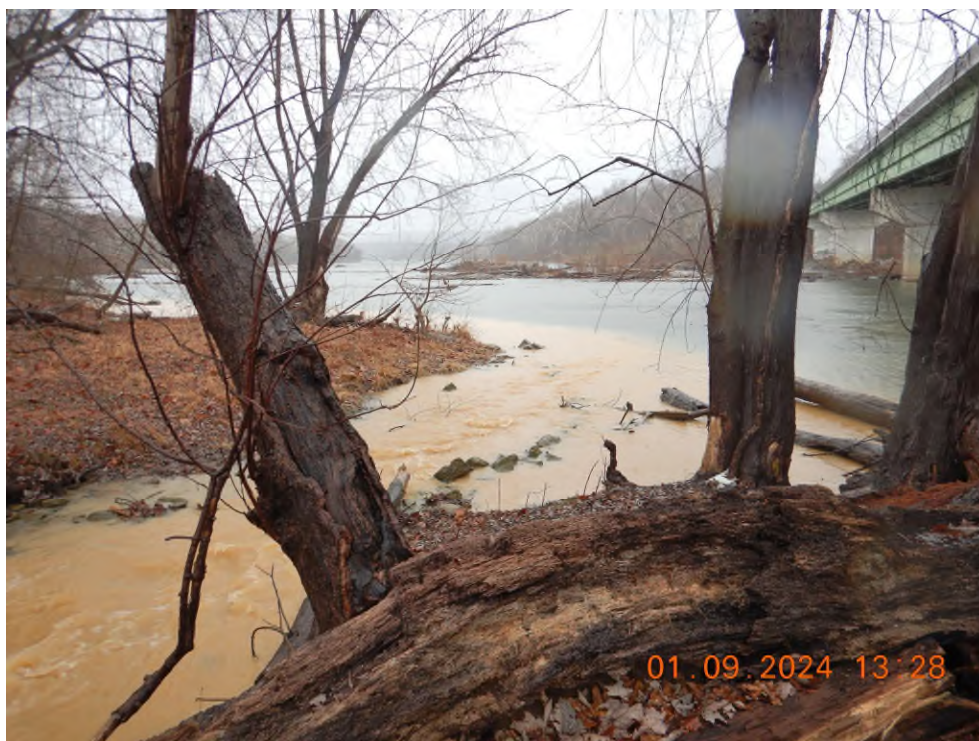
Mixing Zone between Evitts Run and the Shenandoah River.

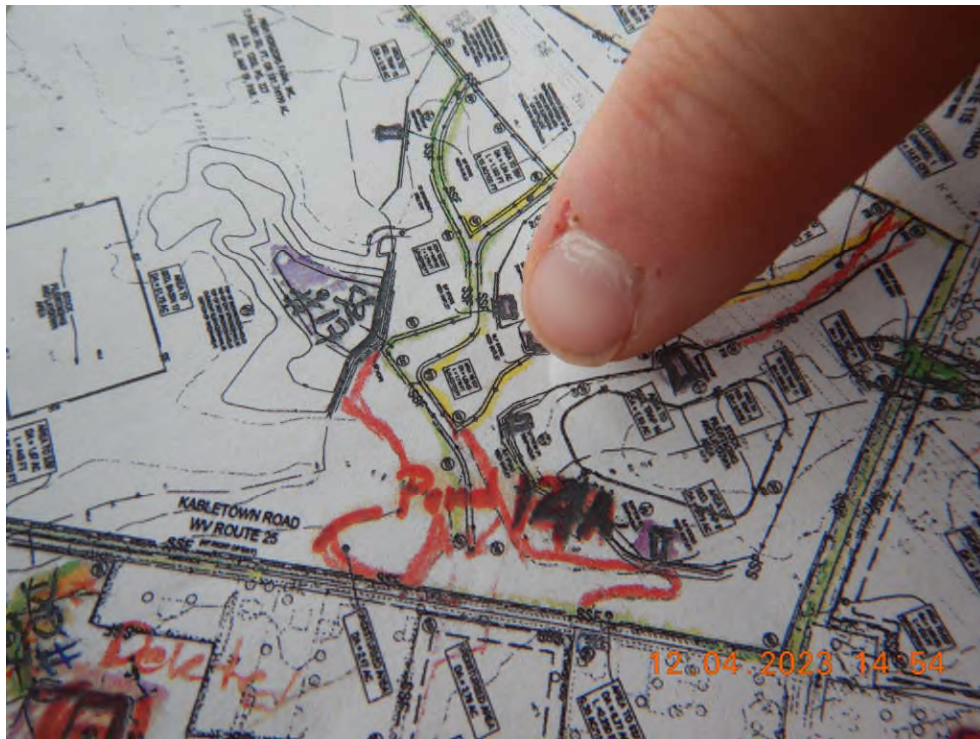
Pond 14A which is installed and not in the approved SWPPP.

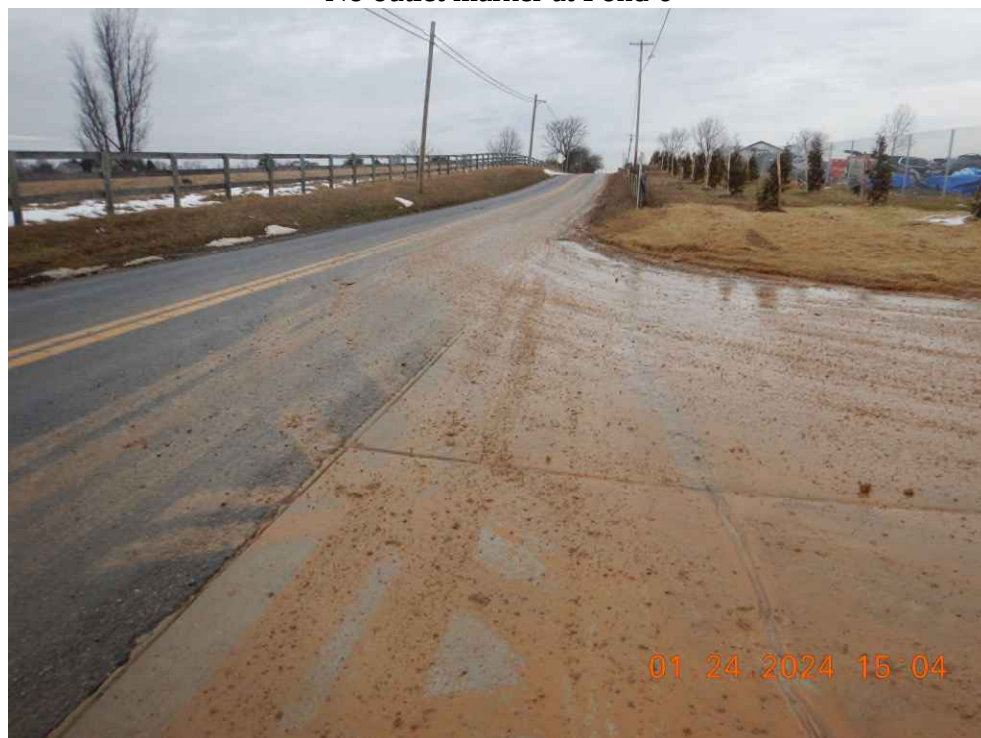
Track-out from Construction Entrance 2 that was not being cleaned during inspection.

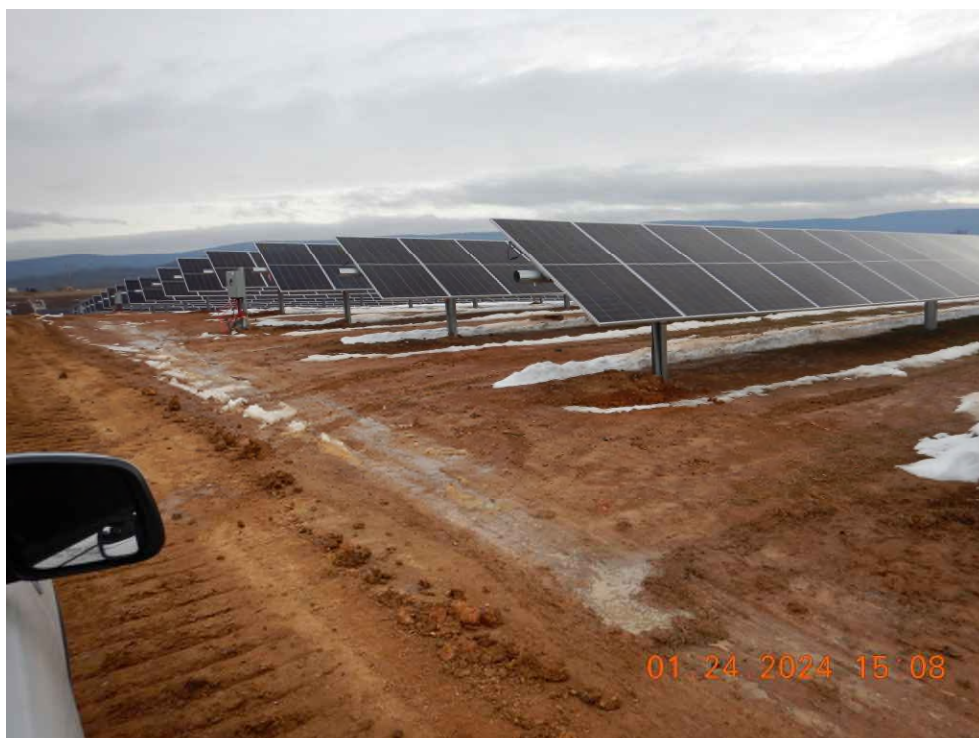
Unstabilized area that has not been worked within the past 14 days.

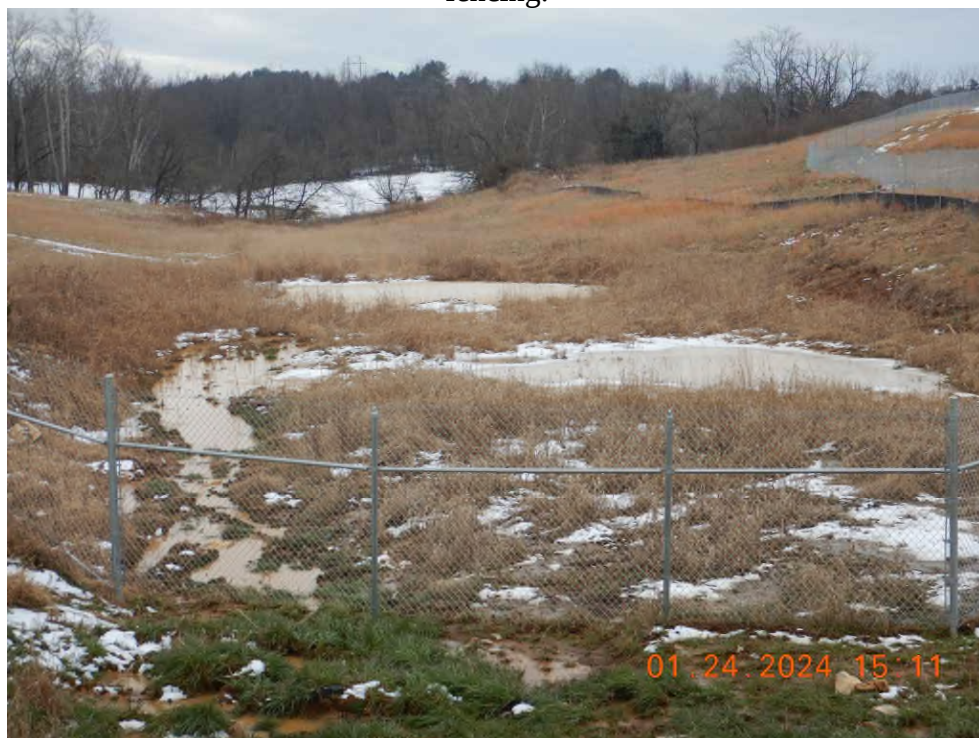
Supersilt fencing above outlet for Basin 13 needs maintenance. Sediment laden water is undermining the fencing.

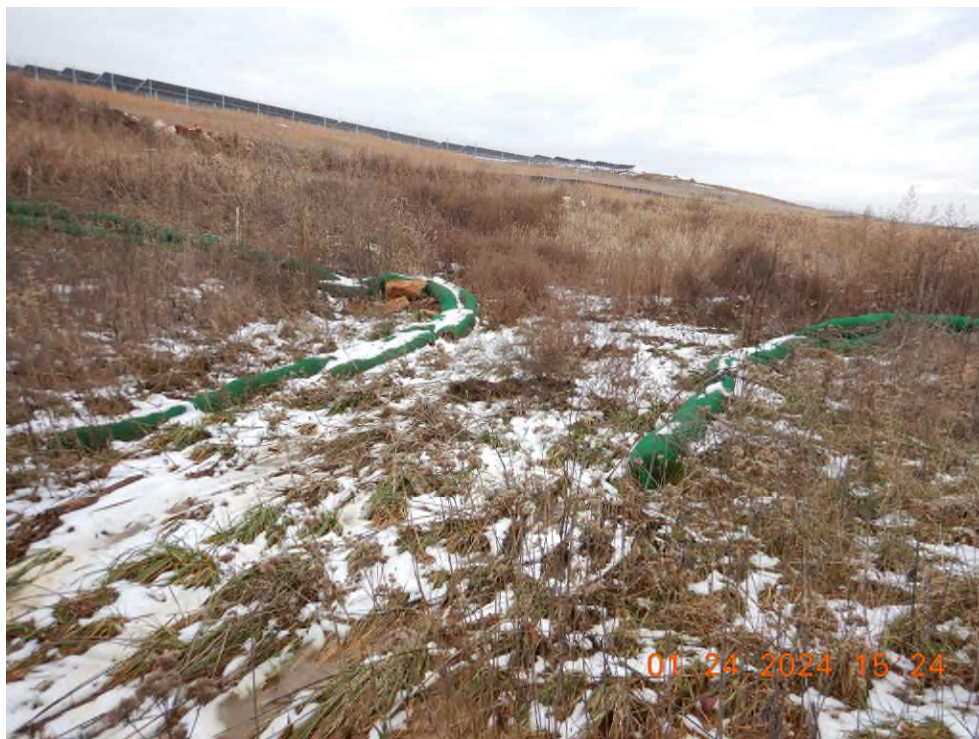
Sediment laden discharge into wetlands from Basin 13. Leading to Evitts Run.

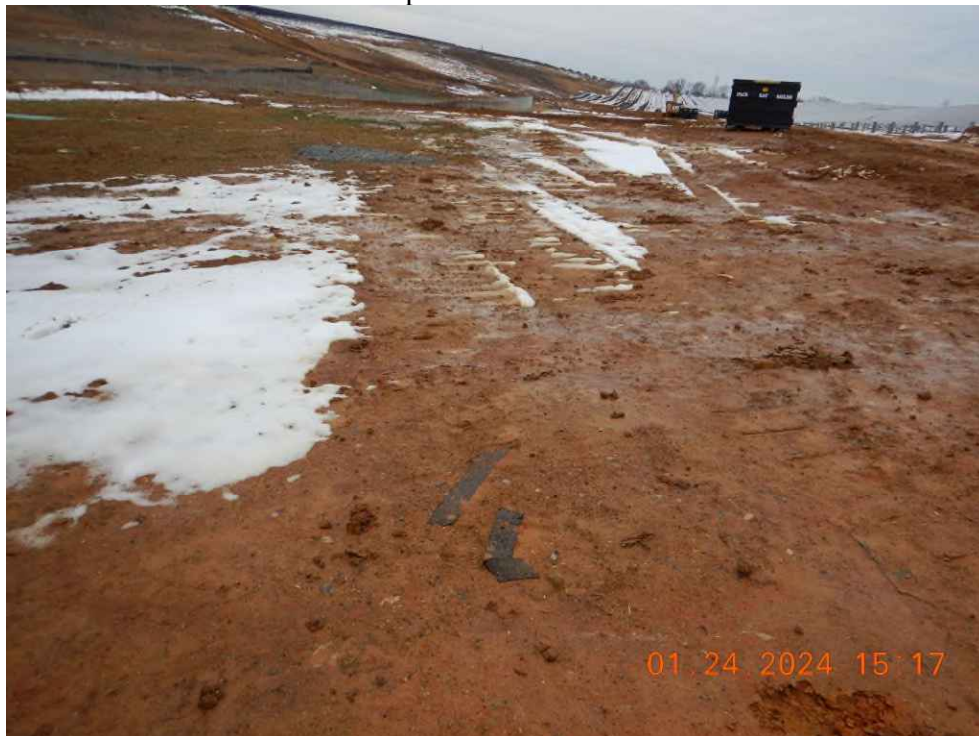
Area above Basin 13 is unstabilized prior to installation of the final stormwater feature.
