**CONSENT ORDER  
ISSUED UNDER THE  
WATER POLLUTION CONTROL ACT  
WEST VIRGINIA CODE CHAPTER 22, ARTICLE 11**

ORDER NO.: 10260

1. Horus West Virginia 1, LLC is conducting land disturbance activity associated with the Blake Solar Project in Jefferson County, West Virginia. Horus West Virginia 1, LLC was issued WV/NPDES Water Pollution Control Permit No. WV0115924, Registration No. WVR111837, on August 12, 2022.
2. On May 15, 2023, West Virginia Department of Environmental Protection (WVDEP) personnel conducted an inspection of the facility. During the inspection, violations of the following sections of the WV/NPDES permit were observed and documented:
  - a. Section II.H.1.d. – Horus West Virginia 1, LLC failed to provide an adequate stone access entrance/exit to reduce the tracking of sediment onto public or private roads.

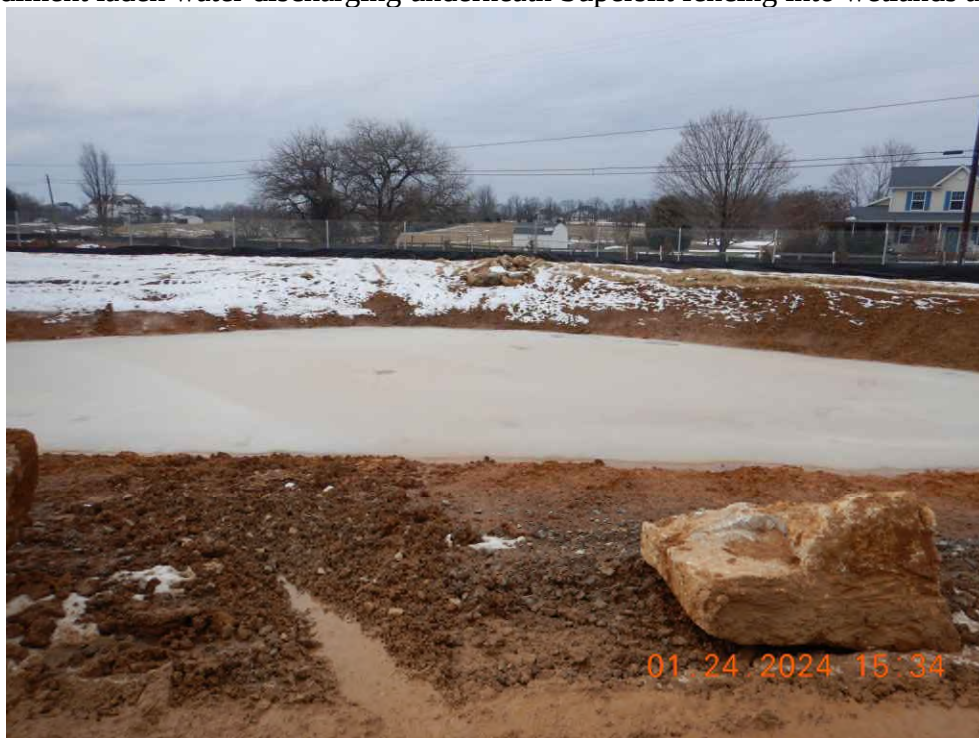
Sediment laden water discharging underneath Supersilt fencing into wetlands area.

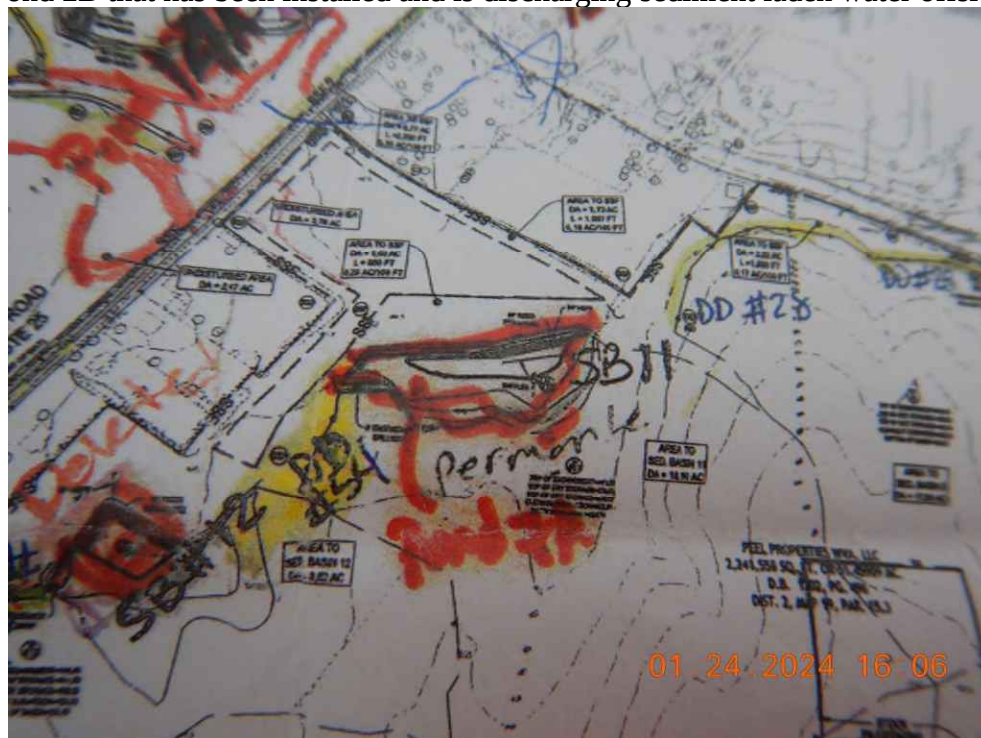
Pond 2B that has been installed and is discharging sediment laden water offsite.

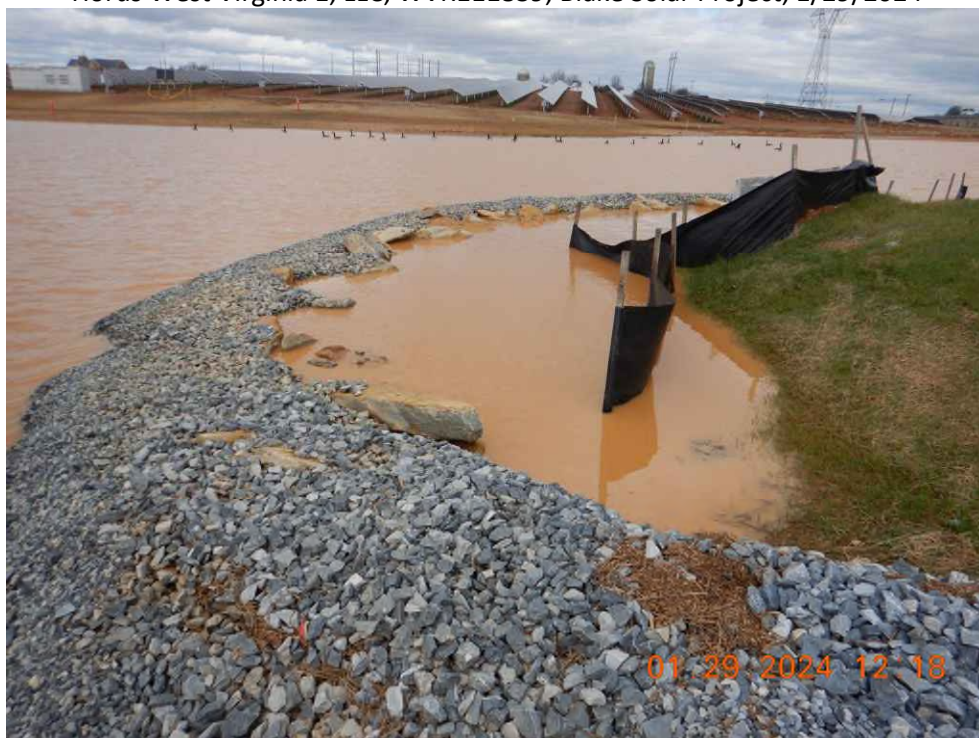
Basin 11 converted to stormwater management.

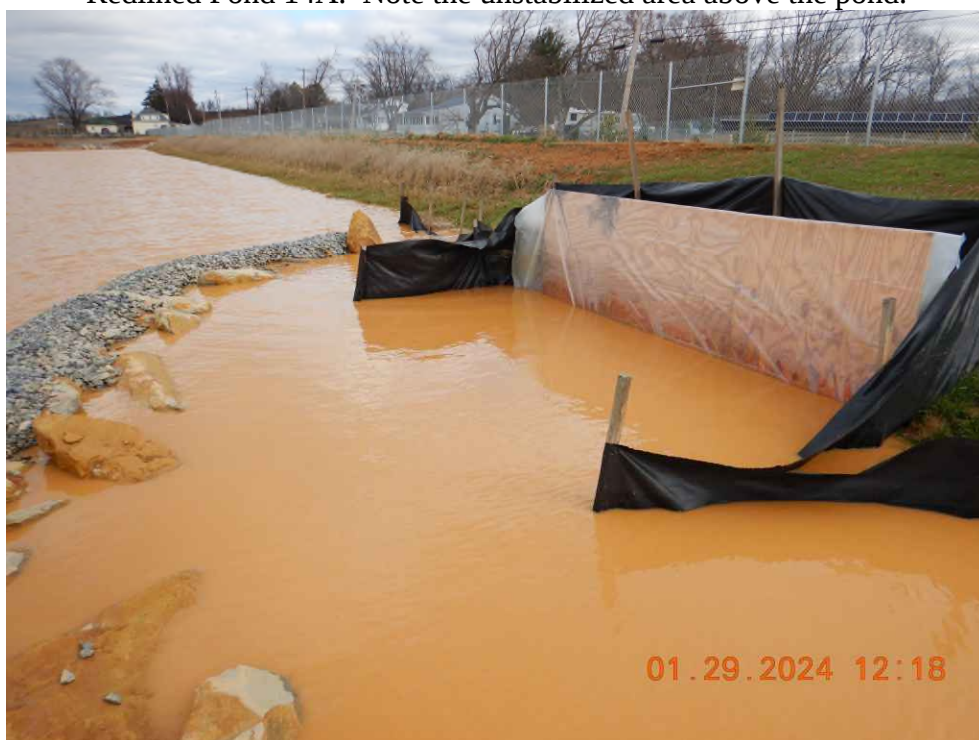
Redlined Pond 14A. Note the unstabilized area above the pond.

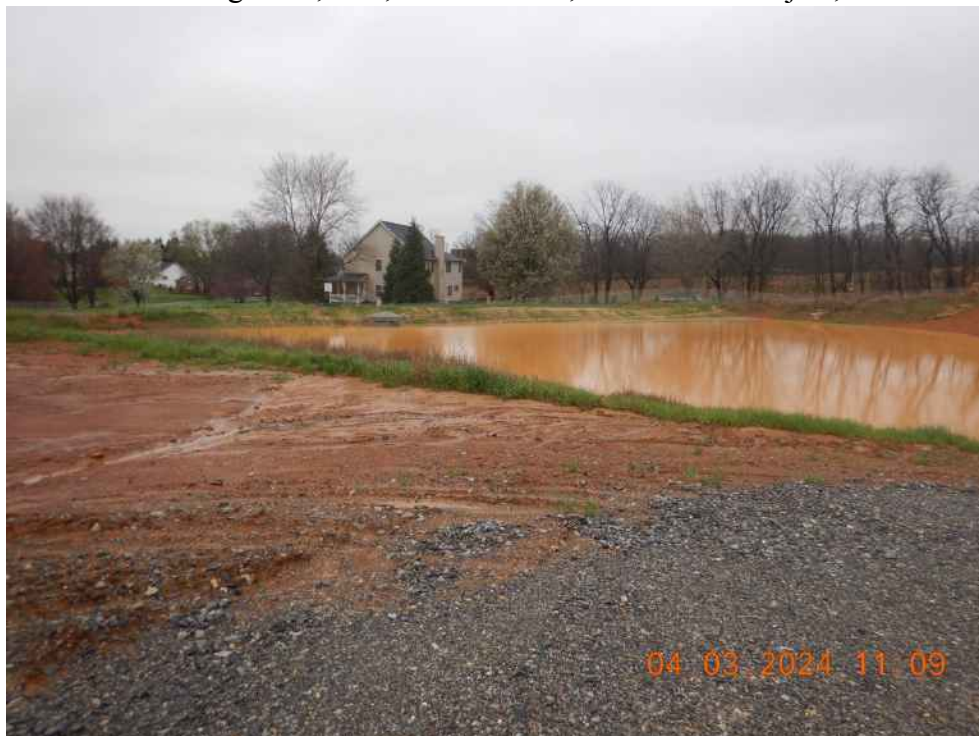
Pond 14A which is installed and not in the approved SWPPP.

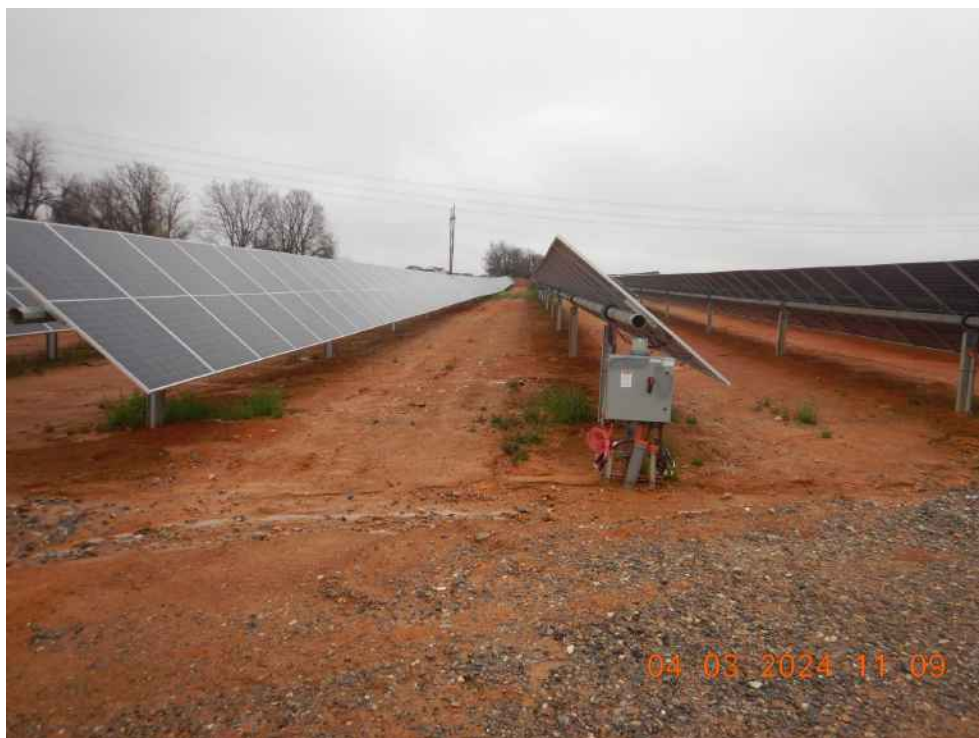
Area above Pond 16A that has not been stabilized.

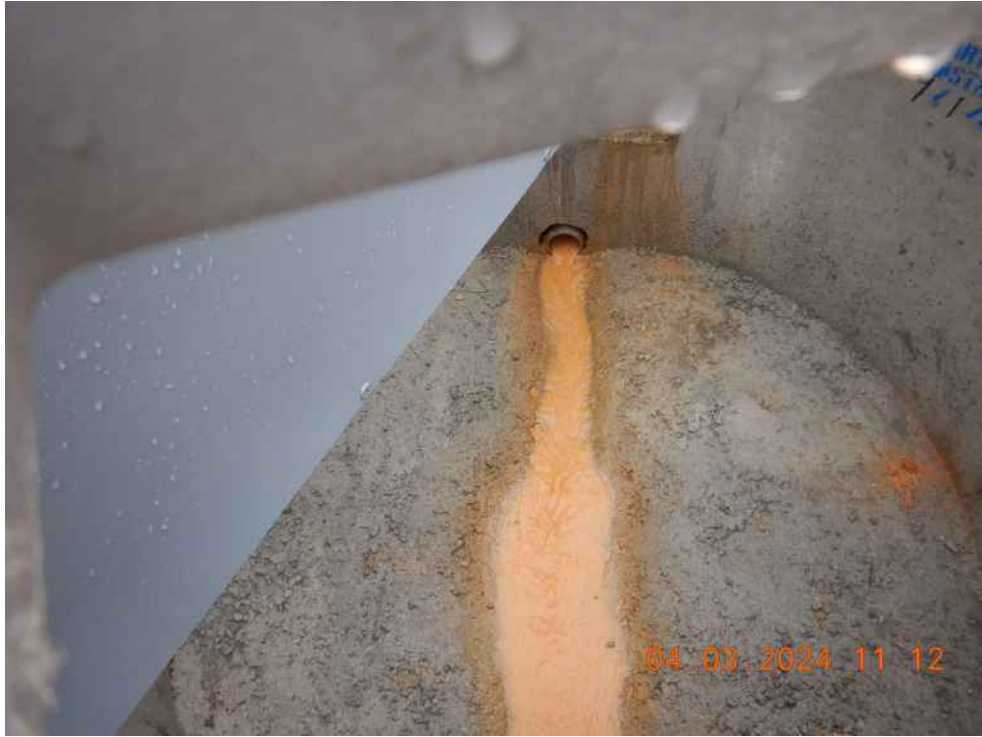
Unstabilized area above Pond 16A.

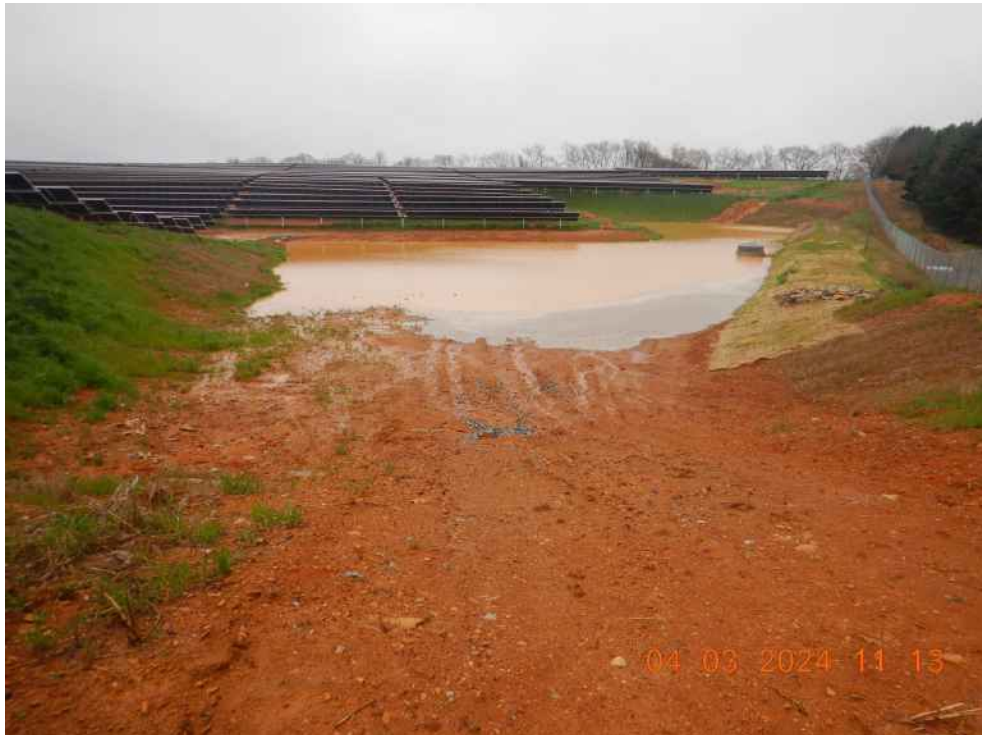
Structure for Pond 16A discharging sediment laden water.

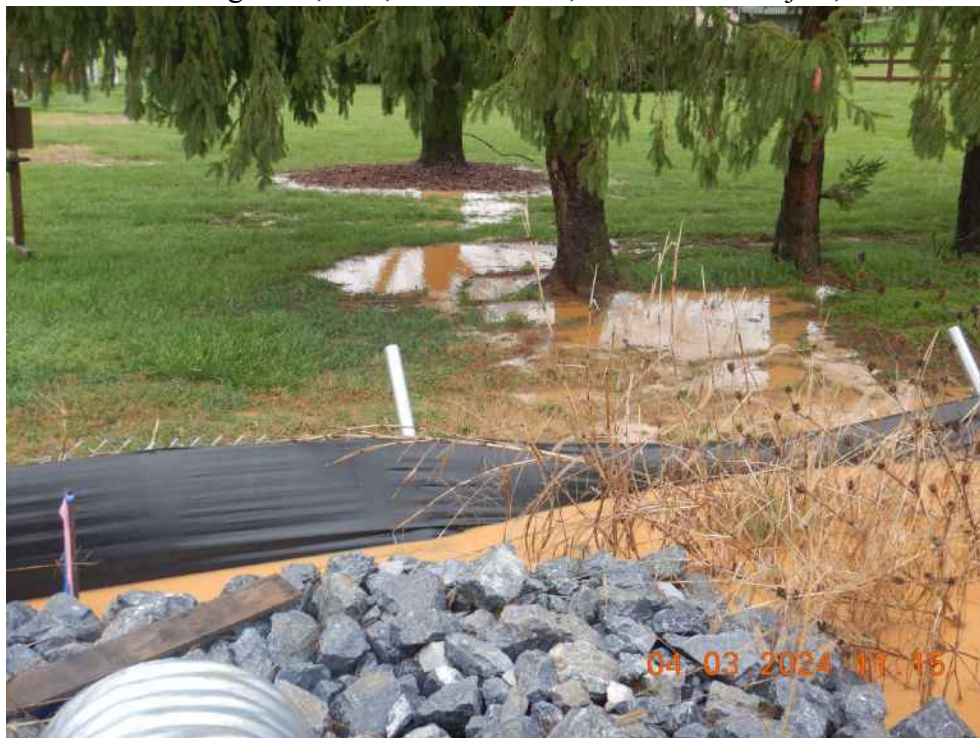
Area that has not been worked in the past 14 days and lacks stabilization above Pond 16B.

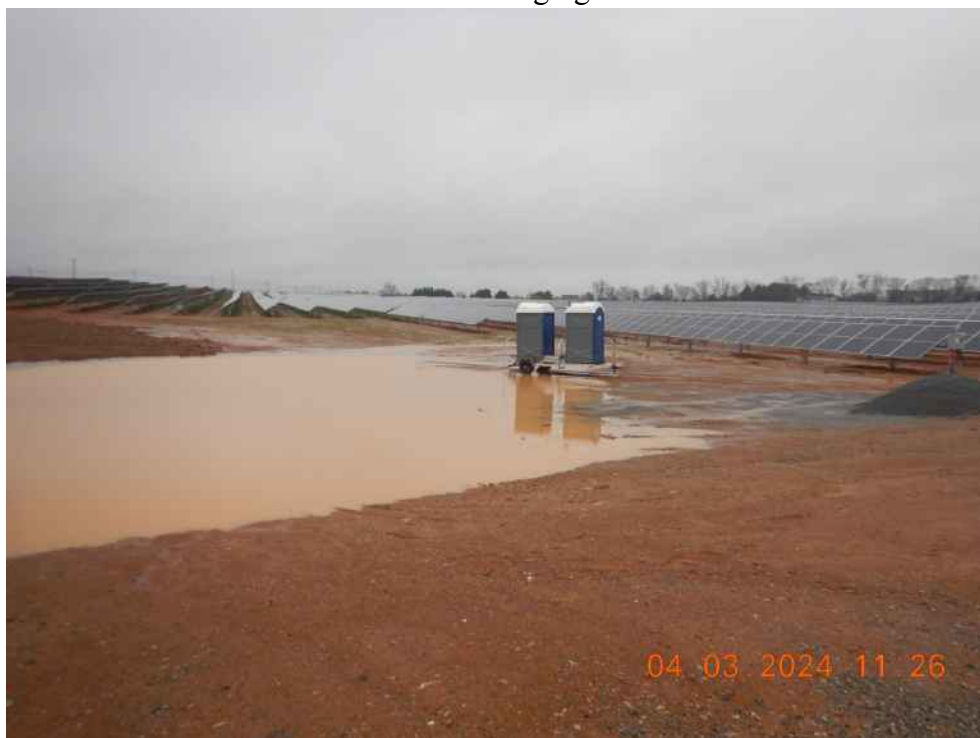
Pond 16B discharging offsite.

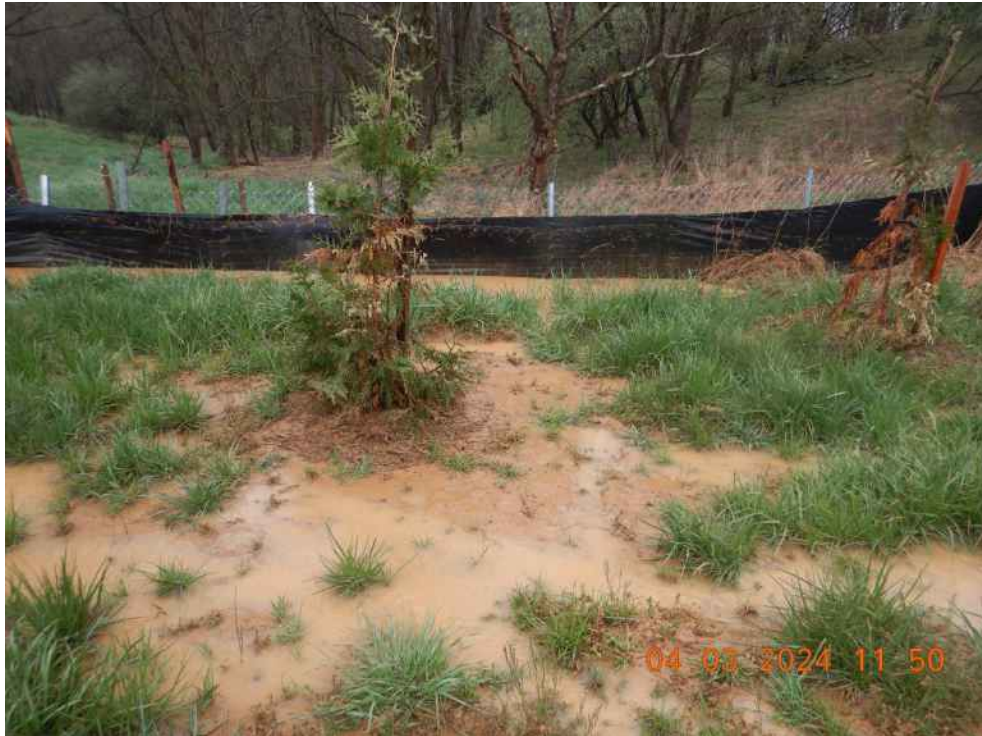
Unstabilized area that has not been excavated in the past 14 days.

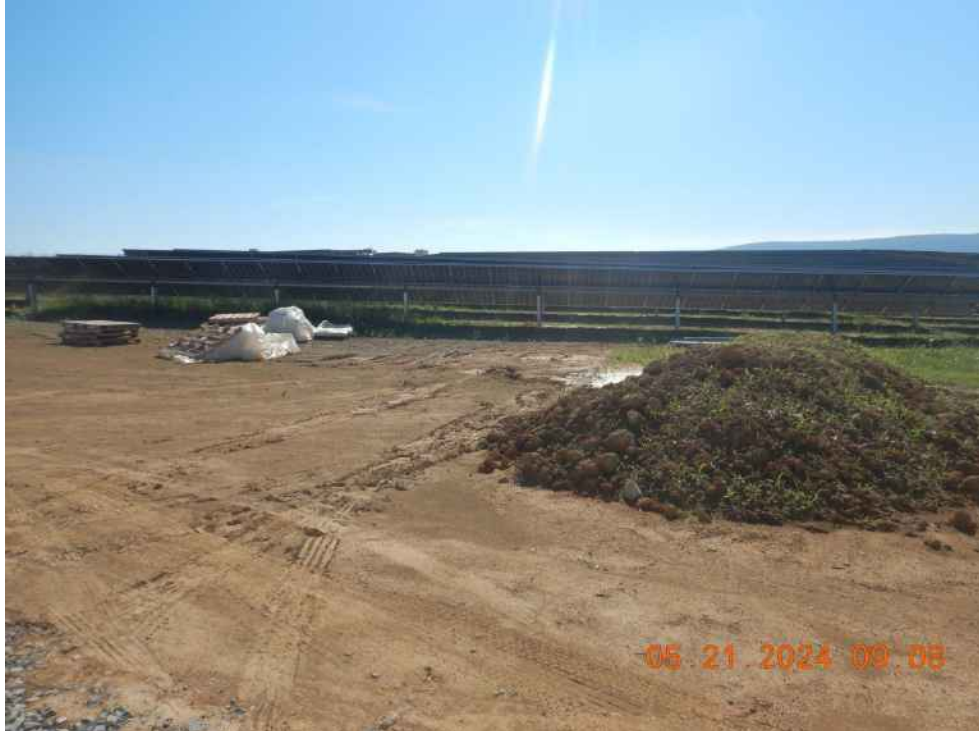
Area that has not been stabilized. Contributing area to Sediment Basin 12 which has been removed.

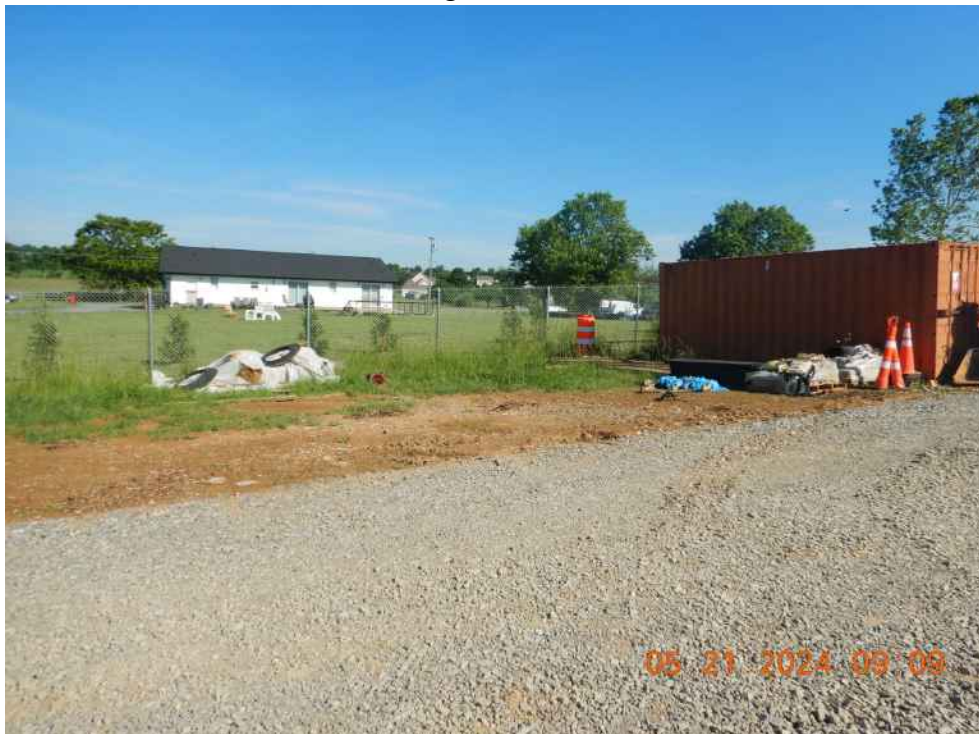
Unstabilized area where sediment basin 12 is supposed to be installed.

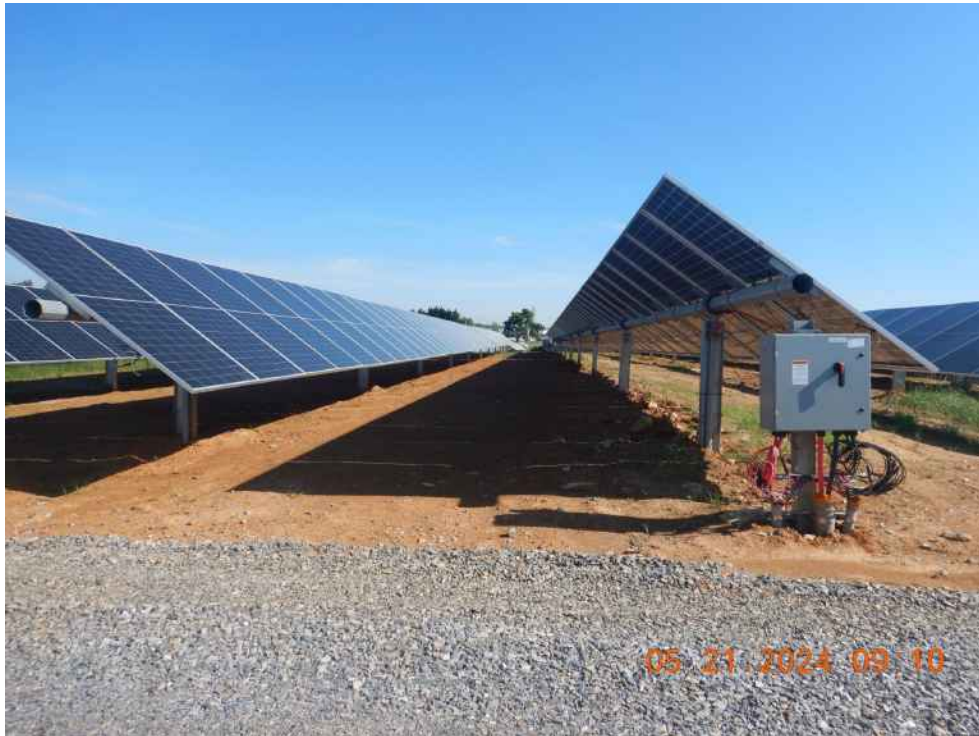
Area that has not been worked in the past 14 days and lacks stabilization

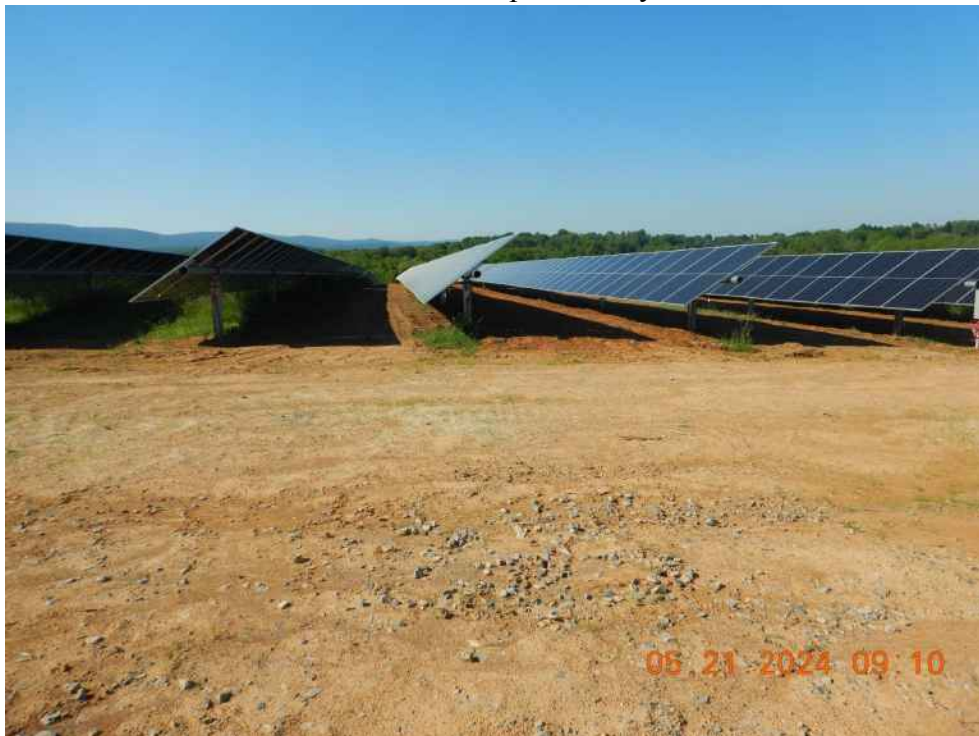
Area that has not been worked in the past 14 days and lacks stabilization.

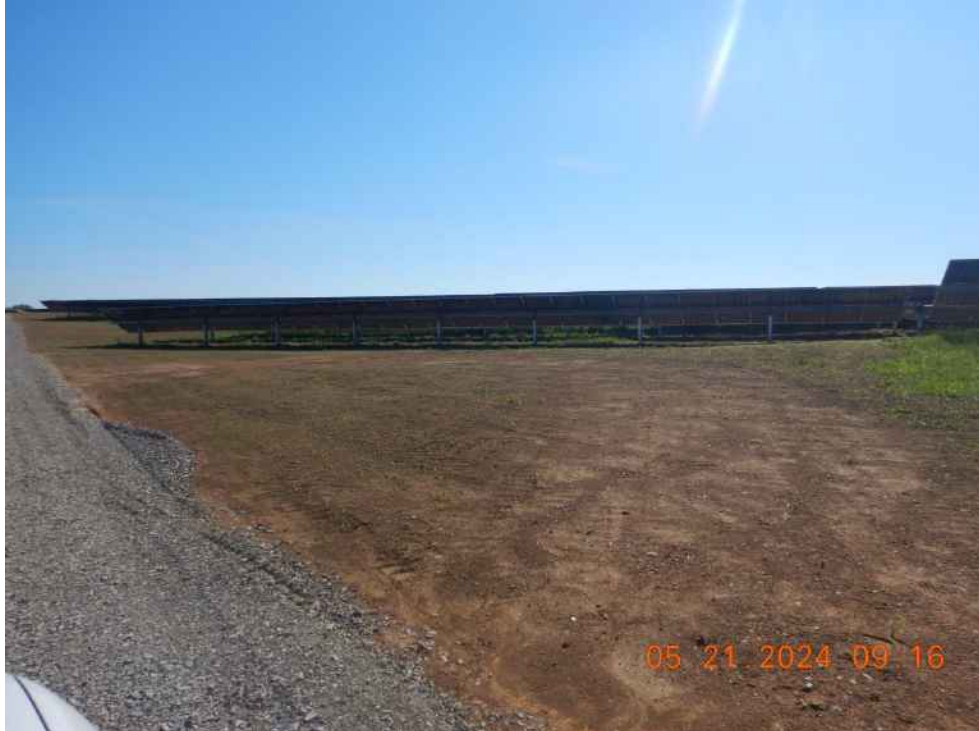
Area that has not been worked in the past 14 days and lacks stabilization.

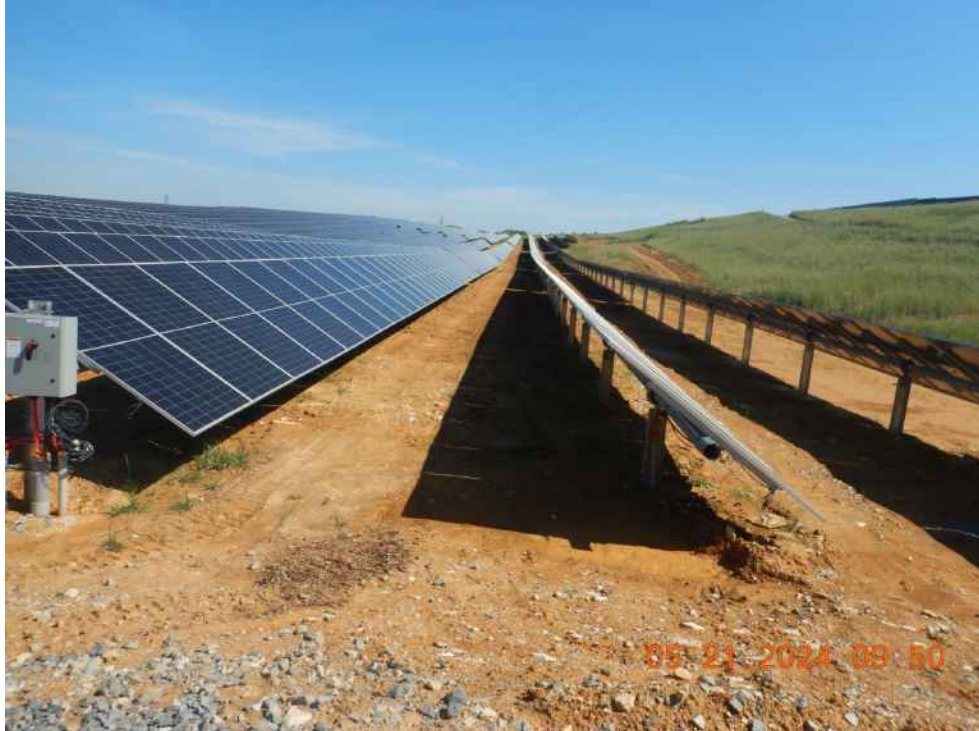
Area that has not been worked in the past 14 days and lacks stabilization.

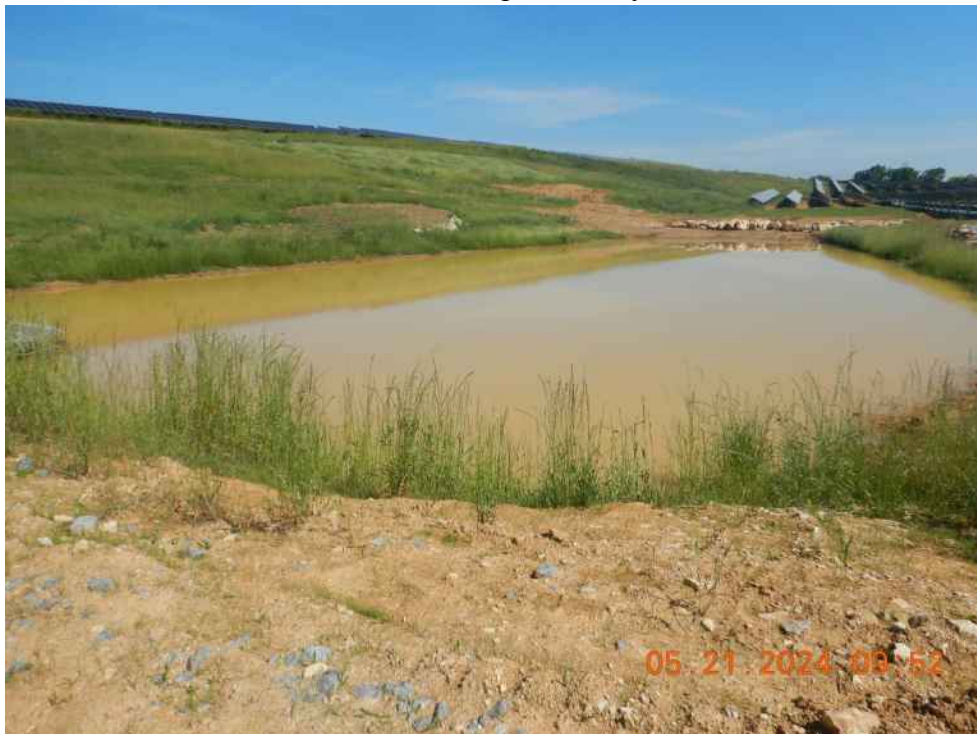
Sediment Basin 13 discharging off site directly into Evitts Run.  
Sediment Laden Water Leaving Site

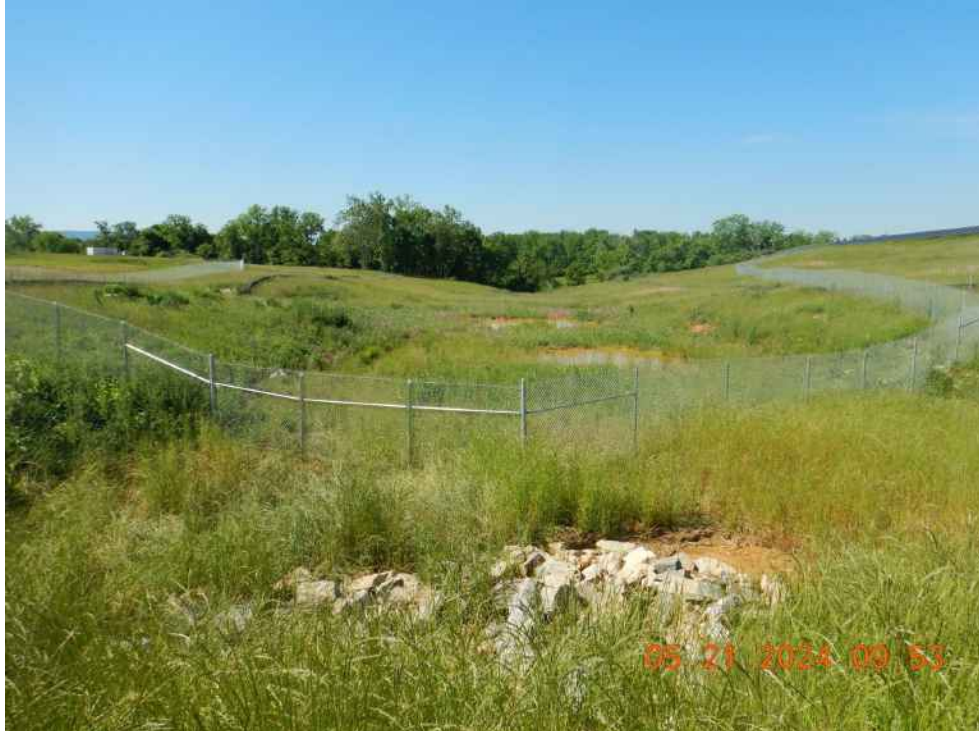
Sediment Basin 13 discharging off site directly into Evitts Run. Sediment Laden Water Leaving Site

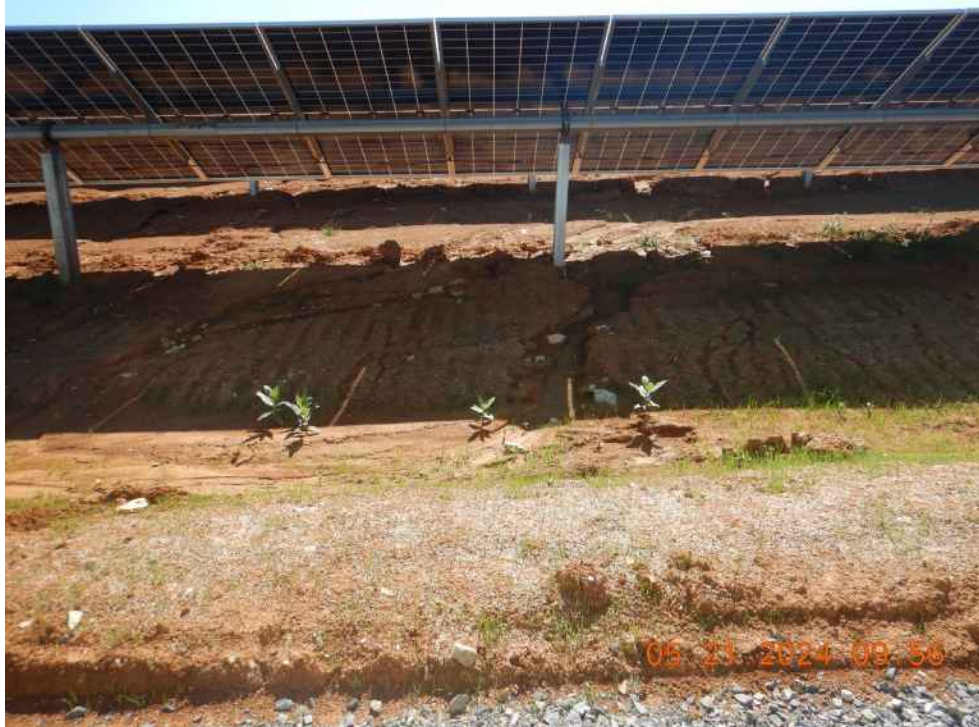
Area that has not been worked in the past 14 days and lacks stabilization.

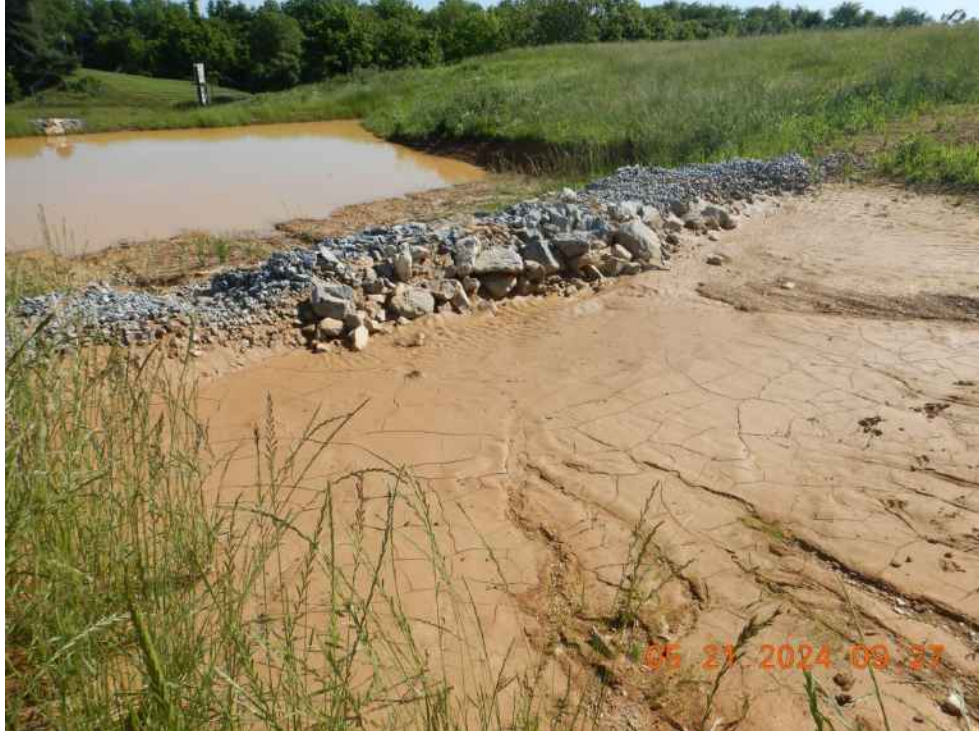
Sediment Basin 6 discharging sediment laden water offsite.

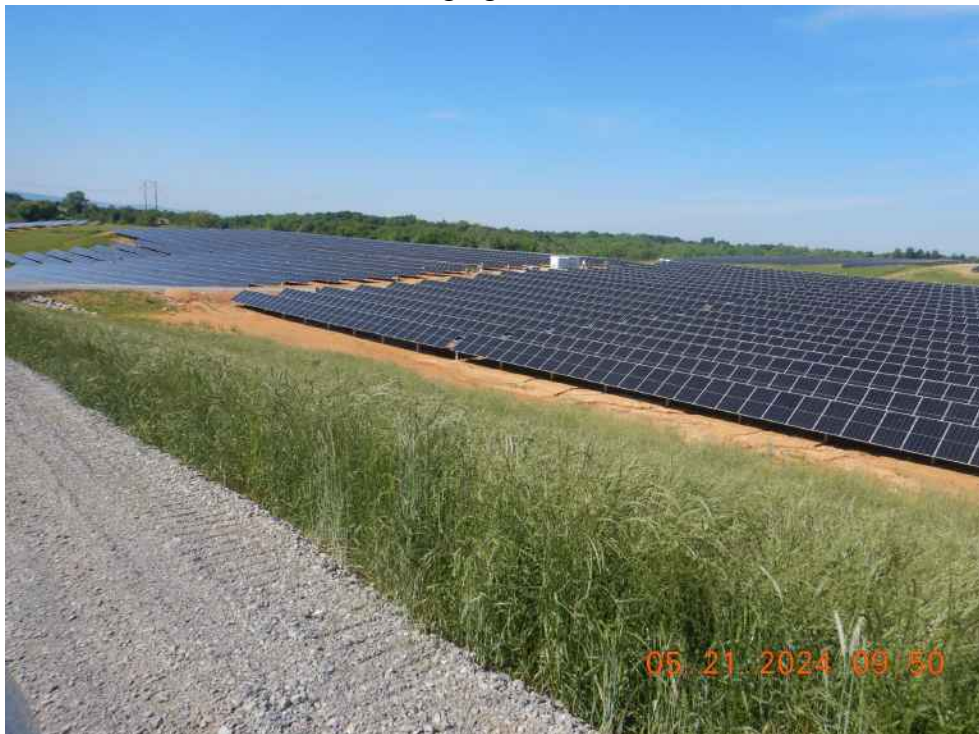
Unstabilized area that has not been stabilized or worked within 14 days.

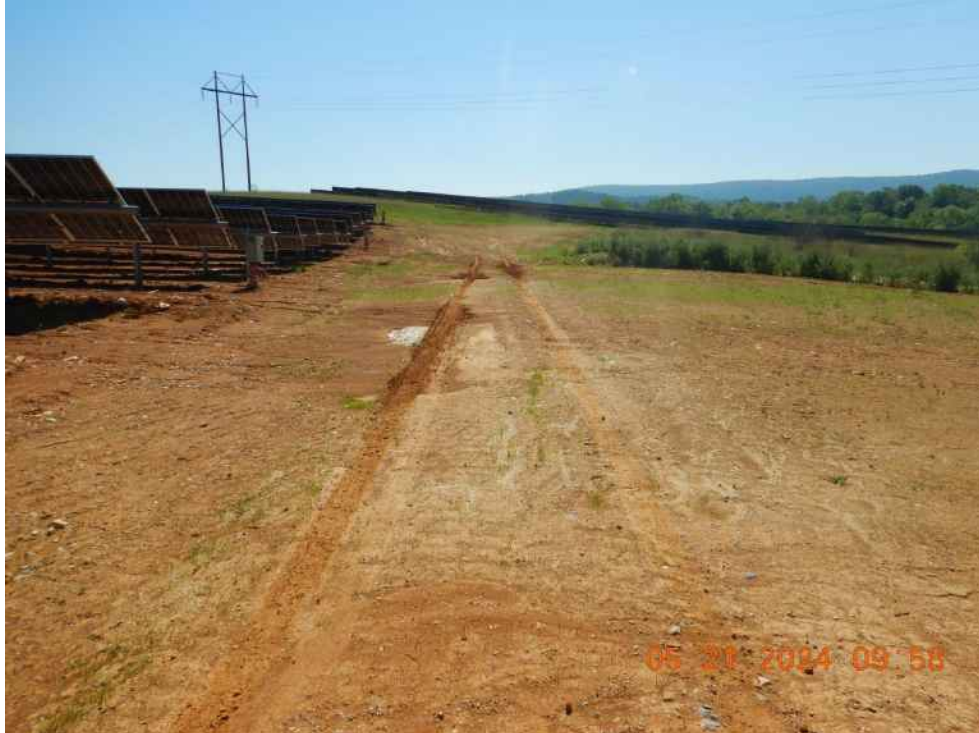
Unstabilized area above Sediment Basin 15.

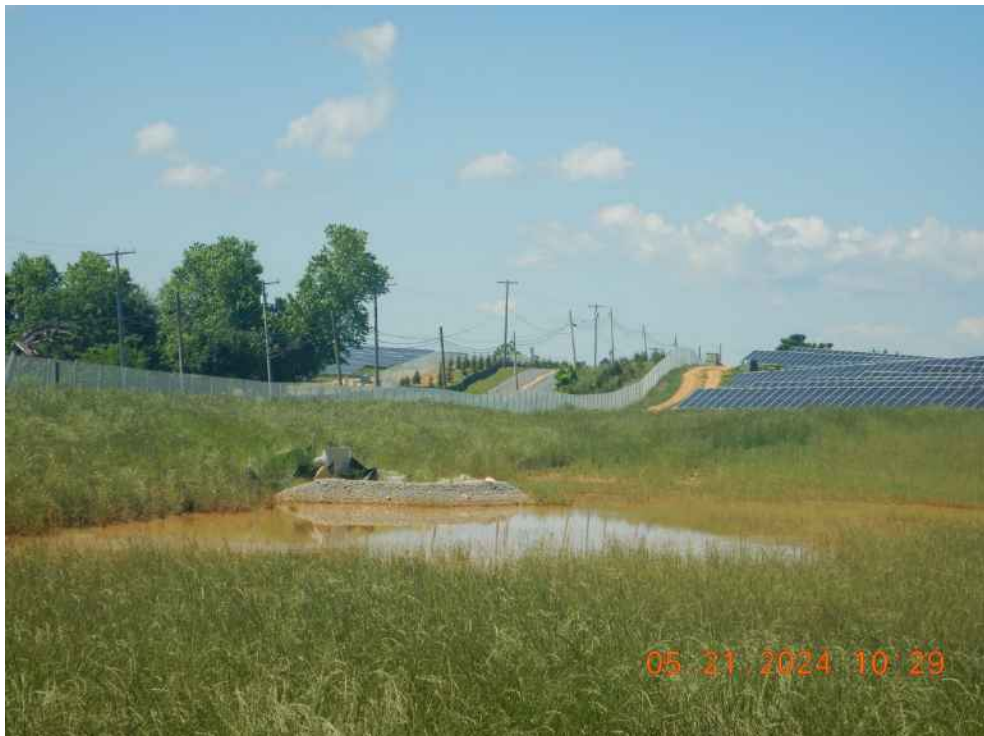
Unstabilized area above and around Pond 14A.

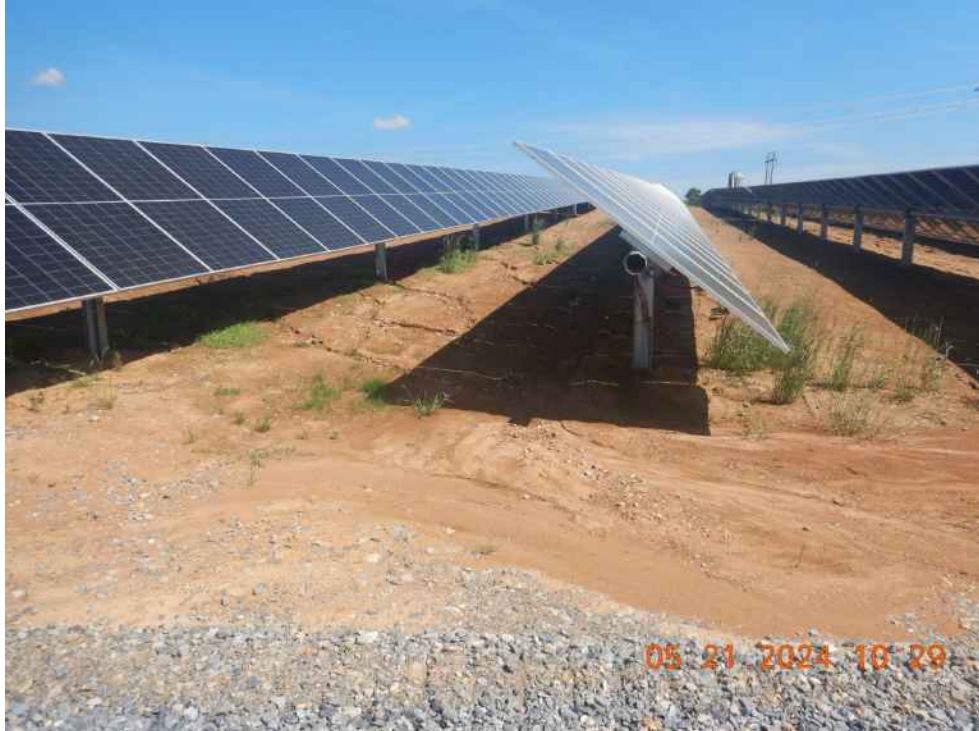
Unstabilized area above and around Pond 14A.

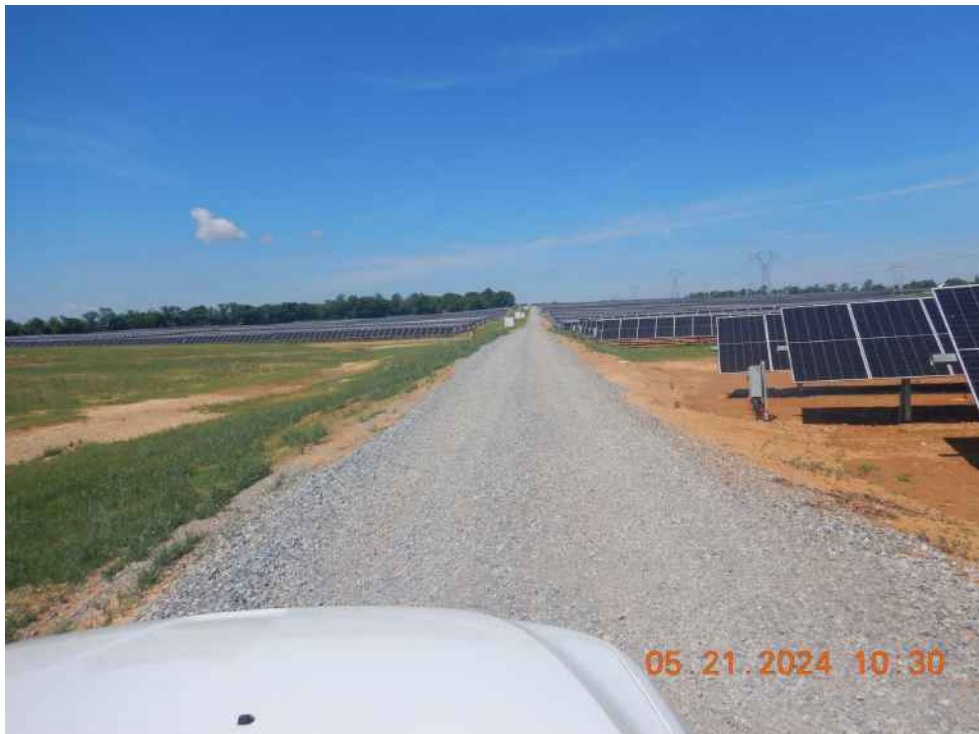
Unstabilized area above and around Pond 14A.

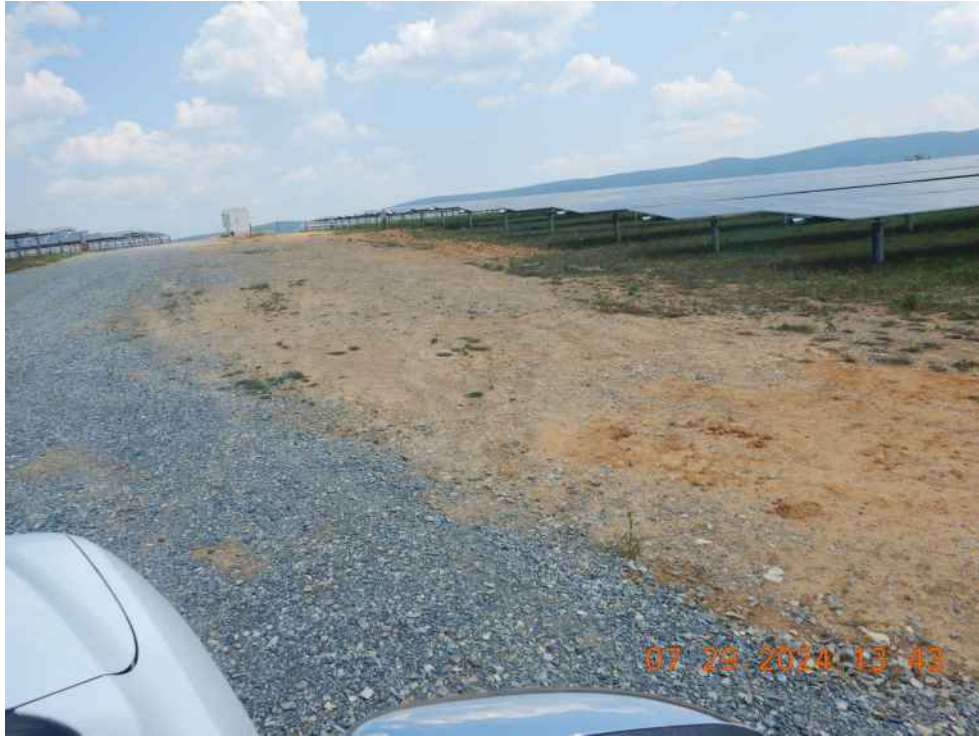
An unstabilized area that has not been actively worked. Sediment basin 16 drainage area.

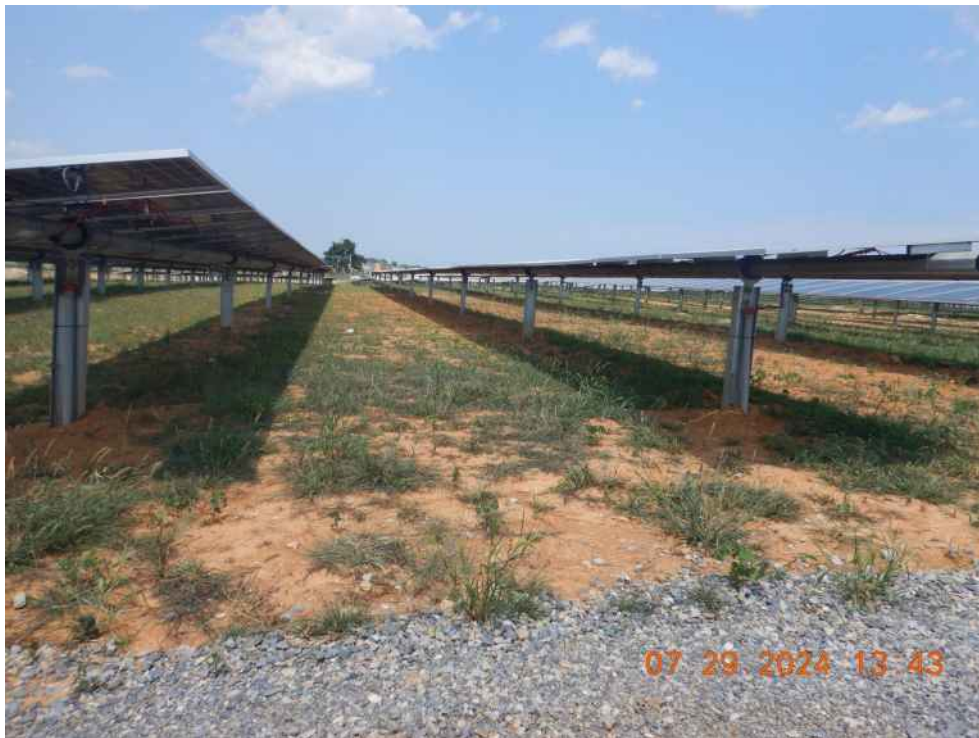
An unstabilized area that has not been actively worked. Sediment basin 12 drainage area.

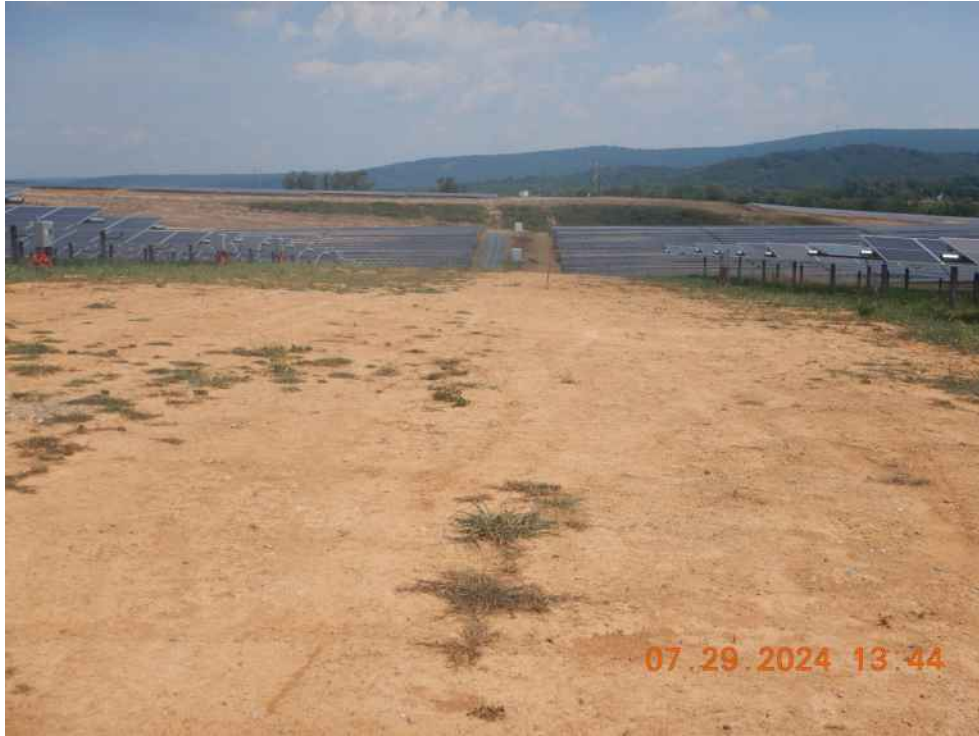
An unstabilized area that has not been actively worked. Sediment basin 13 drainage area.

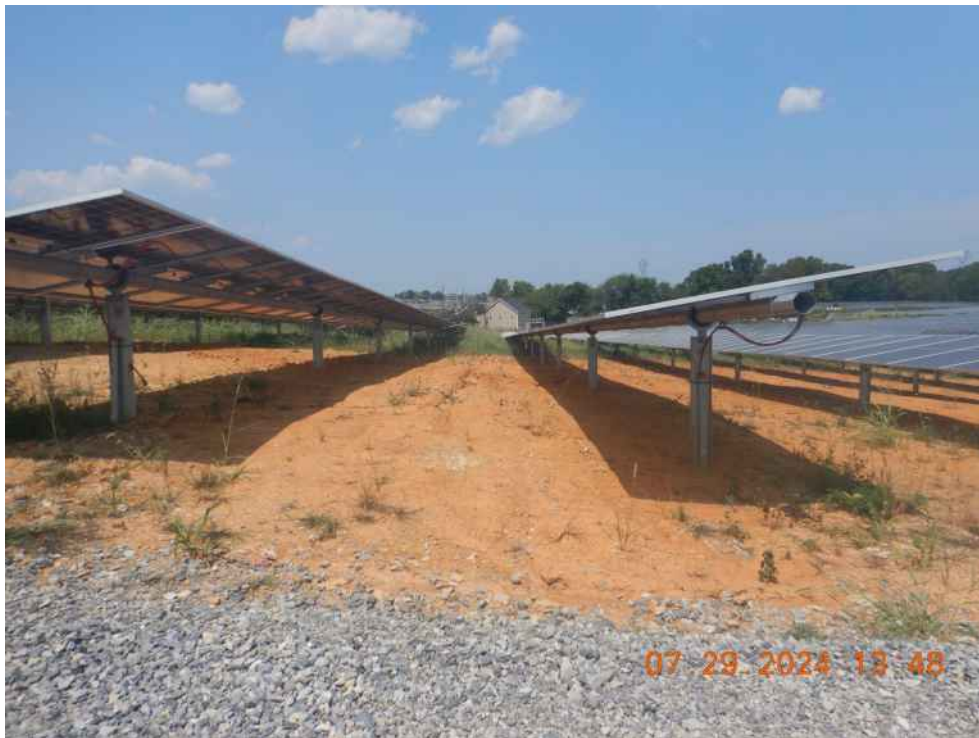
An unstabilized area that has not been actively worked. Sediment basin 17 drainage area.

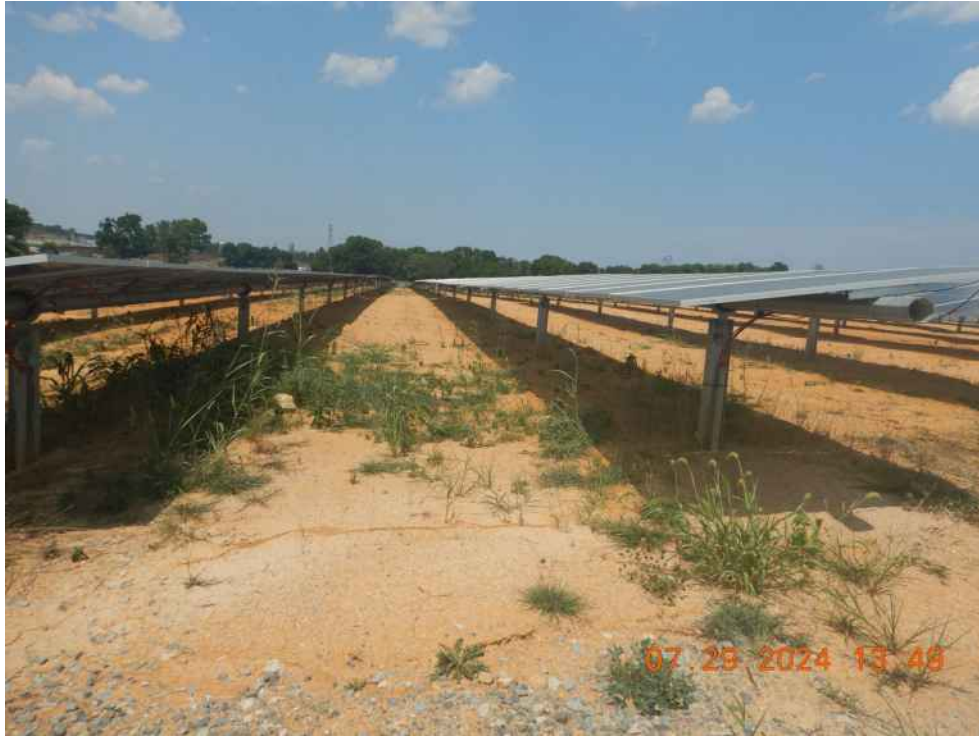
An unstabilized area that has not been actively worked. Sediment basin 6 drainage area.
