**CONSENT ORDER  
ISSUED UNDER THE  
WATER POLLUTION CONTROL ACT  
WEST VIRGINIA CODE CHAPTER 22, ARTICLE 11**

ORDER NO.: 10260

1. Horus West Virginia 1, LLC is conducting land disturbance activity associated with the Blake Solar Project in Jefferson County, West Virginia. Horus West Virginia 1, LLC was issued WV/NPDES Water Pollution Control Permit No. WV0115924, Registration No. WVR111837, on August 12, 2022.
2. On May 15, 2023, West Virginia Department of Environmental Protection (WVDEP) personnel conducted an inspection of the facility. During the inspection, violations of the following sections of the WV/NPDES permit were observed and documented:
  - a. Section II.H.1.d. – Horus West Virginia 1, LLC failed to provide an adequate stone access entrance/exit to reduce the tracking of sediment onto public or private roads.

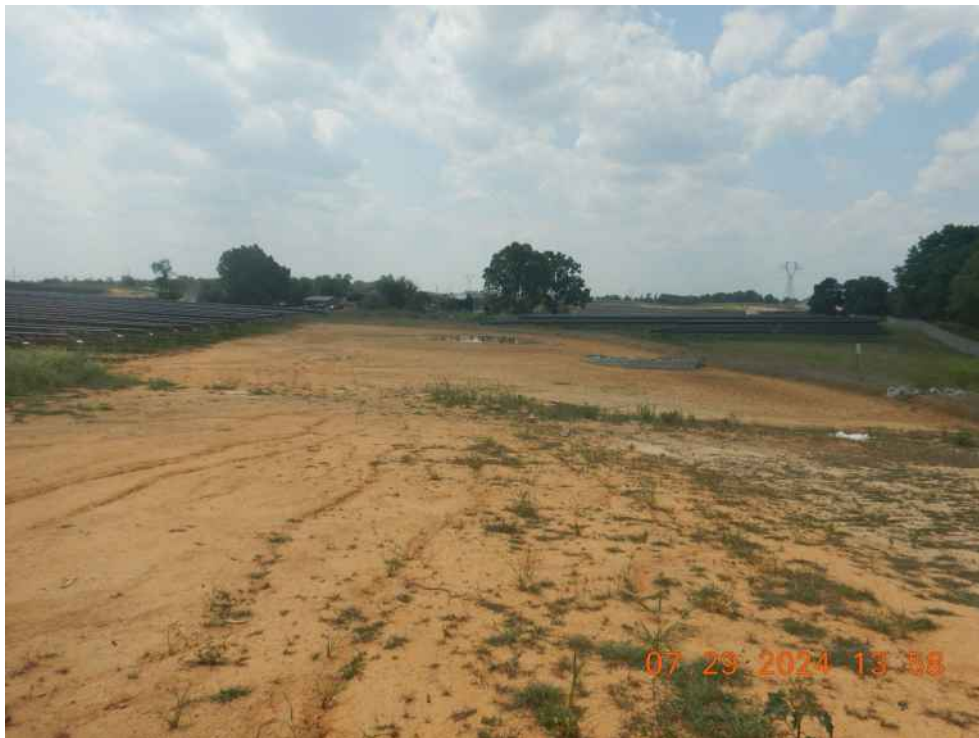
An unstabilized area, above sediment basin 6, that has not been stabilized.

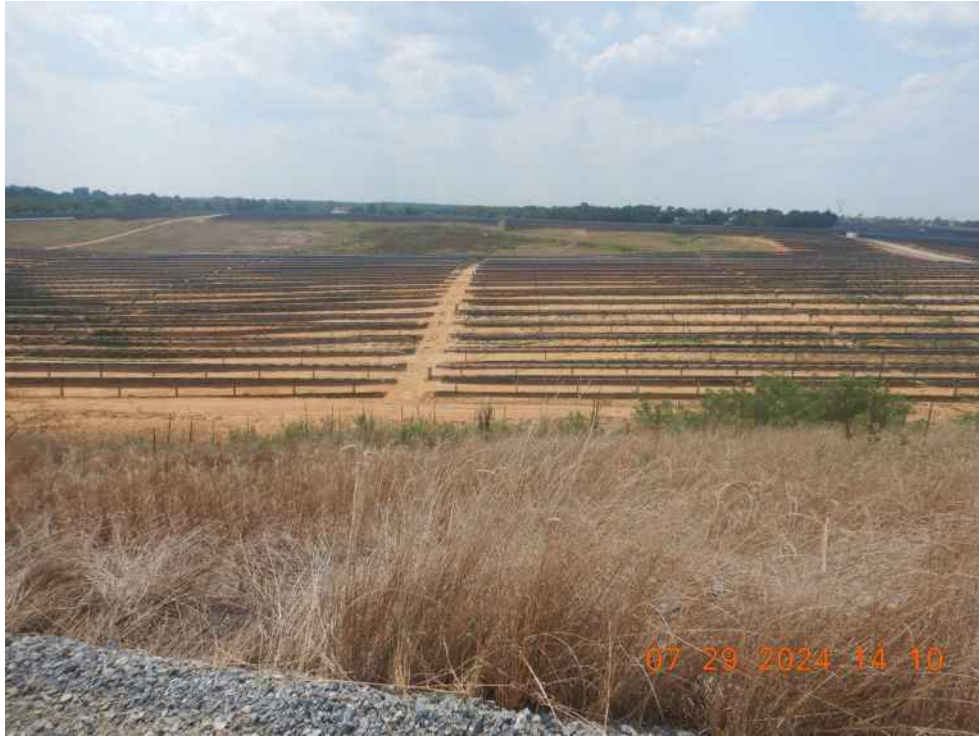
An unstabilized area that has not been actively worked. Sediment basin 13 drainage area.

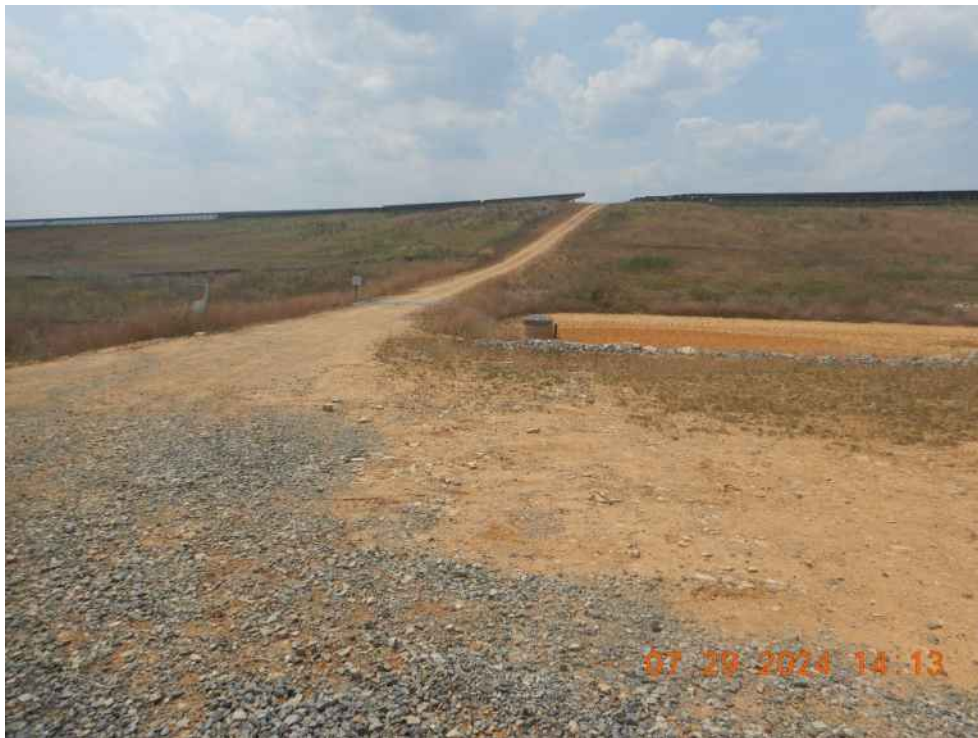
An unstabilized area, above sediment basin 13, that has not been stabilized.

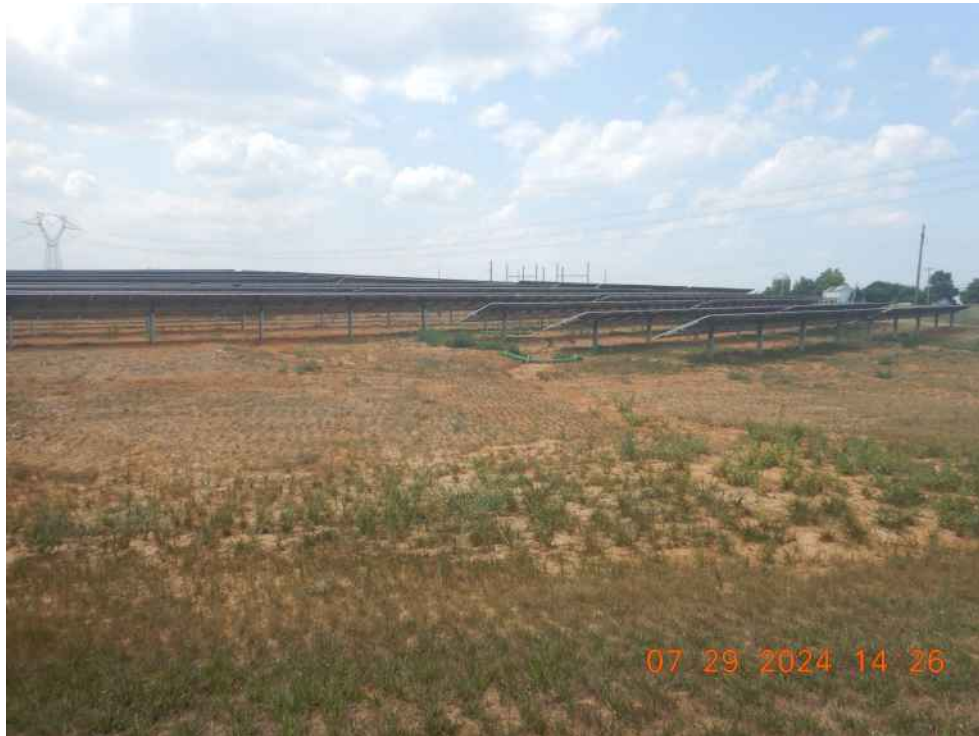
An unstabilized area that has not been actively worked. Sediment basin 17 drainage area.

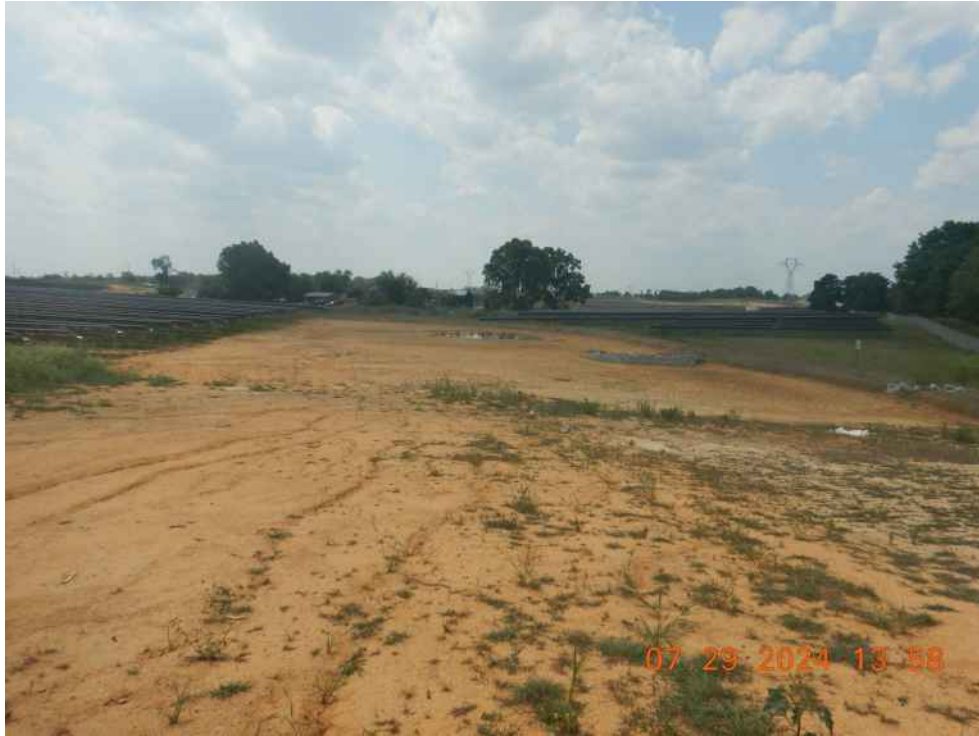
Sediment basin 10, that has been converted prior to all uphill stabilization being finished.

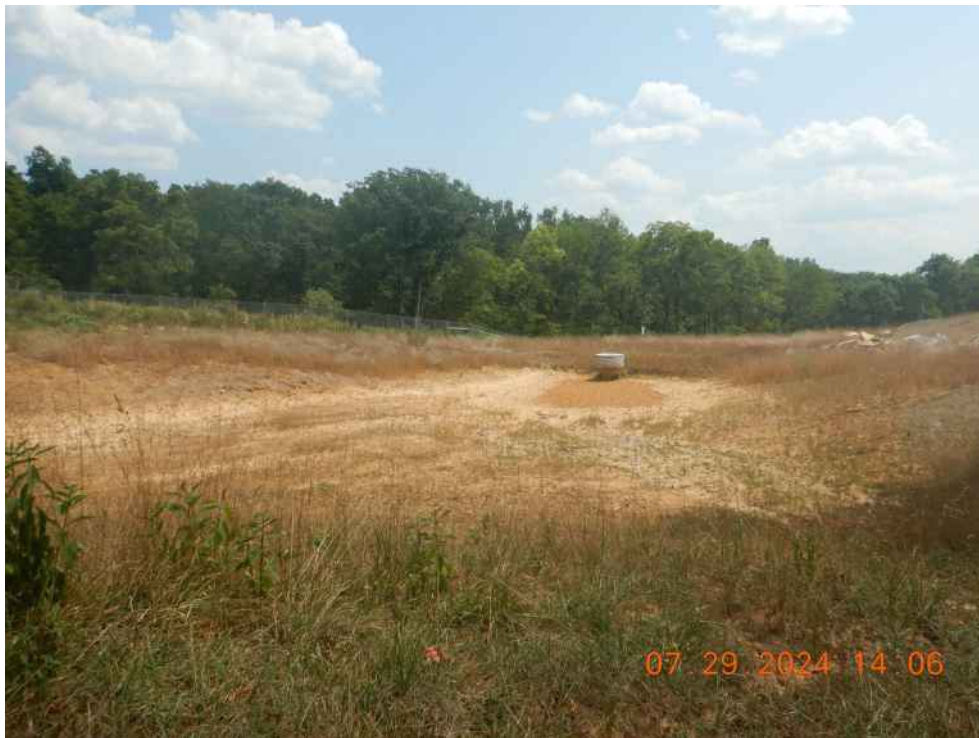
Sediment basin 5, that has been converted prior to all uphill disturbance being stabilized.

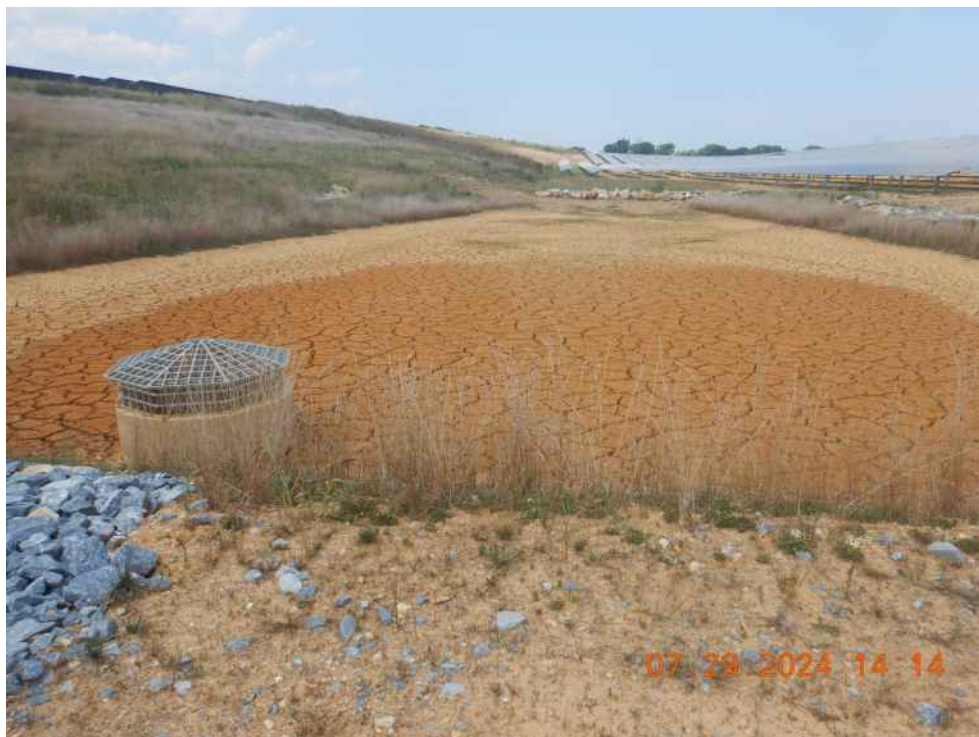
Sediment basin 13, that has been converted prior to all uphill disturbance being finished.

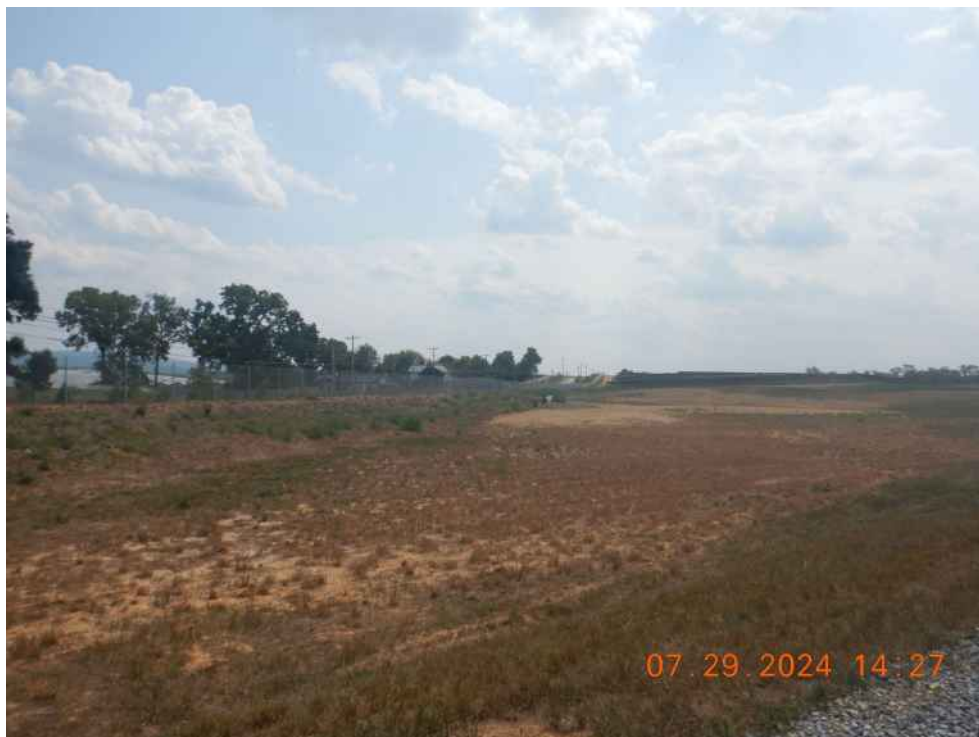
Pond 14A, that has not been formally modified.

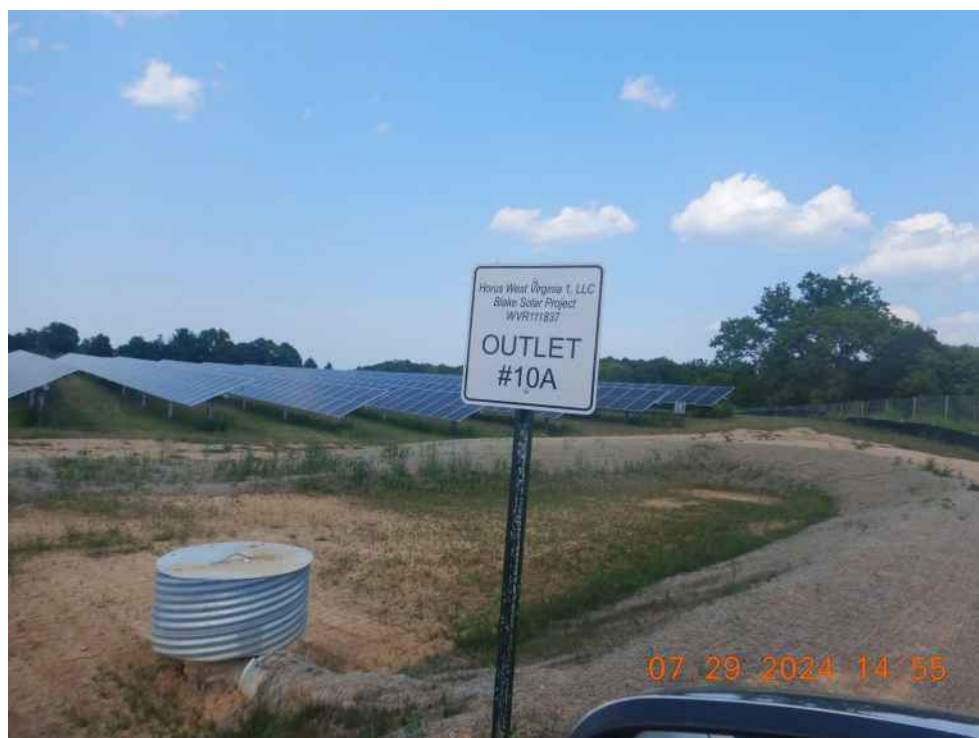
Sediment basin 9, that has been converted prior to all uphill disturbance being stabilized.

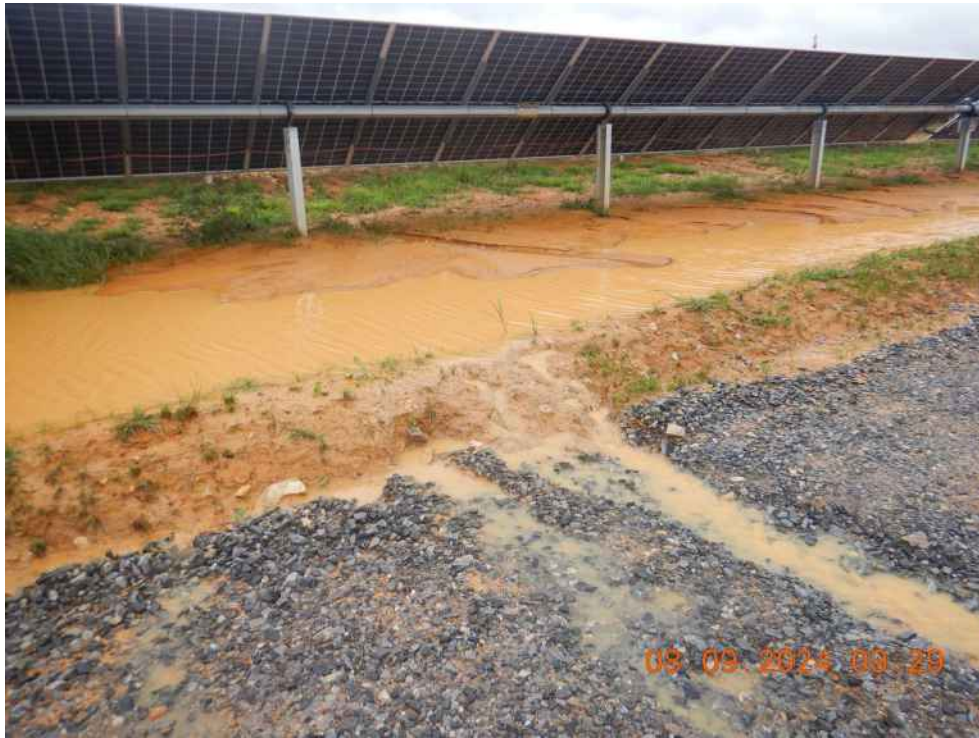
An unstabilized area that has not been actively worked. Sediment basin 13 drainage area.

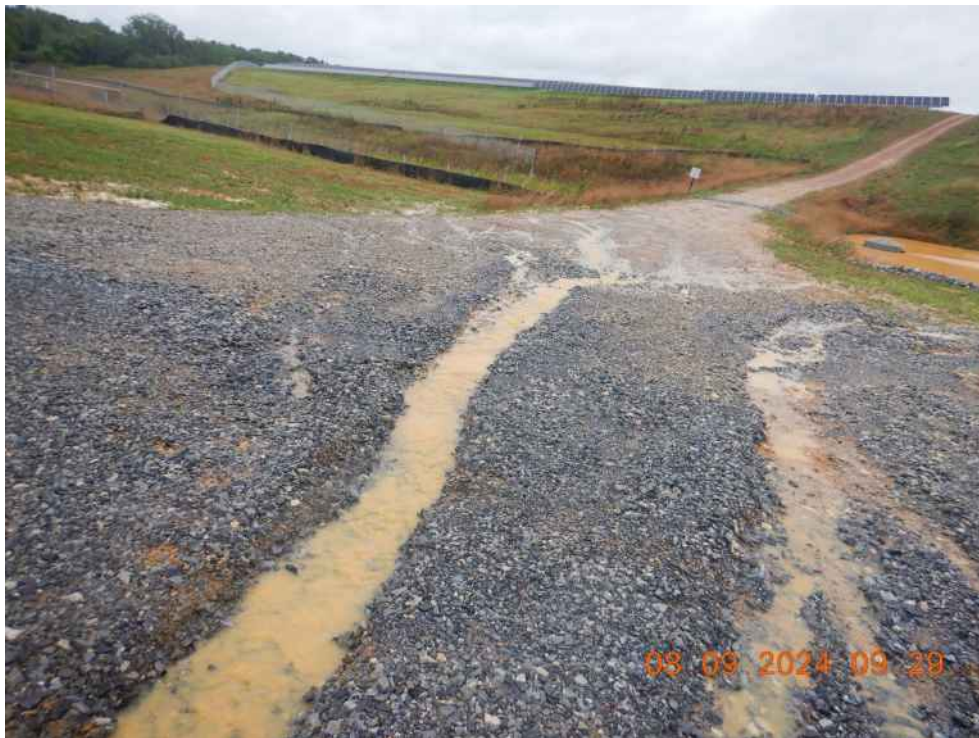
An unstabilized area that has not been actively worked. Sediment basin 13 drainage area.

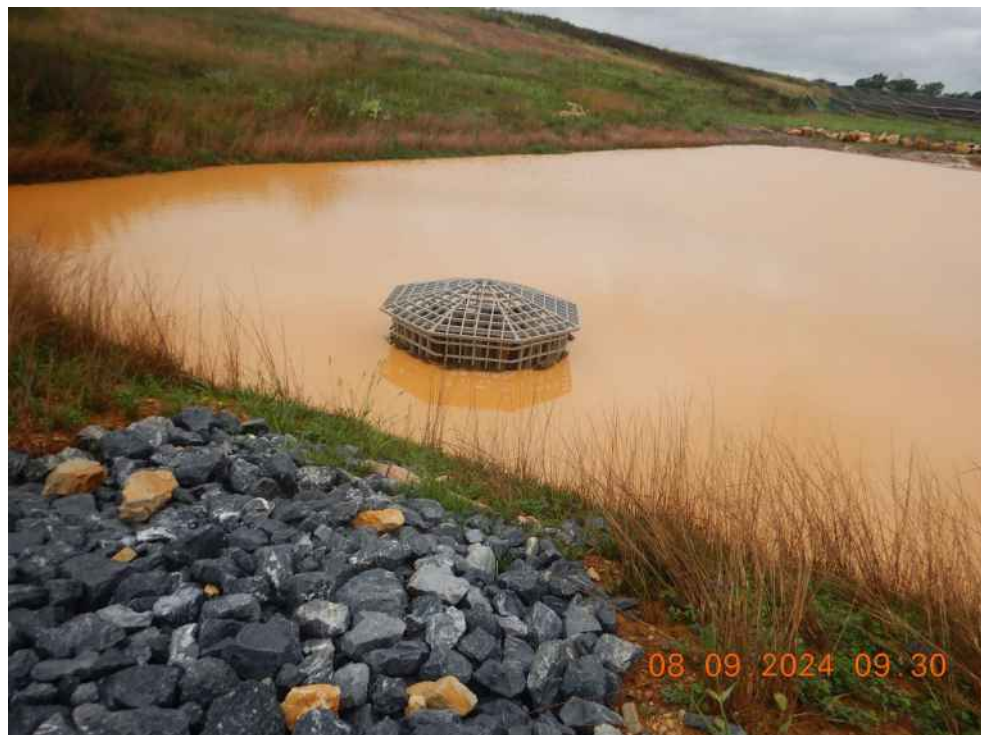
Sediment basin 12 drainage area discharging into Evitts Run.

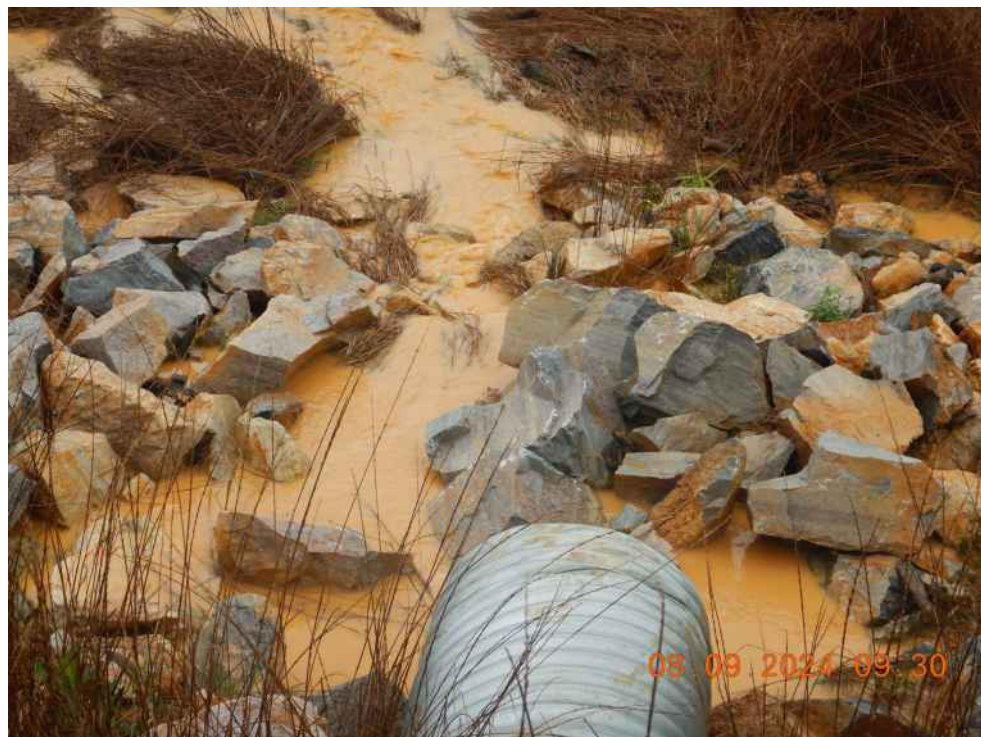
Sediment basin 12 discharging sediment-laden water into Evitts Run.

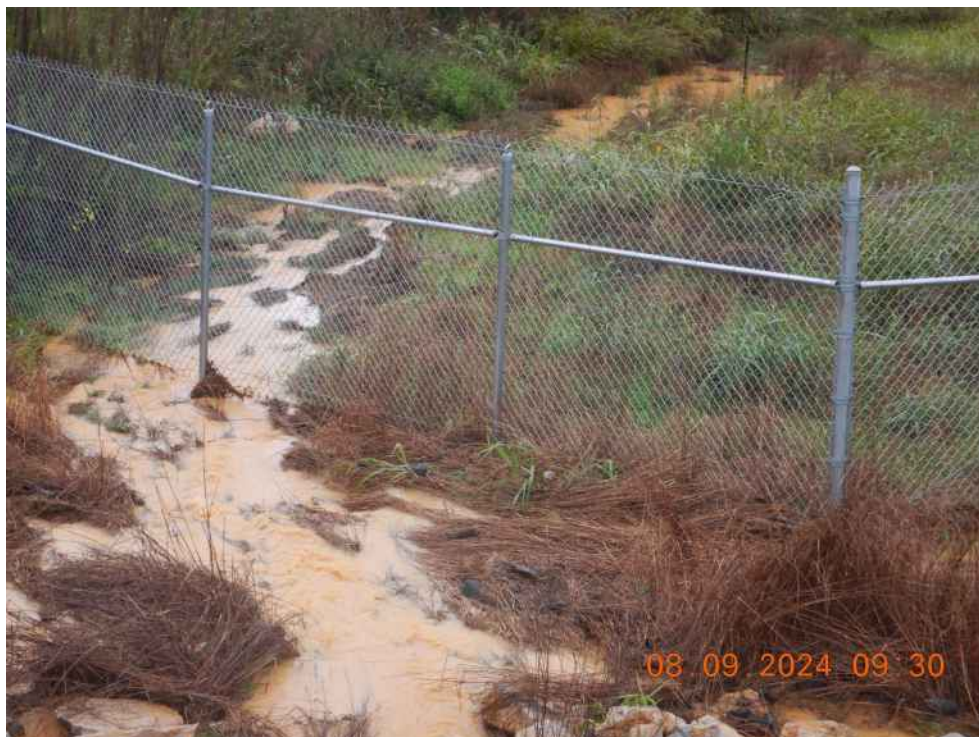
Sediment basin 12 discharging sediment-laden water into Evitts Run.

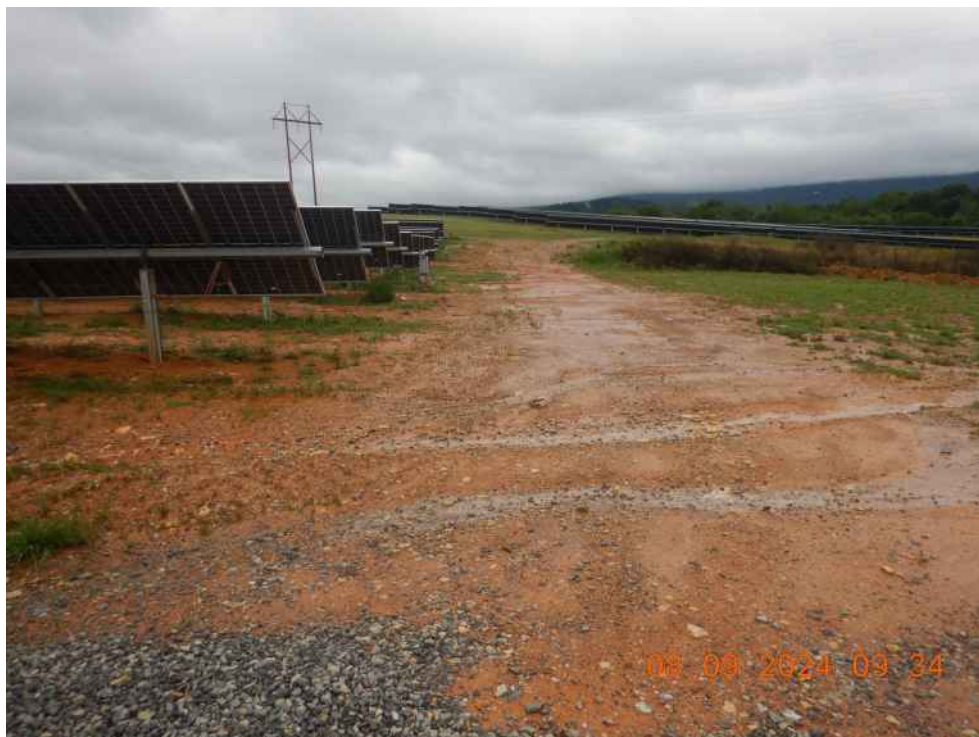
An unstabilized area, above sediment basin 12, that has not been stabilized.

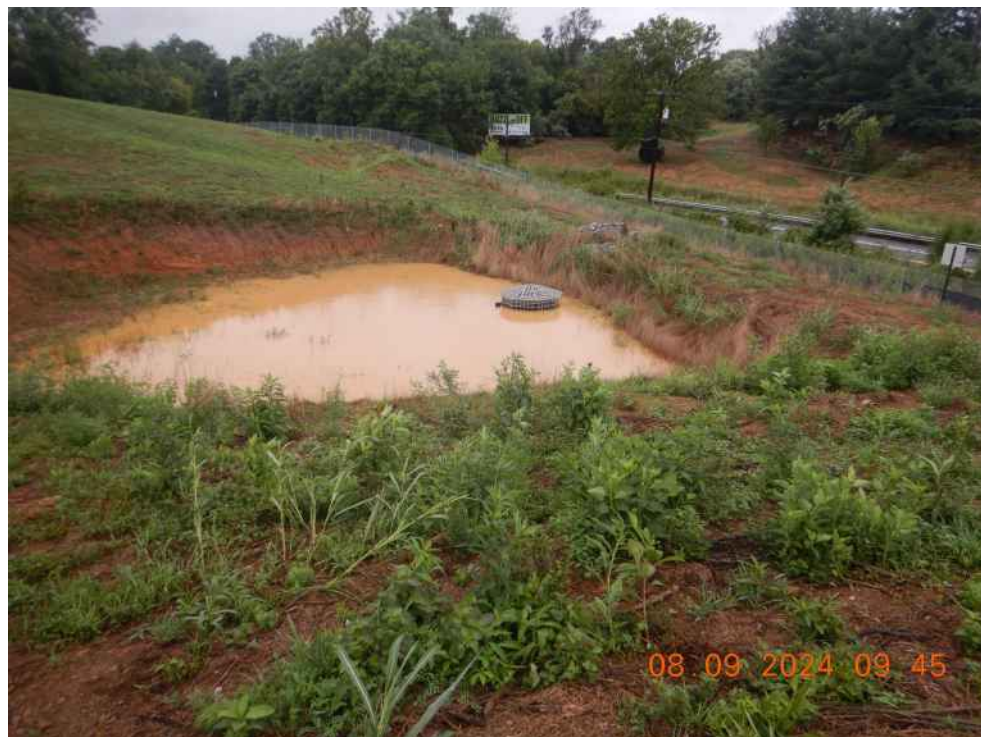
Sediment basin 6 discharging offsite into a WVDOH right-of-way.

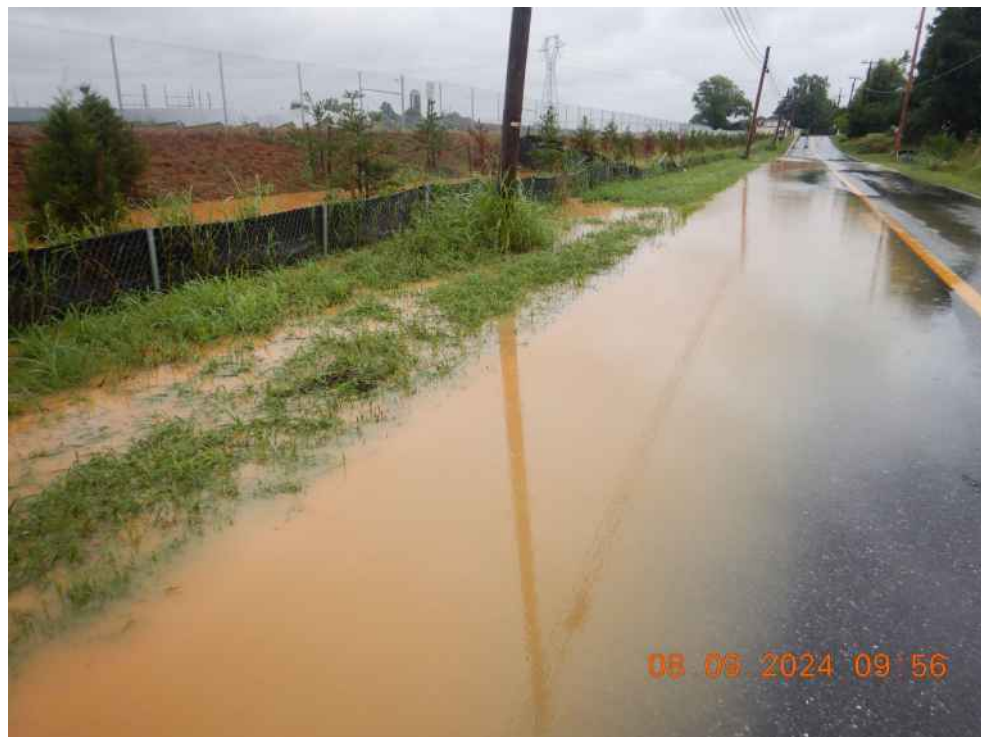
Pond 14A discharging into a WVDOH right-of-way.

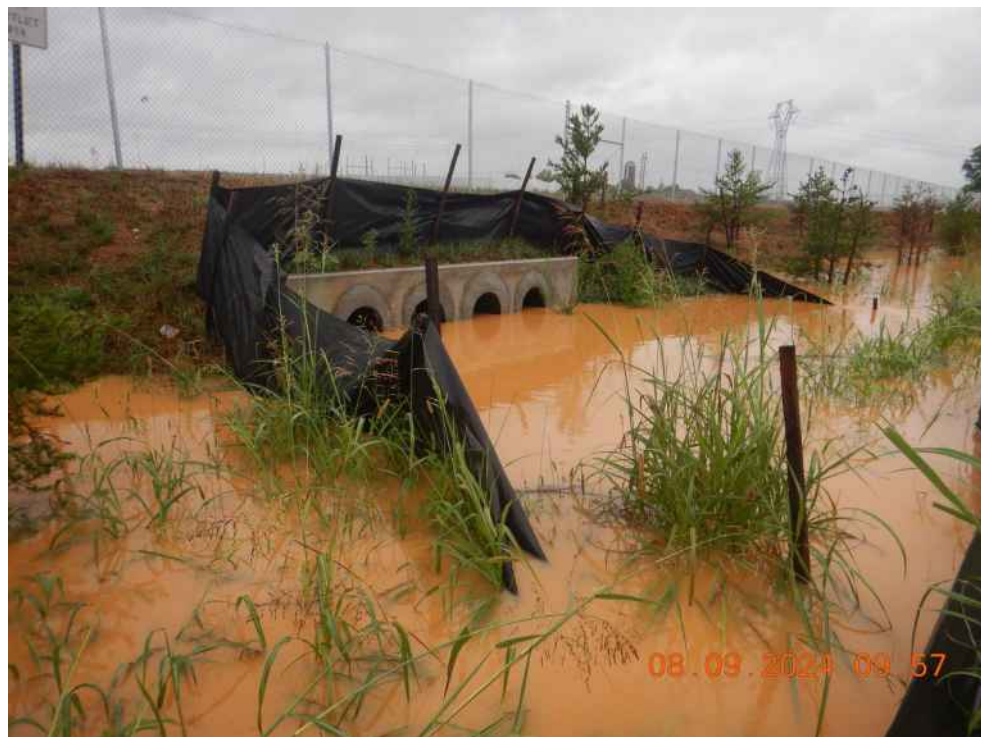
Pond 14A discharging offsite.

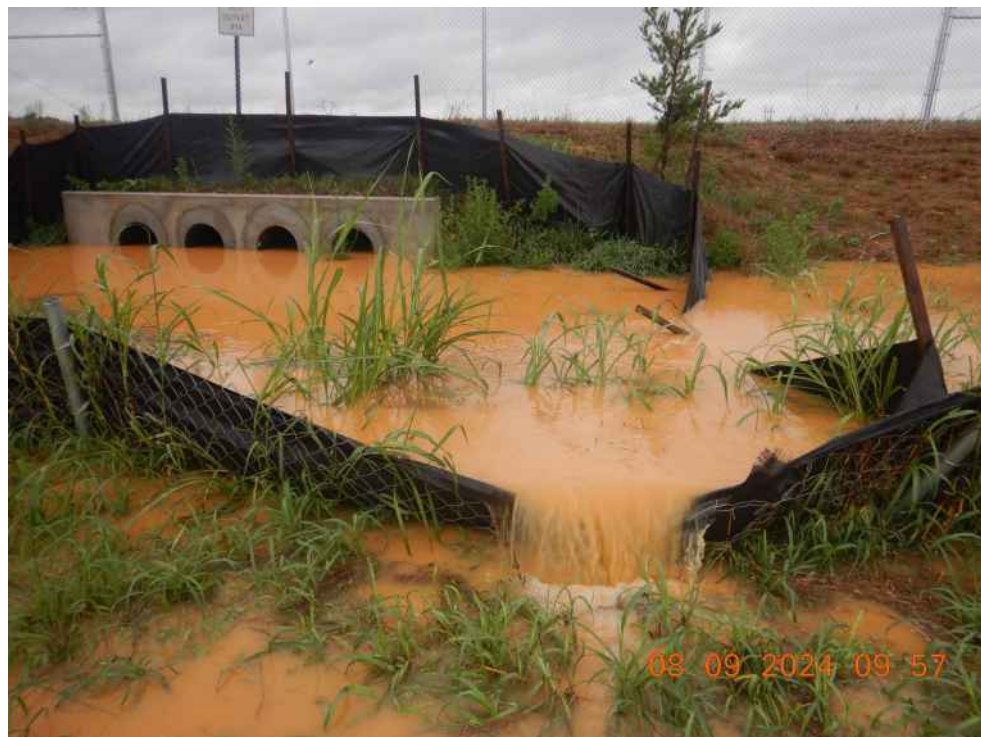
Pond 14A discharging offsite into a WVDOH right-of-way.

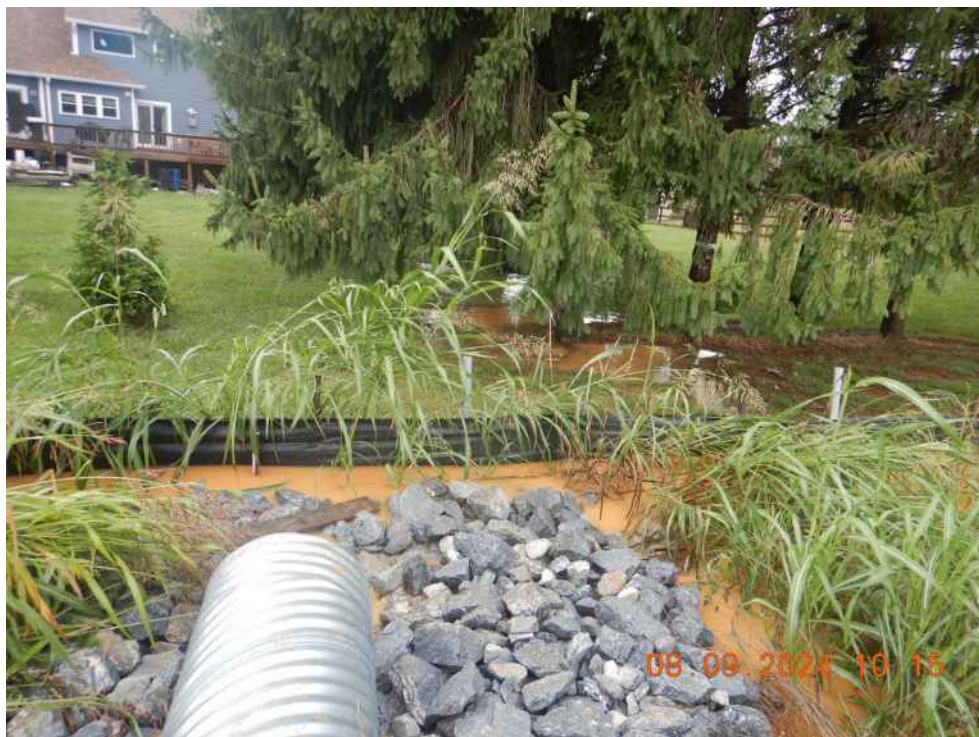
Sediment pond 7 discharging offsite.

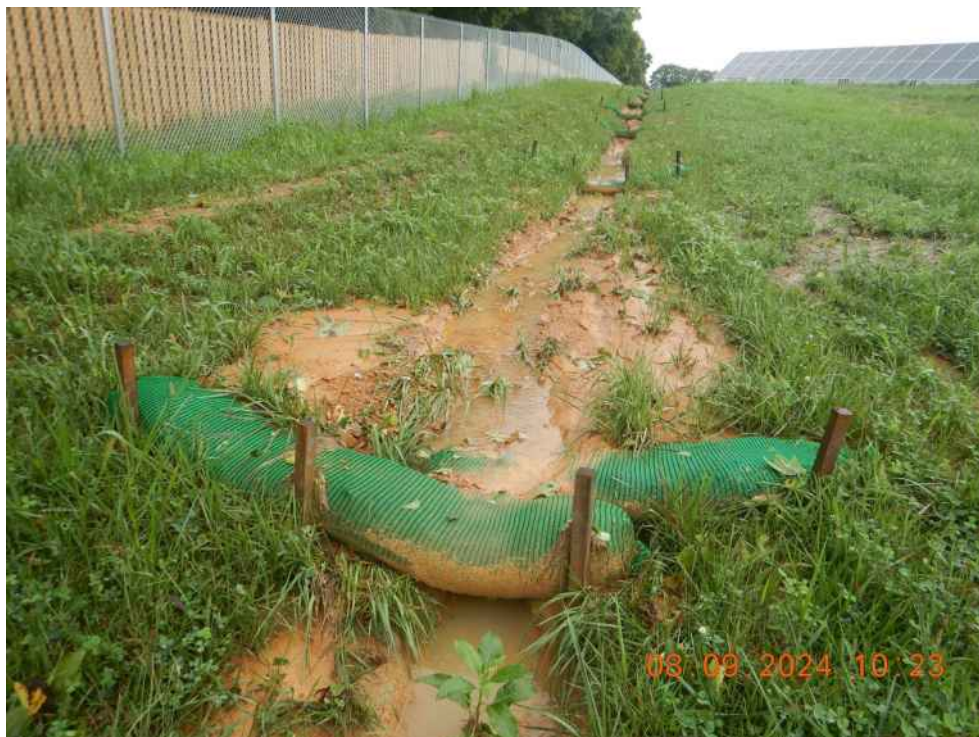
Ditch checks lack maintenance and have been undermined.

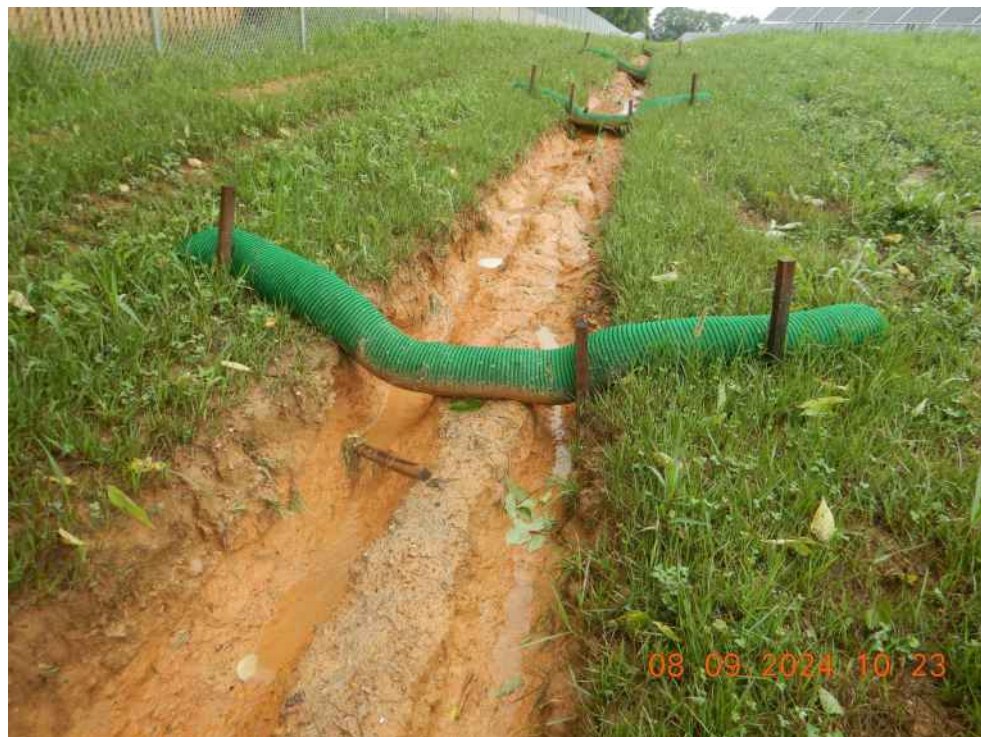
Ditch checks lack maintenance and have been undermined.

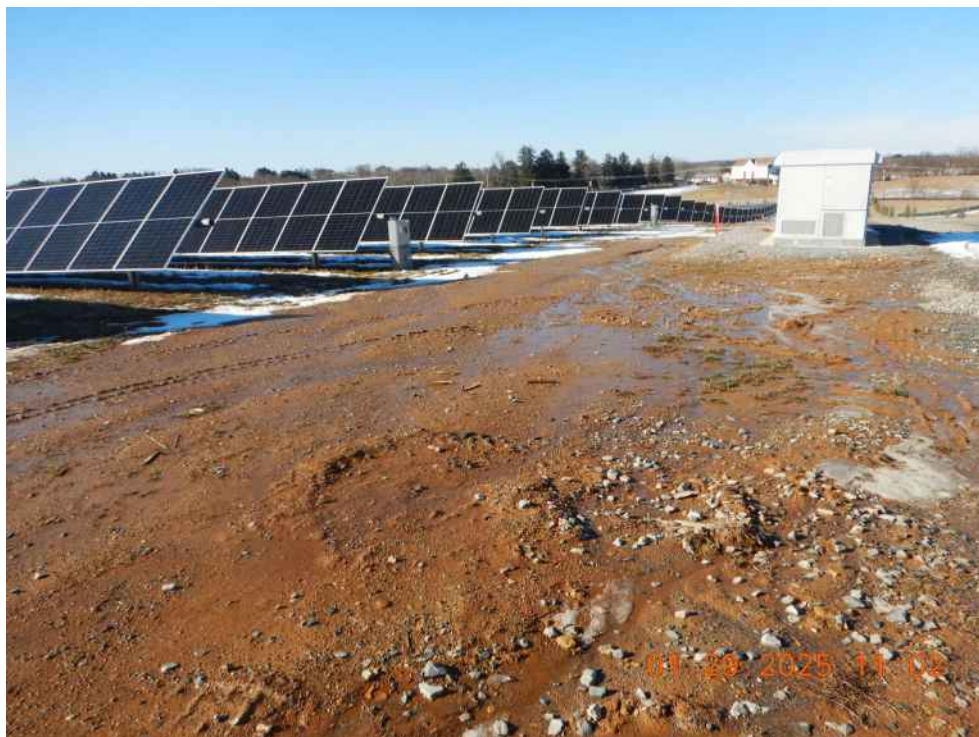
An unstabilized area of the project.

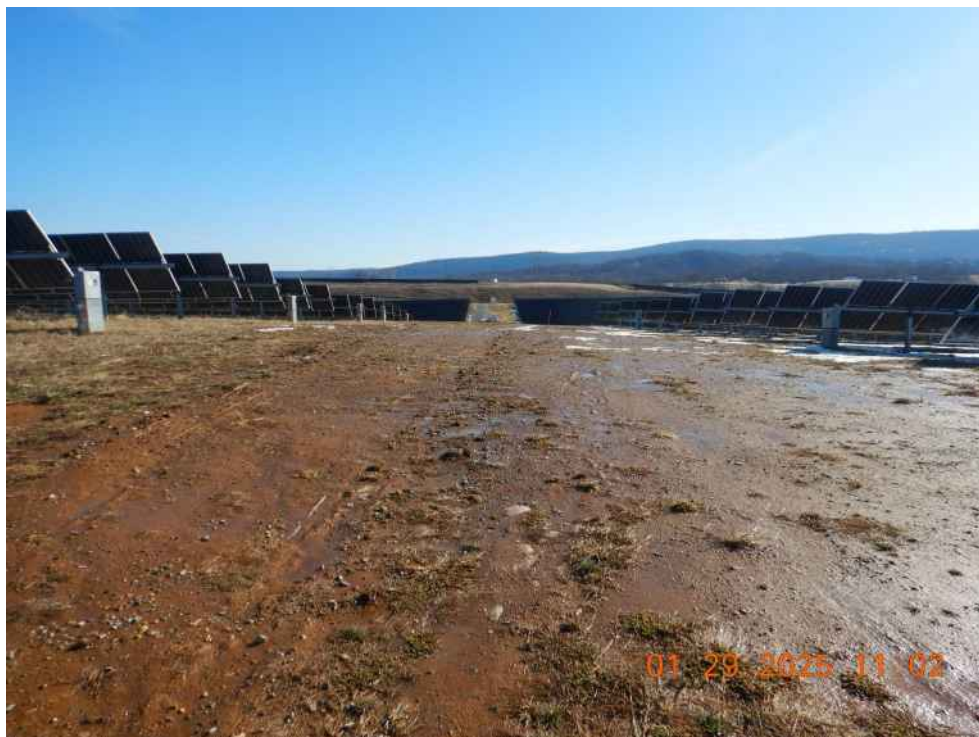
An unstabilized area of the project.

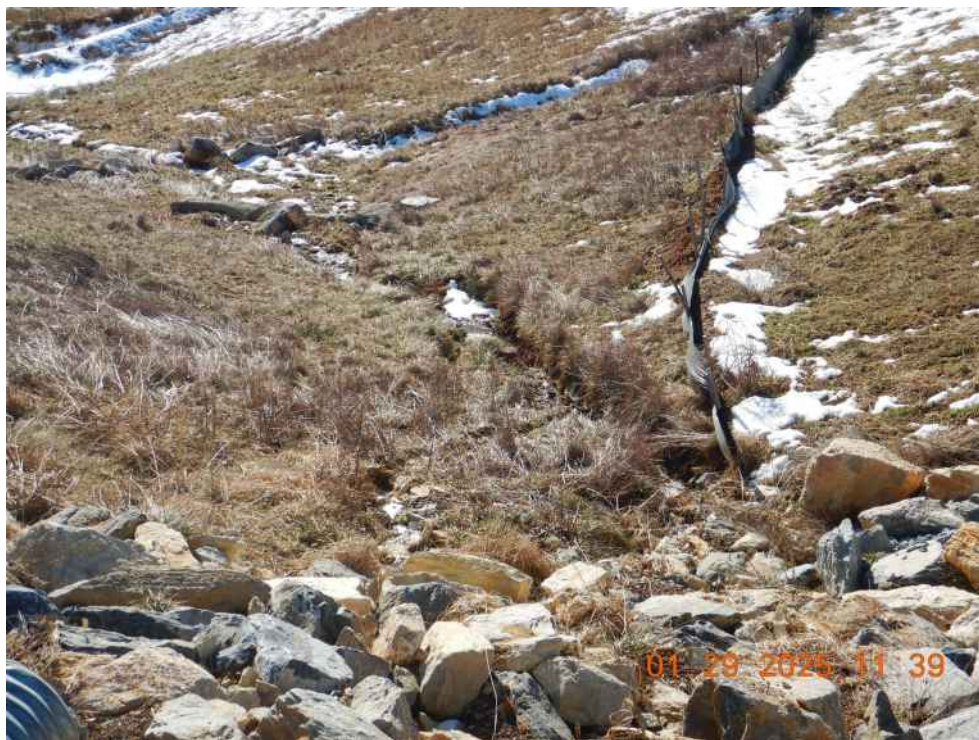
An unstabilized channel that has eroded due to lack of vegetation.

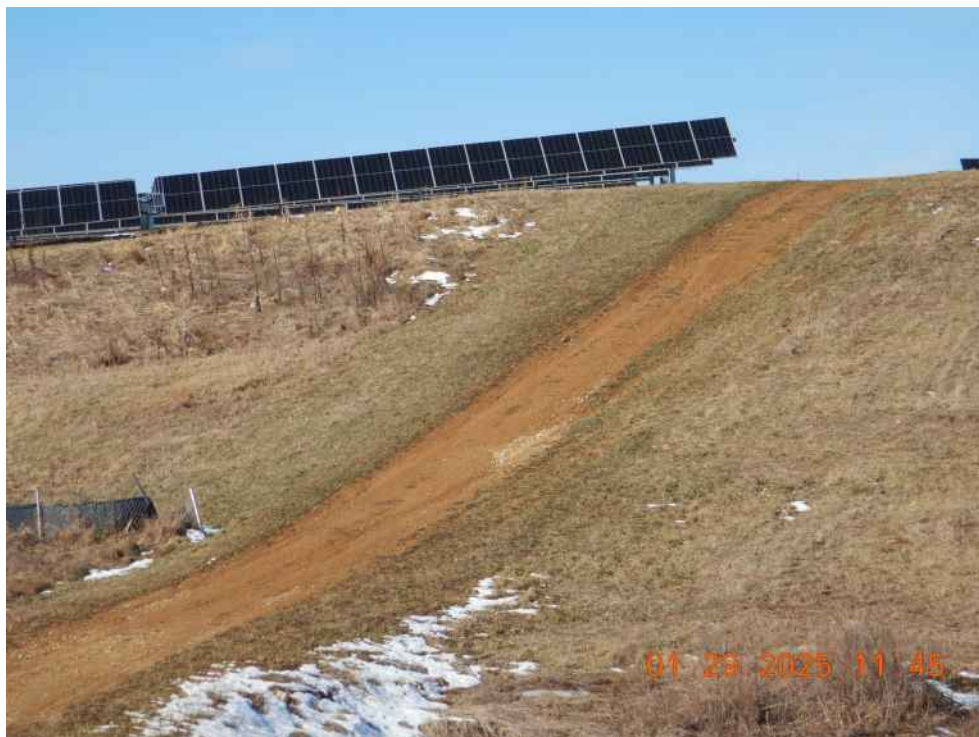
An unstabilized area above sediment basin 13.
